Regent's Canal Wall Survey

Revision B 7/5/2021 (projecting jetty removed)

1 St Mark's Crescent London NW1 7TS

October 2020

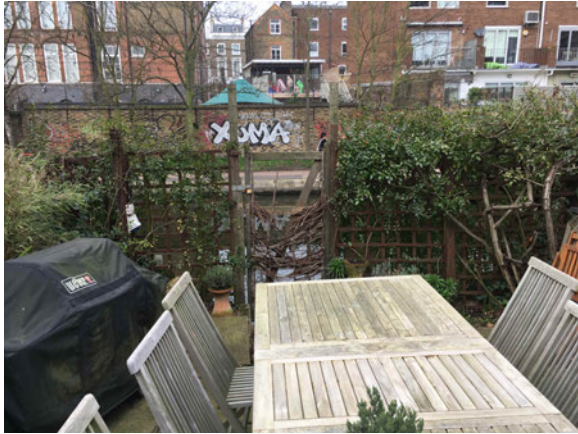
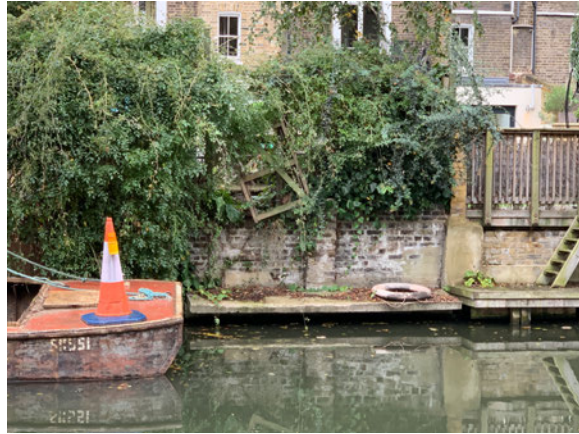
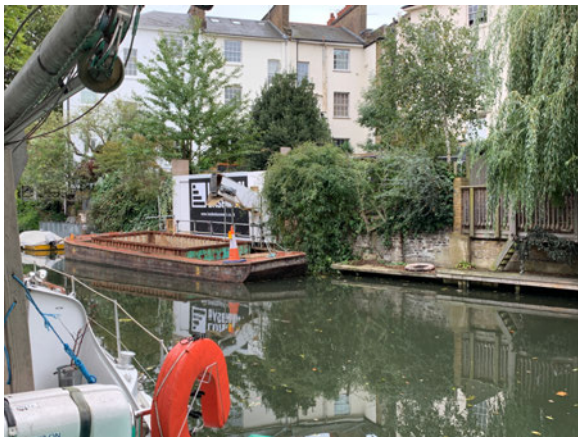
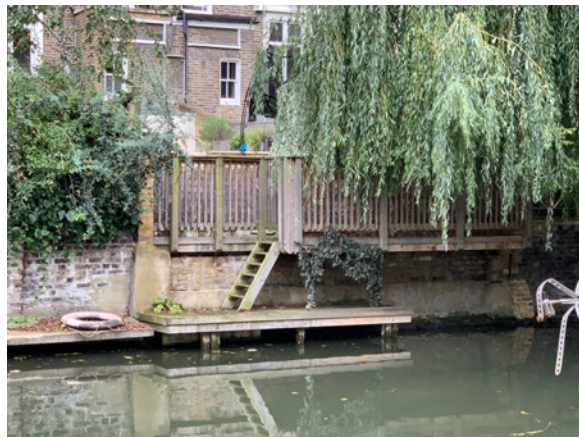
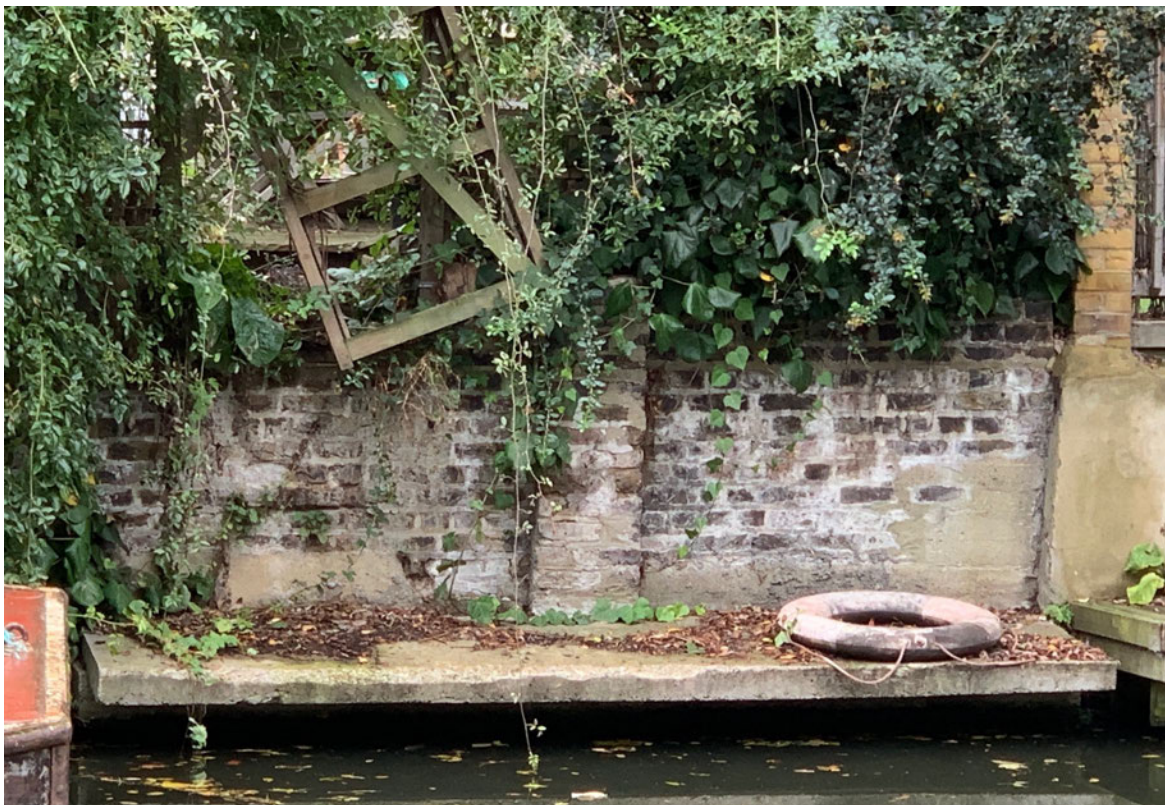
Canal Wall Photos

The canal wall is a 225mm – 750mm thick battered retaining brick wall. The width reaches 750mm thick at a depth of 1650mm with a three piers on the Canal side 340mm wide and projecting 110mm from the point just above water level where the wall steps. A trial pit carried out on 4/12/2019 showed the profile of the wall and is recorded with photos and an excavation log at the end of this survey report. There is a projecting 150mm thick concrete slab 300mm above water level forming a jetty. This slab was built pre-WWII and has rotated slightly over the last 80 years or so under its own weight. The jetty it forms matches the width of those at the properties on either side that are constructed of timber. The brickwork below the water line is firm and undisturbed by the slight rotation of the wall above.

It is proposed first to strengthen the wall from the rear garden side with a 250mm thick concrete retaining wall behind it, all hidden below ground level. This retaining wall will be secured from rotation by a 1m toe projecting beneath the garden and also by two transverse concrete walls containing in-set steps. This will spread the load over a greater width than at present thus reducing any load on the old brickwork beneath. The facing brickwork towards the Canal will be rebuilt in the existing or matching reclaimed buff-coloured London stock bricks with the central pier retained as a feature. The steps will be faced with yorkstone paving stones on the both the landing treads and step risers as the existing steps.

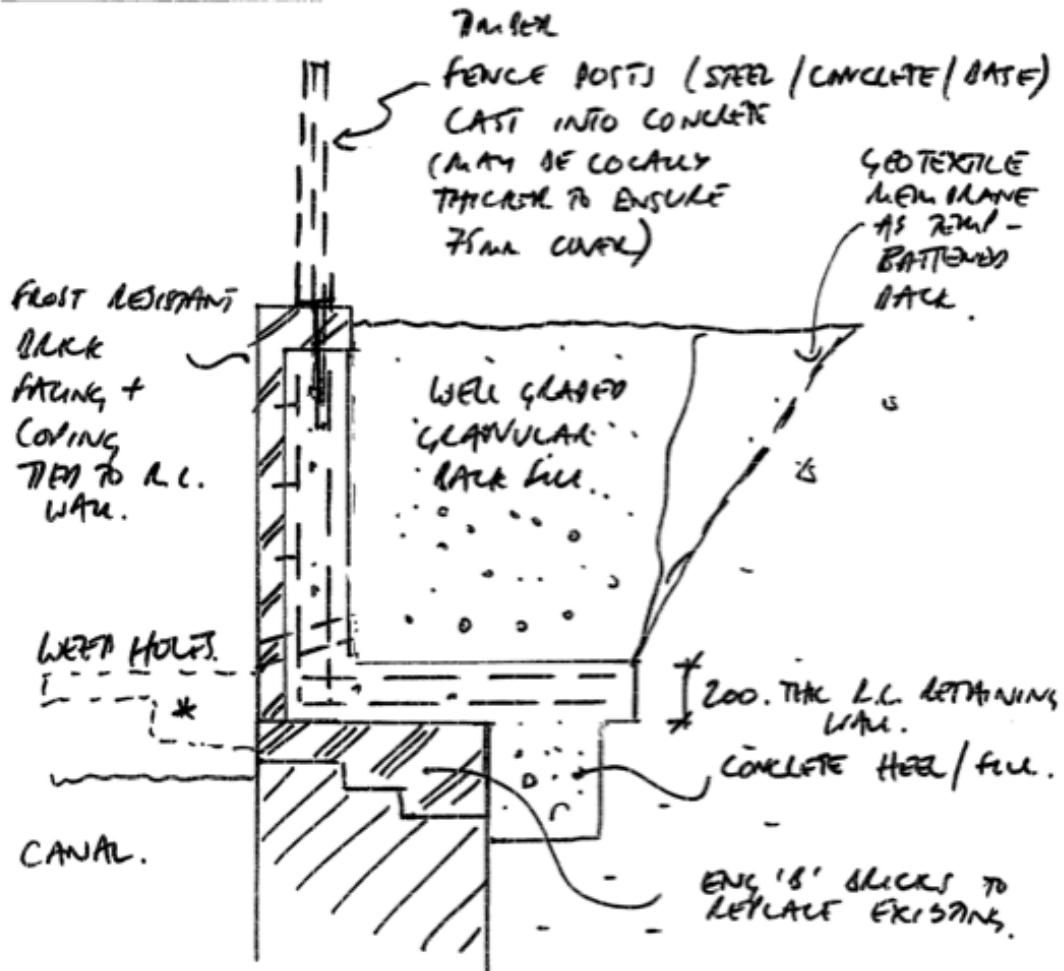
* OLD CONCRETE CANTILEVERED JETTY + BATE REMOVED.

It is proposed to rebuild the canal wall with a 200mm thick reinforced concrete retaining wall with brick facing, and with a 200mm thick reinforced concrete base leg projecting back 1m from the canal face (see drawing SK-S-010 attached). This will resist rotation better than a brick wall and result in only slightly greater loads (<10% assuming all loads are transferred vertically and evenly) on the old brick wall below. However, masonry is typically good in compression and a retaining wall is better under a certain amount of compression / loading, therefore any modest increase in loading will not be detrimental to the existing retaining wall below, and where there maybe areas of higher stress (i.e. at the edges /below new concrete), then bricks will be replaced with engineering bricks.

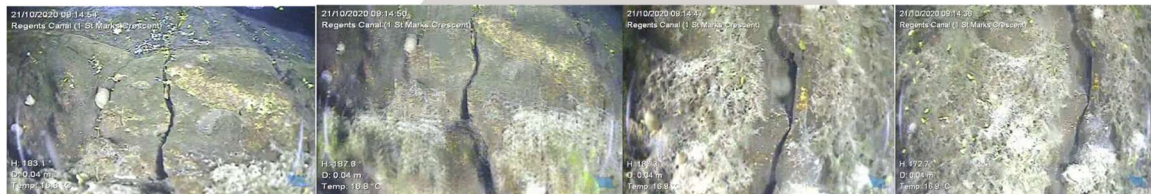
Anomaly 1 was located approximately 1.4 meters to the left of the outer edge of the jetty, this was a vertical crack approximately 5 to 10mm wide.

Repairs to the limited cracks found in the canal wall below the water line will be carried out by a specialist firm using Rockbond Underwater Super Accelerated Mortar (RB UWSAM) powder. This is a blend of special cement powders, high quality graded sands, water soluble polymers and an unique combination of accelerating agents. The powder, when mixed with water, produces a rapid early strength mortar for underwater void filling and concrete repairs at freezing temperatures, and to fast stop the flow of water through cementitious surfaces, masonry, brick and stone.

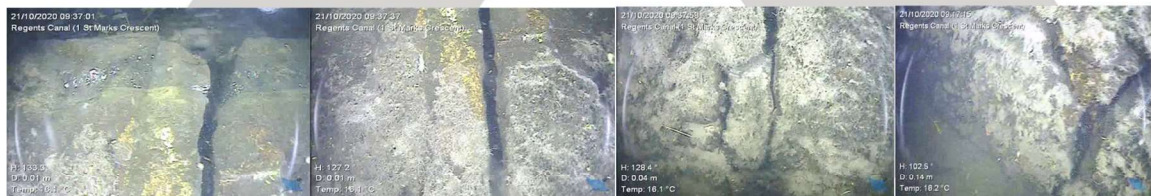
Anomaly 2 was the worst of the 3 anomalies, this was located approximately 1 meter to the left of the outer edge of the jetty, this crack has migrated across as seen in the diagram. The crack at its widest was at approximately 30mm.

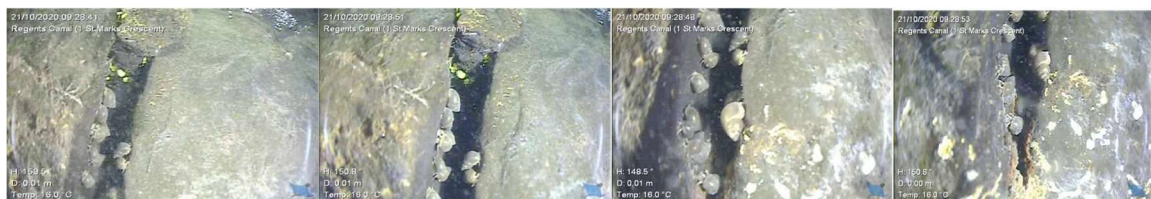
Anomaly 3 was located approximately 875mm from the centre of the jetty, this was vertical and was approximately 20mm wide at its widest, this appears to be mortar that has come away from in between the brickwork.

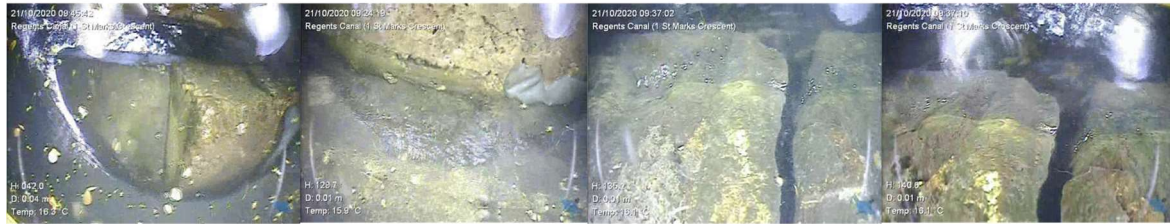
Stone blocks above water

It was noticed that the stone block ended level with the start of the concrete jetty

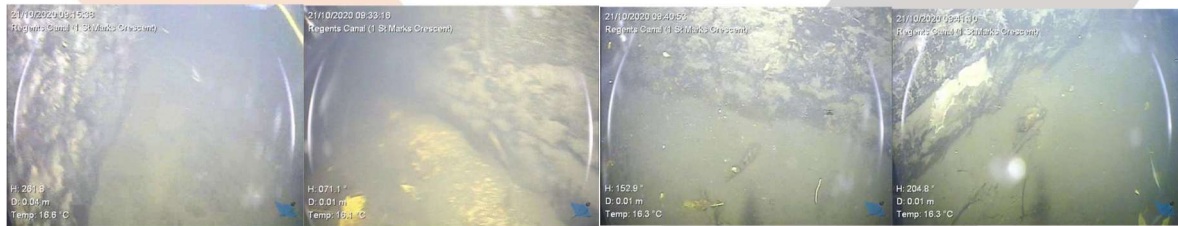
Canal Bed

No scour noted.
