### FACTUAL GEOTECHNICAL GROUND INVESTIGATION REPORT

<b>Site Address:</b>	219A Goldhurst Terrace NW6 3EP
<b>Site Coordinates:</b>	525948, 184004
<b>Prepared for:</b>	Marcus Zaman
<b>Report Reference:</b>	GT-2021-000045
<b>Version No:</b>	1.0
<b>Date:</b>	16/06/2021
<b>Report Authors:</b>	Gregory Northwood (MSc) <b>Geo-environmental Consultant</b>
<b>Authorised by:</b>	Simon Makoni (MSc, BSc) <b>Director</b>

STM Environmental Consultants Limited were commissioned by Marcus Zaman (Client) to undertake a ground investigation at 219A Goldhurst Terrace, NW6 3EP (the Site).

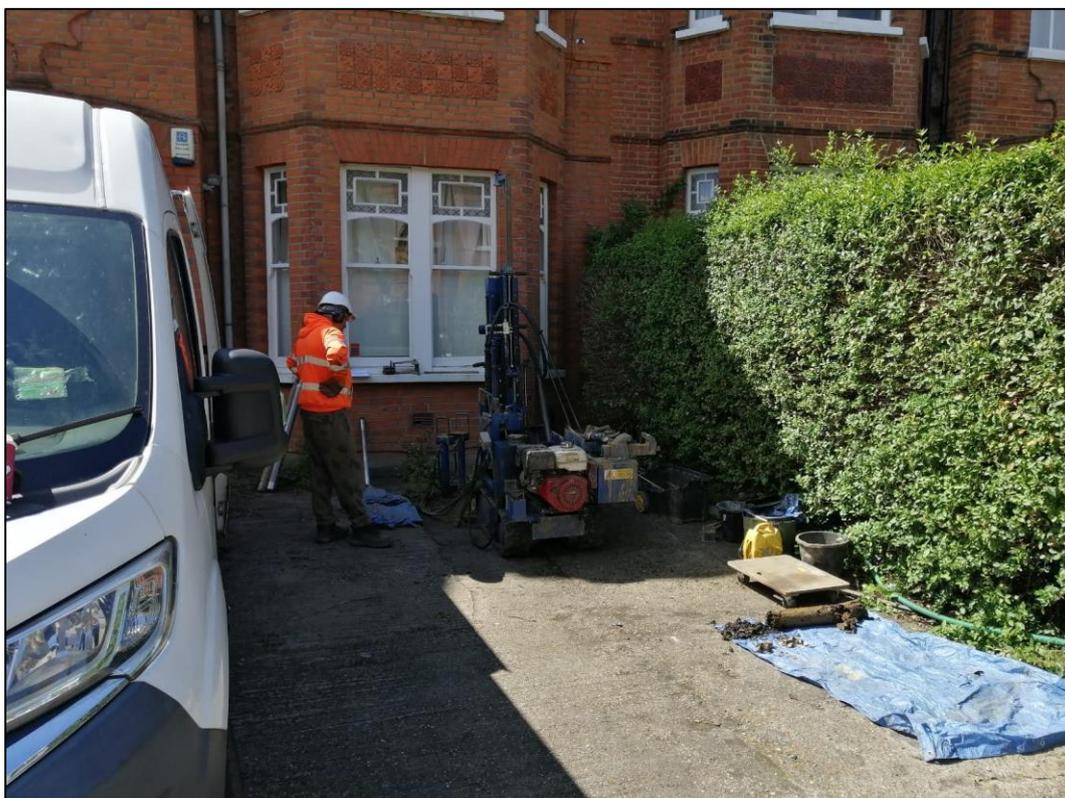
Photograph showing the Dynamic Windowless Sampling Rig in operation at BH01.

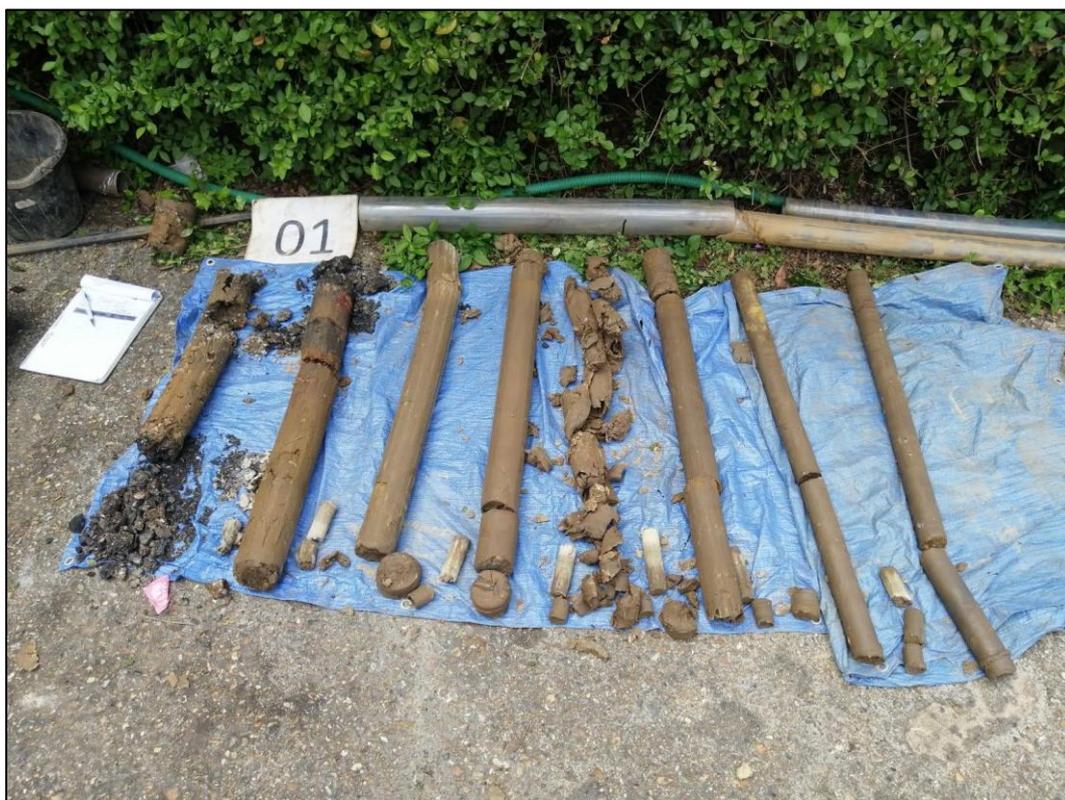
The borehole revealed ground conditions that were generally consistent with the geological records of the area. Made Ground (Gravelly CLAY containing occasional fragments of bituminous material) was encountered to a maximum depth of 1.15mbgl, and was underlain by light brown CLAY with pockets of orange fine SAND to a maximum depth of 8mbgl.

Photograph showing the 1<sup>st</sup> to 8<sup>th</sup> (left to right) meter of soil retrieved from BH01.
