18th April 2018

FULL BUILDING SURVEY REPORT

20-22 Wenlock Road, London, N1 7GU

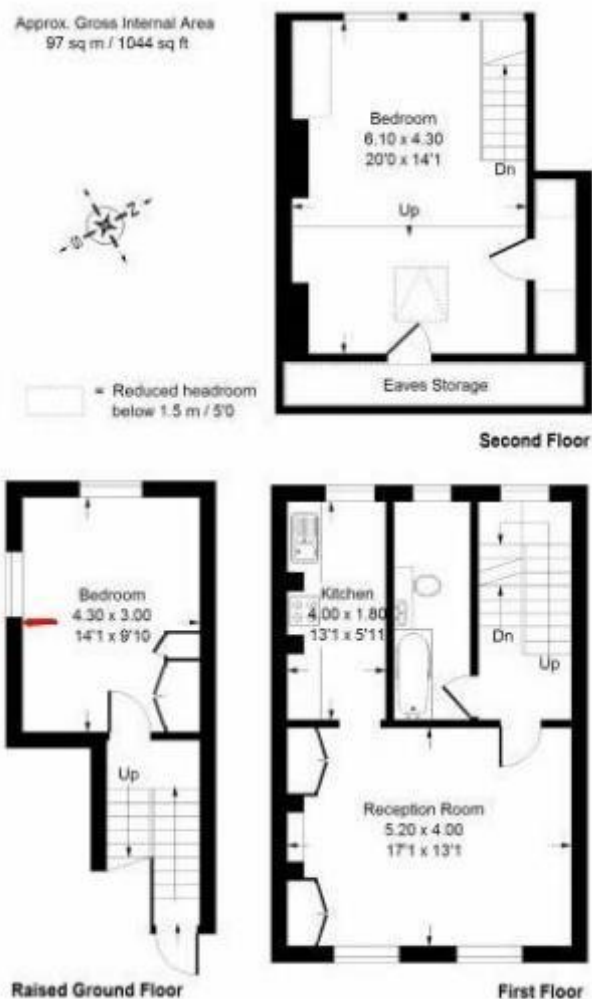
Photo 72

The source of this moisture appears to be caused by roof leak. The roof requires renewal.

You are advised to commission a skilled builder to undertake the works the cause of dampness is not due to a defective damp proof course.

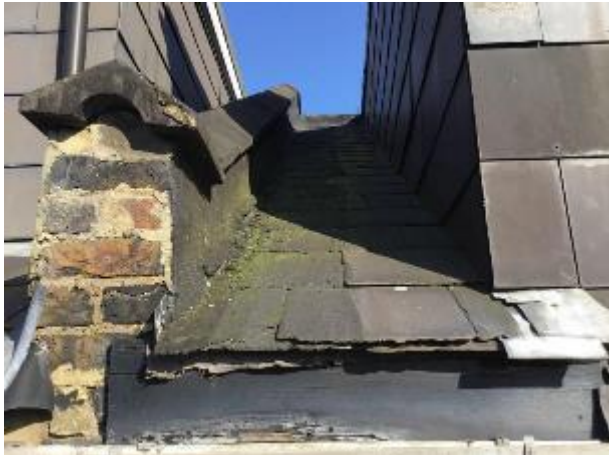
Photo 2

There are several slipped tiles to the front, which is a sign of frost damage or corrosion of the nails, which hold the tiles to the below battens. It is recommended that you seek quotes from reputable roofing contractors for the replacement of affected tiles immediately. [Survey Photographs - Photo 2], [Survey Photographs - Photo 3]

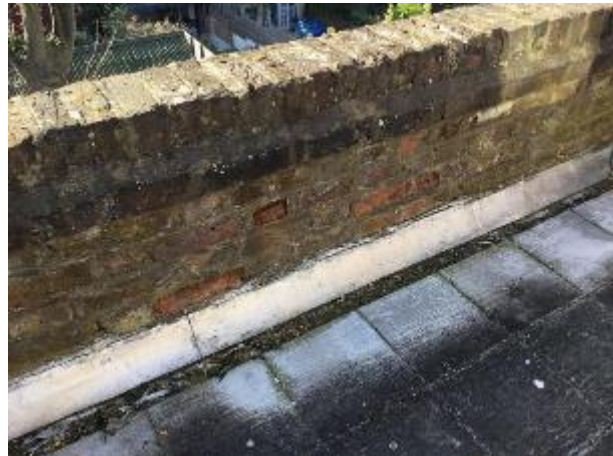
Photo 9

The rear dormer roof structure is flat and was in an unsatisfactory condition at the time of the survey. The roof coverings appear to be in an unsatisfactory condition and require renewal.

The abutments are sealed with lead, which appeared to be adequate at the time of the survey and requires no repairs. Overall, it is estimated that the remaining life of the roof coverings to this section is 0 years. [Survey Photographs - Photo 4], [Survey Photographs - Photo 5], [Survey Photographs - Photo 6], [Survey Photographs - Photo 7], [Survey Photographs - Photo 8], [Survey Photographs - Photo 9], [Survey Photographs - Photo 10], [Survey Photographs - Photo 11]

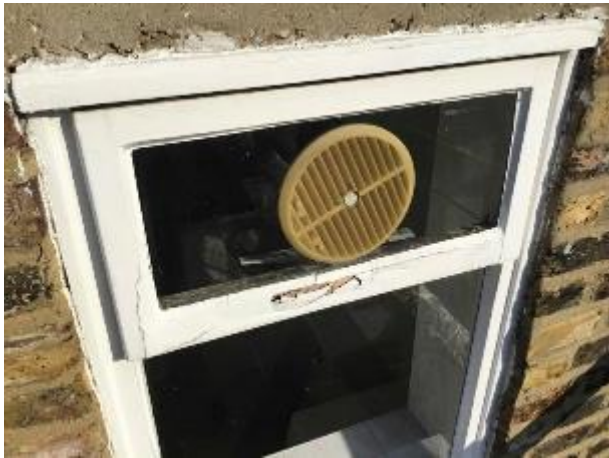
Photo 14

The external window sills were in a satisfactory condition. [Survey Photographs - Photo 14], [Survey Photographs - Photo 15], [Survey Photographs - Photo 16], [Survey Photographs - Photo 17]
