Repair of party fence wall between Numbers 10 and 11 Chalcot Square

Design and Access Statement

This application relates to the repair of the party fence wall (garden wall) separating Numbers 10 and 11 Chalcot Square London NW1 8YB.

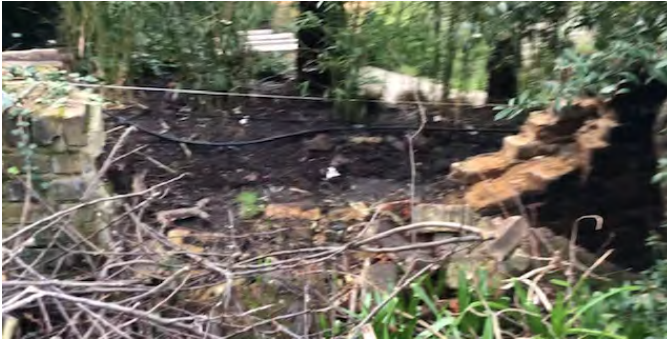
In November 2019, a 3 metres long section of the wall collapsed (photo 1). Over the following months it became apparent that the adjacent section of wall was leaning increasingly towards Number 11 Chalcot Square and was in imminent danger of collapse. By this time, the country was in lockdown for the pandemic.

Photo 1: Collapsed section, Number 11 side

A firm of structural engineers was appointed in September 2020 to advise on how the wall should be repaired and their report is attached to this application. The engineers advised that the wall needed to be rebuilt from the end of the garden of Number 10 for a length of 8.3 metres up to and including the second pier.

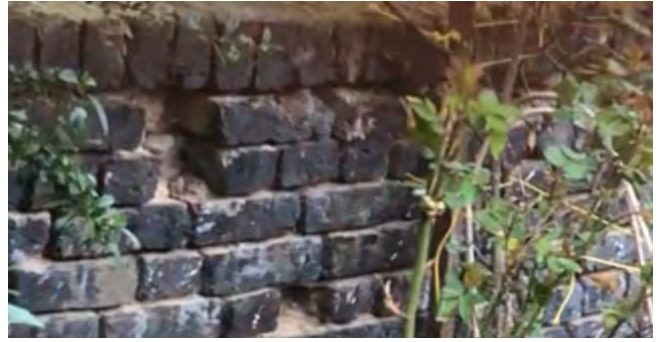
This was built mainly of reddish coloured London stock bricks and included two tapered piers. Parts of the brickwork were missing (photo 2) including about 25% of the second pier (photo 3), and parts had been poorly repaired (photo 5). The wall was capped with stock bricks on edge.

Photo 2: Number 11 side

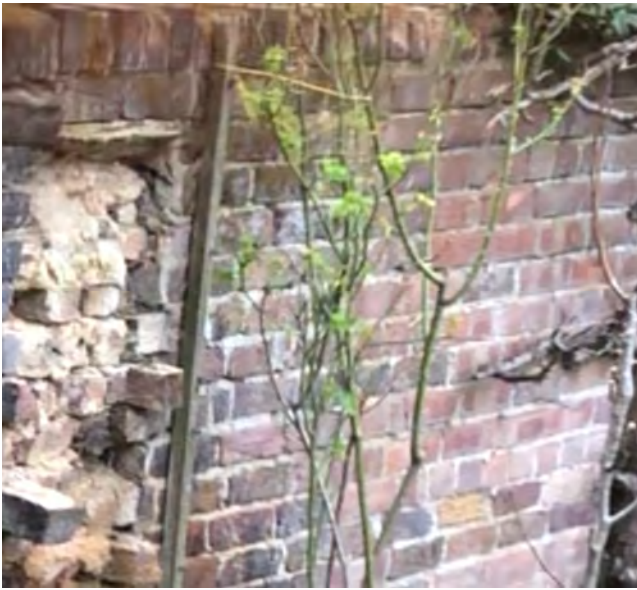
Photo 3: 2nd pier, Number 11 side

The second pier detail required minor adaptation to provide a transition between the vertical rebuilt wall and the original wall which was just under 75 mm off vertical.

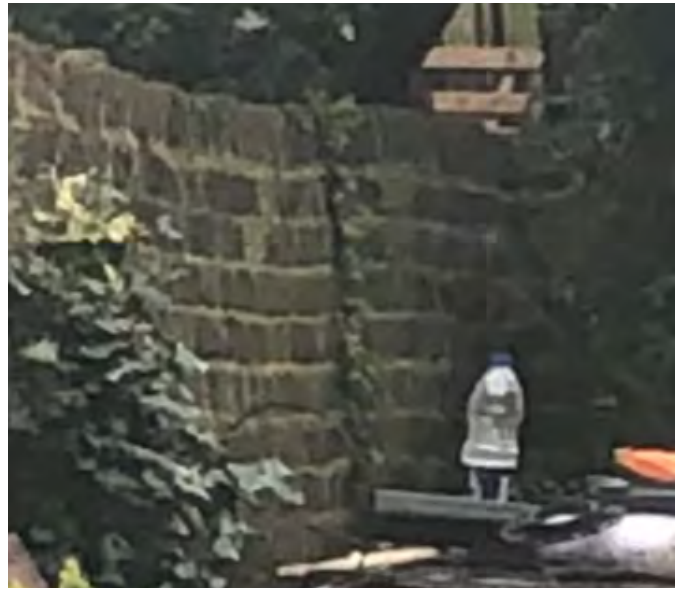
Photo 4: 2nd pier, Number 10 side

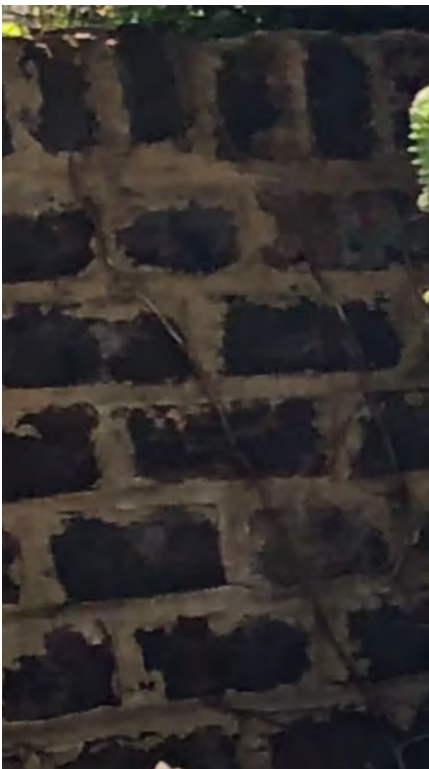
Photo 5: Old cement repairs, Number 10 side

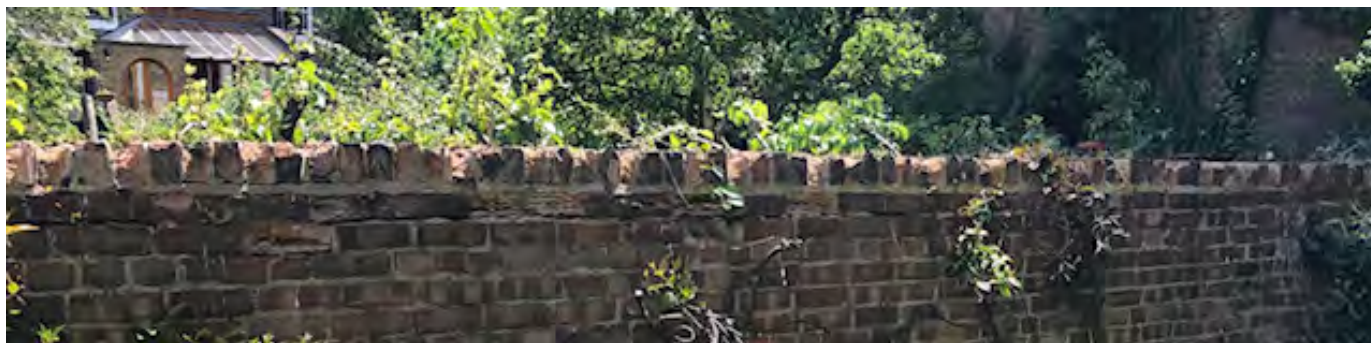
In addition, the capping on the remainder of the wall was badly eroded (photo 6) and needed replacing to avoid further erosion of the wall.

This section was rebuilt, probably in the first half of the twentieth century, using mainly common bricks but incorporating some 10% of stock bricks. It includes one vertical pier and has brick on edge capping (common bricks) which was severely eroded (photo 6). The general brickwork standard is not high (photos 7 & 8).

Photo 6: Condition of capping before repair

The remaining original wall was recapped with reclaimed stock bricks on edge.

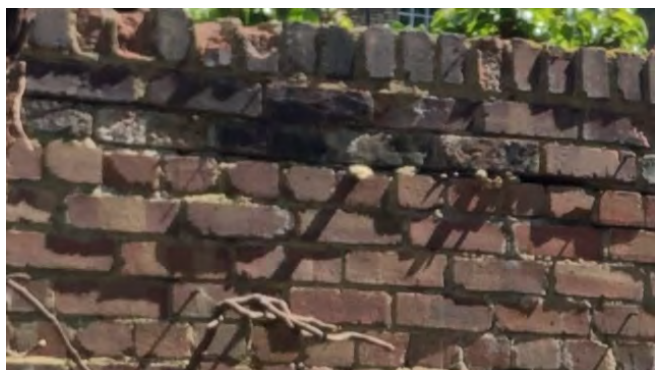
Photo 7: Quality of this section of wall

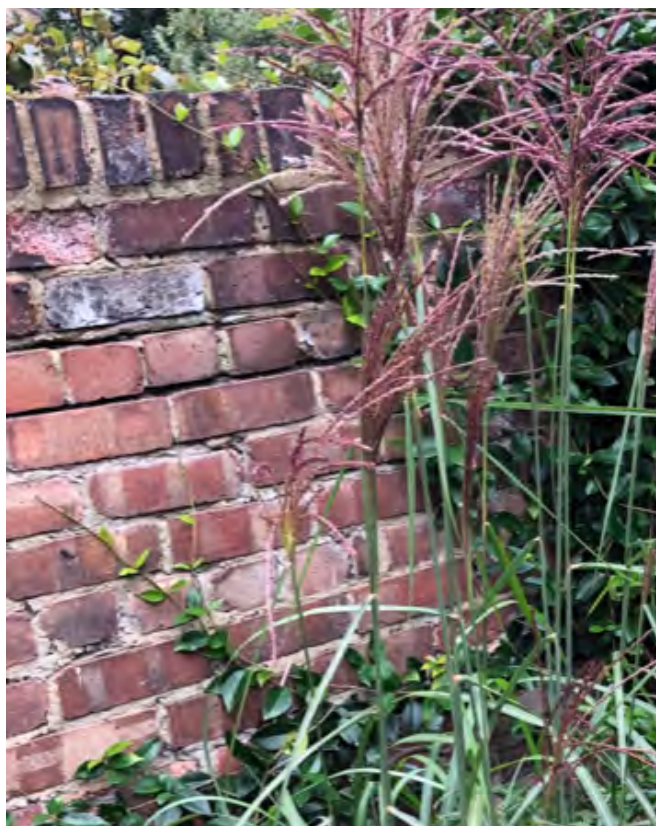
Photo 8: Brick types

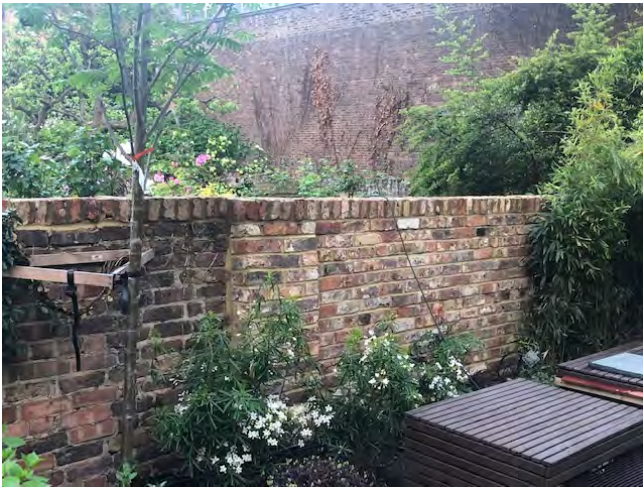
Photo 9: Junction of rebuilt wall & 2nd pier and old recapped wall, Number 10 side

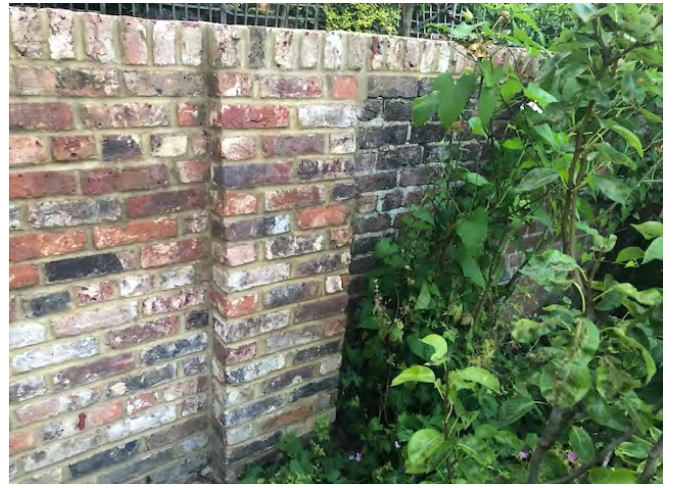
Photo 10: Junction of rebuilt wall & 2nd pier and old recapped wall which is about 75 mm off vertical, Number 11 side

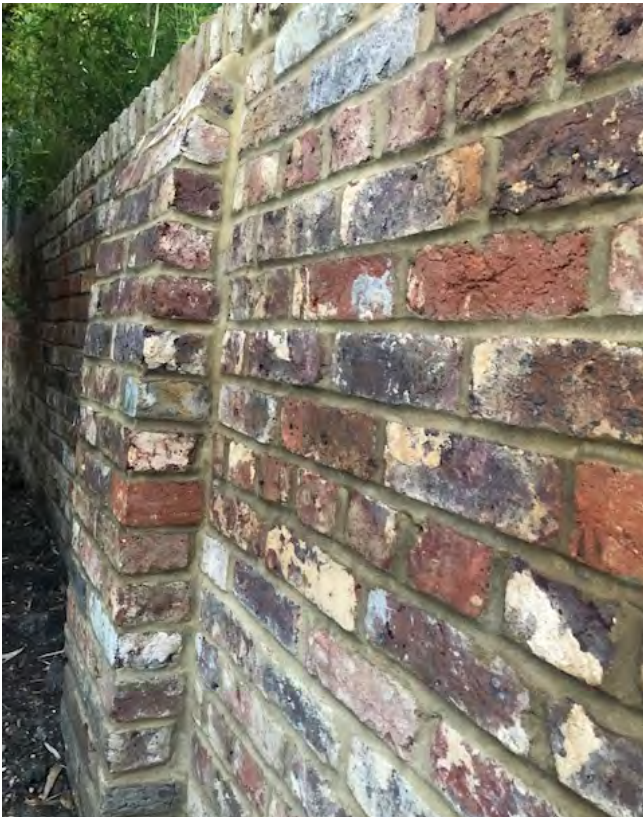
Photo 11: Rebuilt tapered 1st pier, Number 11 side

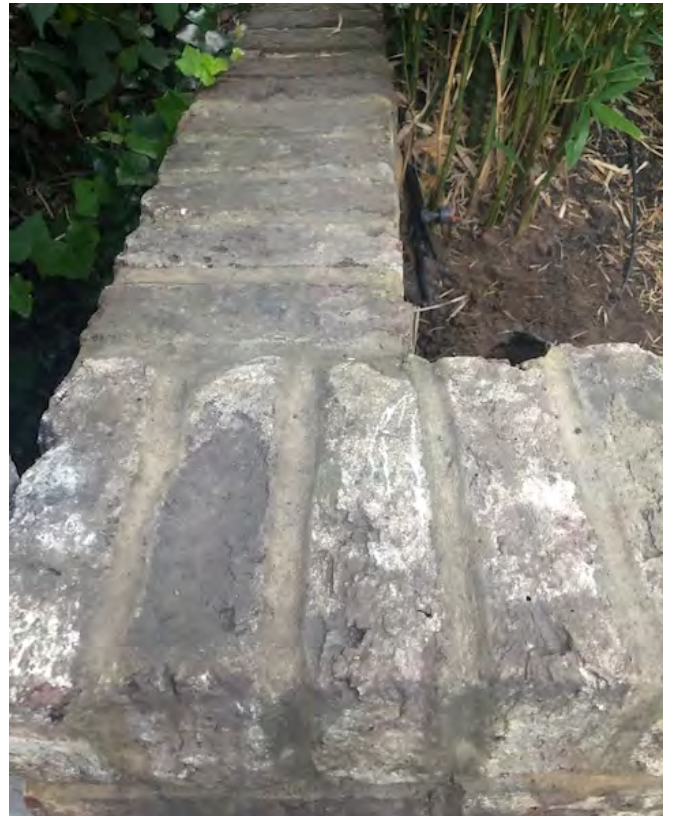
Photo 12: Junction of rebuilt wall between Numbers 10 & 11 (left to right) and existing end wall of Number 10 (top to bottom)

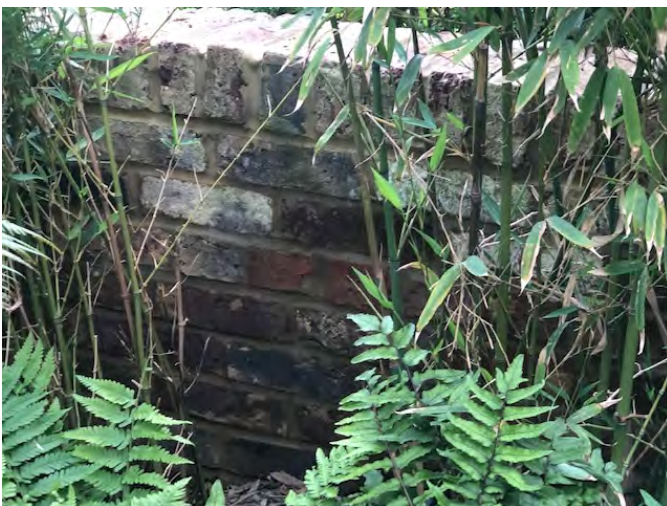
Photo 13: Rebuilt wall, Number 10 side

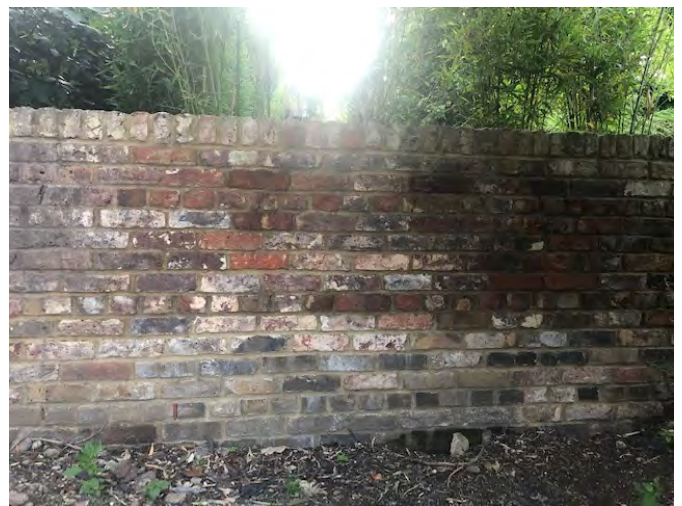
Photo 14: Rebuilt wall, Number 11 side
