## STRUCTURAL ENGINEER'S REPORT

TO INSPECT THE STABILITY OF THE CERAMIC FRIEZE COPING TILES  
AT THE HEAD OF 18 COLUMNS

PROJECT REF:	M19070/BCS/LS/AY
SUBJECT ADDRESS:	<b>Royal College of General Practitioners 30 Euston Square Kings Cross London, NW1 2FB</b>
COMMISSIONING CLIENT/ ADDRESS:	Lewis Berkeley Limited 92 Banner Street London EC1Y 8JU
DATE OF INSPECTION:	Wednesday 3 <sup>rd</sup> April 2019

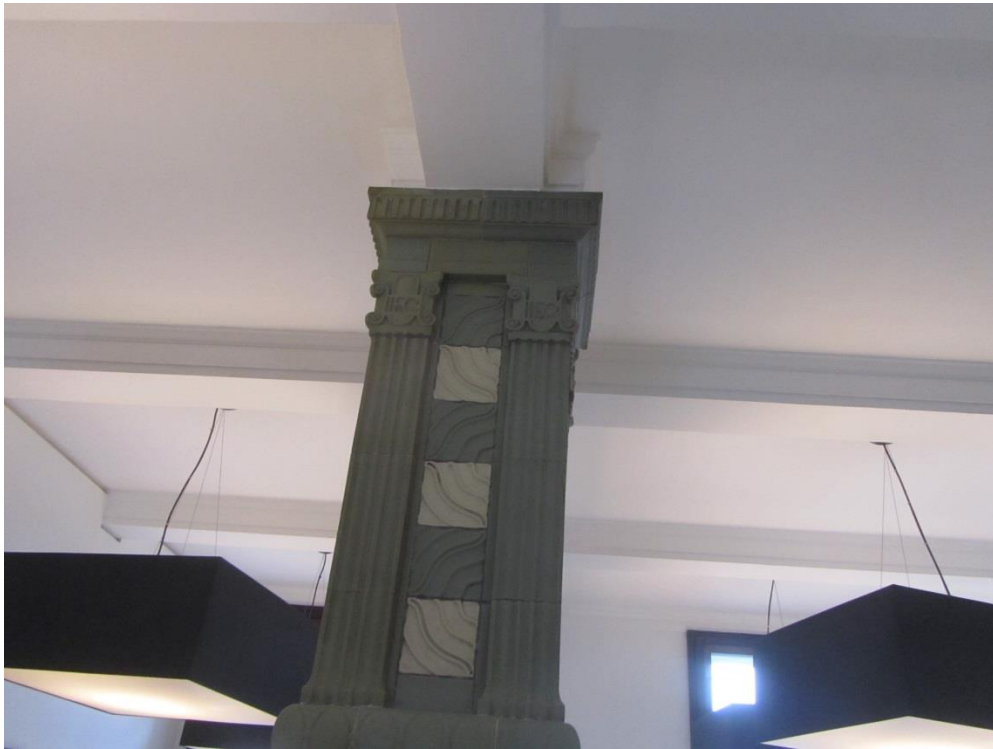
Photo Number	Location (as referenced on drawing)	Type of Frieze Cornice Tile	Comments
<b>Level 3 – see M19070/SK01</b>			
Level 3 C1 -1	Column 1	Ceramic	No loose sections identified
Level 3 C1 -2	Column 1	Ceramic	“
Level 3 C1 -3	Column 1	Ceramic	“
Level 3 C1 -4	Column 1	Ceramic	“
Level 3 C1 -5	Column 1	Ceramic	“
Level 3 C2 -1	Column 2	Ceramic	No loose sections identified but set against the wall. I x no. joint not grouted.
Level 3 C2 -2	Column 2	Ceramic	“
Level 3 C2 -3	Column 2	Ceramic	“
Level 3 C3 -1	Column 3	Ceramic	. Corner section loose and needs re-setting.
Level 3 C3 -2	Column 3	Ceramic	“
Level 3 C3 -3	Column 3	Ceramic	“
Level 3 C3 -4	Column 3	Ceramic	“
Level 3 C4 -1	Column 4	Ceramic	No loose sections identified.
Level 3 C4 -2	Column 4	Ceramic	“
Level 3 C4 -3	Column 4	Ceramic	“
Level 3 C4 -4	Column 4	Ceramic	“
Level 3 C5 -1	Column 5	Ceramic	No loose sections identified
Level 3 C5 -2	Column 5	Ceramic	“

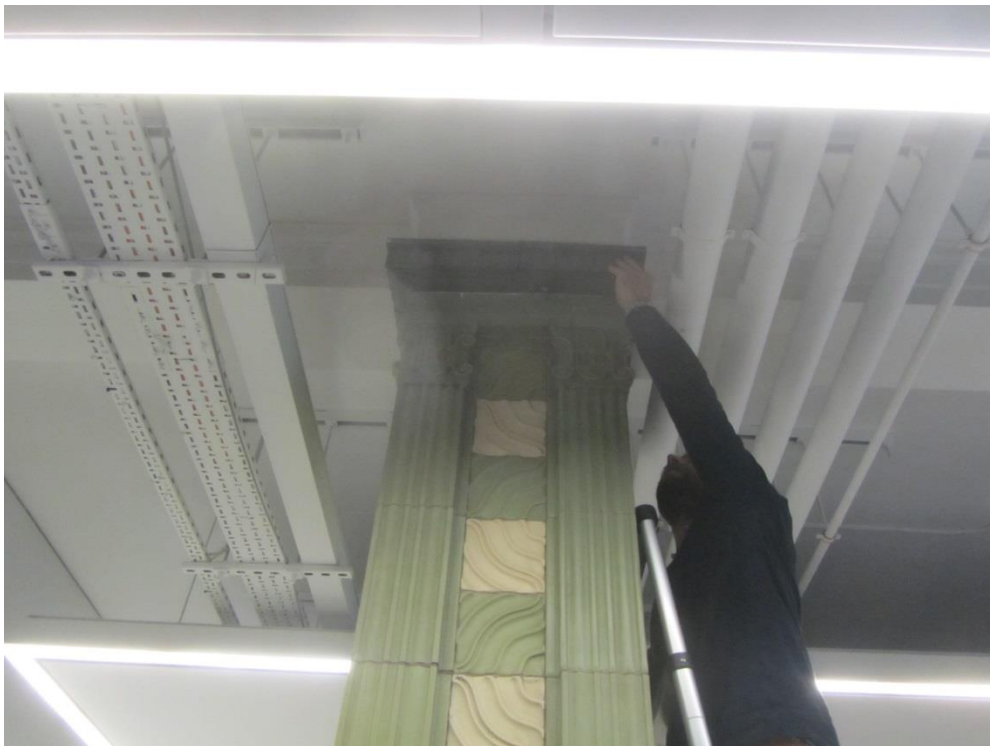
Level 3 C5 -3	Column 5	Ceramic	“
<b>Level 2 – see M19070/SK02</b>			
Level 2 C1 -1	Column 1	Ceramic	No loose sections identified.
Level 2 C1 -2	Column 1	Ceramic	“
Level 2 C2 -1	Column 2	Ceramic	No loose sections identified. Inspection not possible on one sides (desks present)
Level 2 C2 -2	Column 2	Ceramic	“
Level 2 C2 -3	Column 2	Ceramic	“

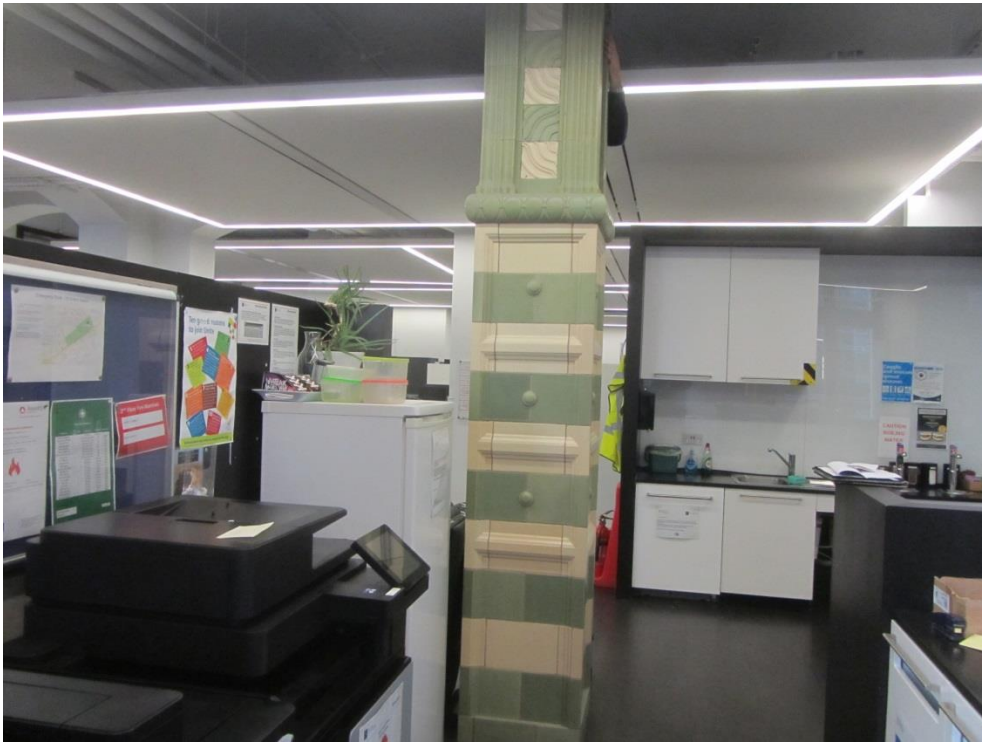
Photo Number	Location (as referenced on drawing)	Type of Frieze Cornice Tile	Comments
Level 2 C3 -1	Column 3	Ceramic	No loose sections identified.
Level 2 C3 -2	Column 3	Ceramic	"
Level 2 C3 -3	Column 3	Ceramic	"
Level 2 C3 -4	Column 3	Ceramic	"
Level 2 C3 -5	Column 3	Ceramic	"
Level 2 C4 -1	Column 4	Ceramic	"
Level 2 C4 -2	Column 4	Ceramic	"
Level 2 C4 -3	Column 4	Ceramic	"
Level 2 C4 -4	Column 4	Ceramic	"
Level 2 C5 -1	Column 5	Part ceramic, with timber sections	Column wrapped and sections missing
Level 2 C5 -2	Column 5	"	"
Level 2 C5 -3	Column 5	"	"
Level 2 C5 -4	Column 5	"	"
Level 2 C5 -5	Column 5	"	"
Level 2 C5 -6	Column 5	"	"
<b>Level 1 - see M19070/SK03</b>			
Level 1 C1 -1	Column 1	Ceramic	No loose sections identified. Paint peeling to beam soffit.
Level 1 C1 -2	Column 1	Ceramic	"
Level 1 C1 -3	Column 1	Ceramic	"
Level 1 C2 -1	Column 2	Ceramic	No loose sections identified.
Level 1 C2 -2	Column 2	Ceramic	"

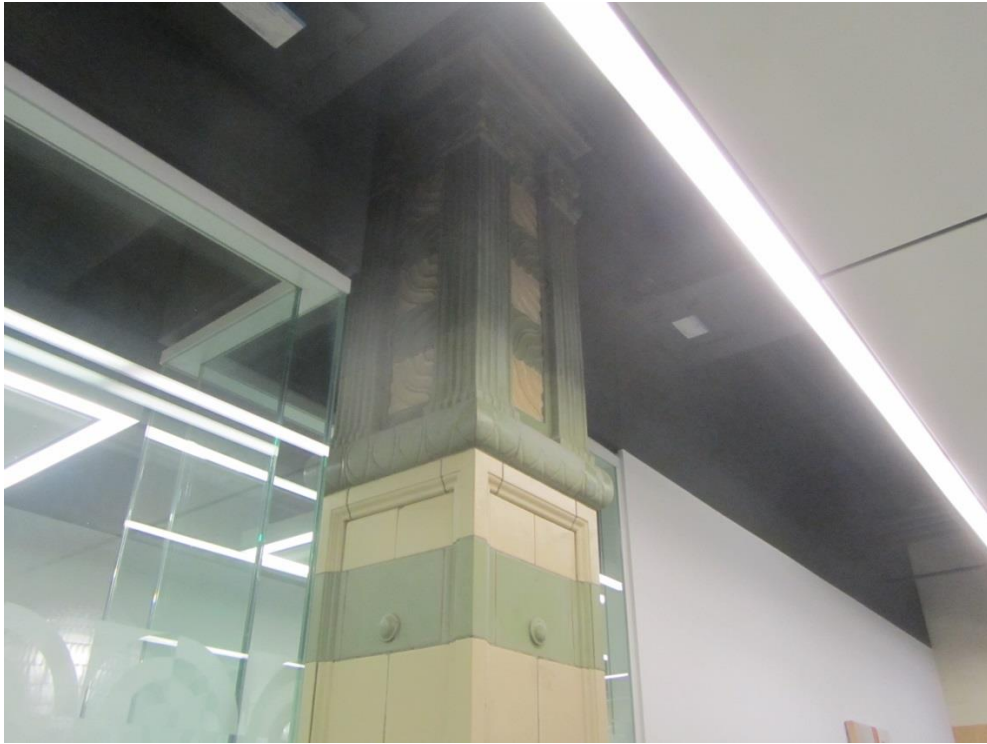
Photo Number	Location (as referenced on drawing)	Type of Frieze Cornice Tile	Comments
Ground floor level – see M19070/SK04			
Ground C1 -1	Column 1	Ceramic	No loose sections identified. Restricted access due to glazed panel
Ground C1 -2	Column 1	Ceramic	“
Ground C1 -3	Column 1	Ceramic	“
Ground C1 -4	Column 1	Ceramic	“
Ground C1 -5	Column 1	Ceramic	“
Ground C2 -1	Column 2	Ceramic	No loose sections identified. Restricted access due to glazed panel
Ground C2 -2	Column 2	Ceramic	“
Ground C2 -3	Column 2	Ceramic	“
Ground C3 -1	Column 3	Ceramic	No loose sections identified. Access restricted due to service counter
Ground C3 -2	Column 3	Ceramic	“
Ground C3 -3	Column 3	Ceramic	“
Ground C4 -1	Column 4	Ceramic	No loose sections identified.
Ground C4 -2	Column 4	Ceramic	“
Ground C4 -3	Column 4	Ceramic	“
Ground C5 -1	Column 5	Ceramic	“
Ground C5 -2	Column 5	Ceramic	“
Ground C5 -3	Column 5	Ceramic	“

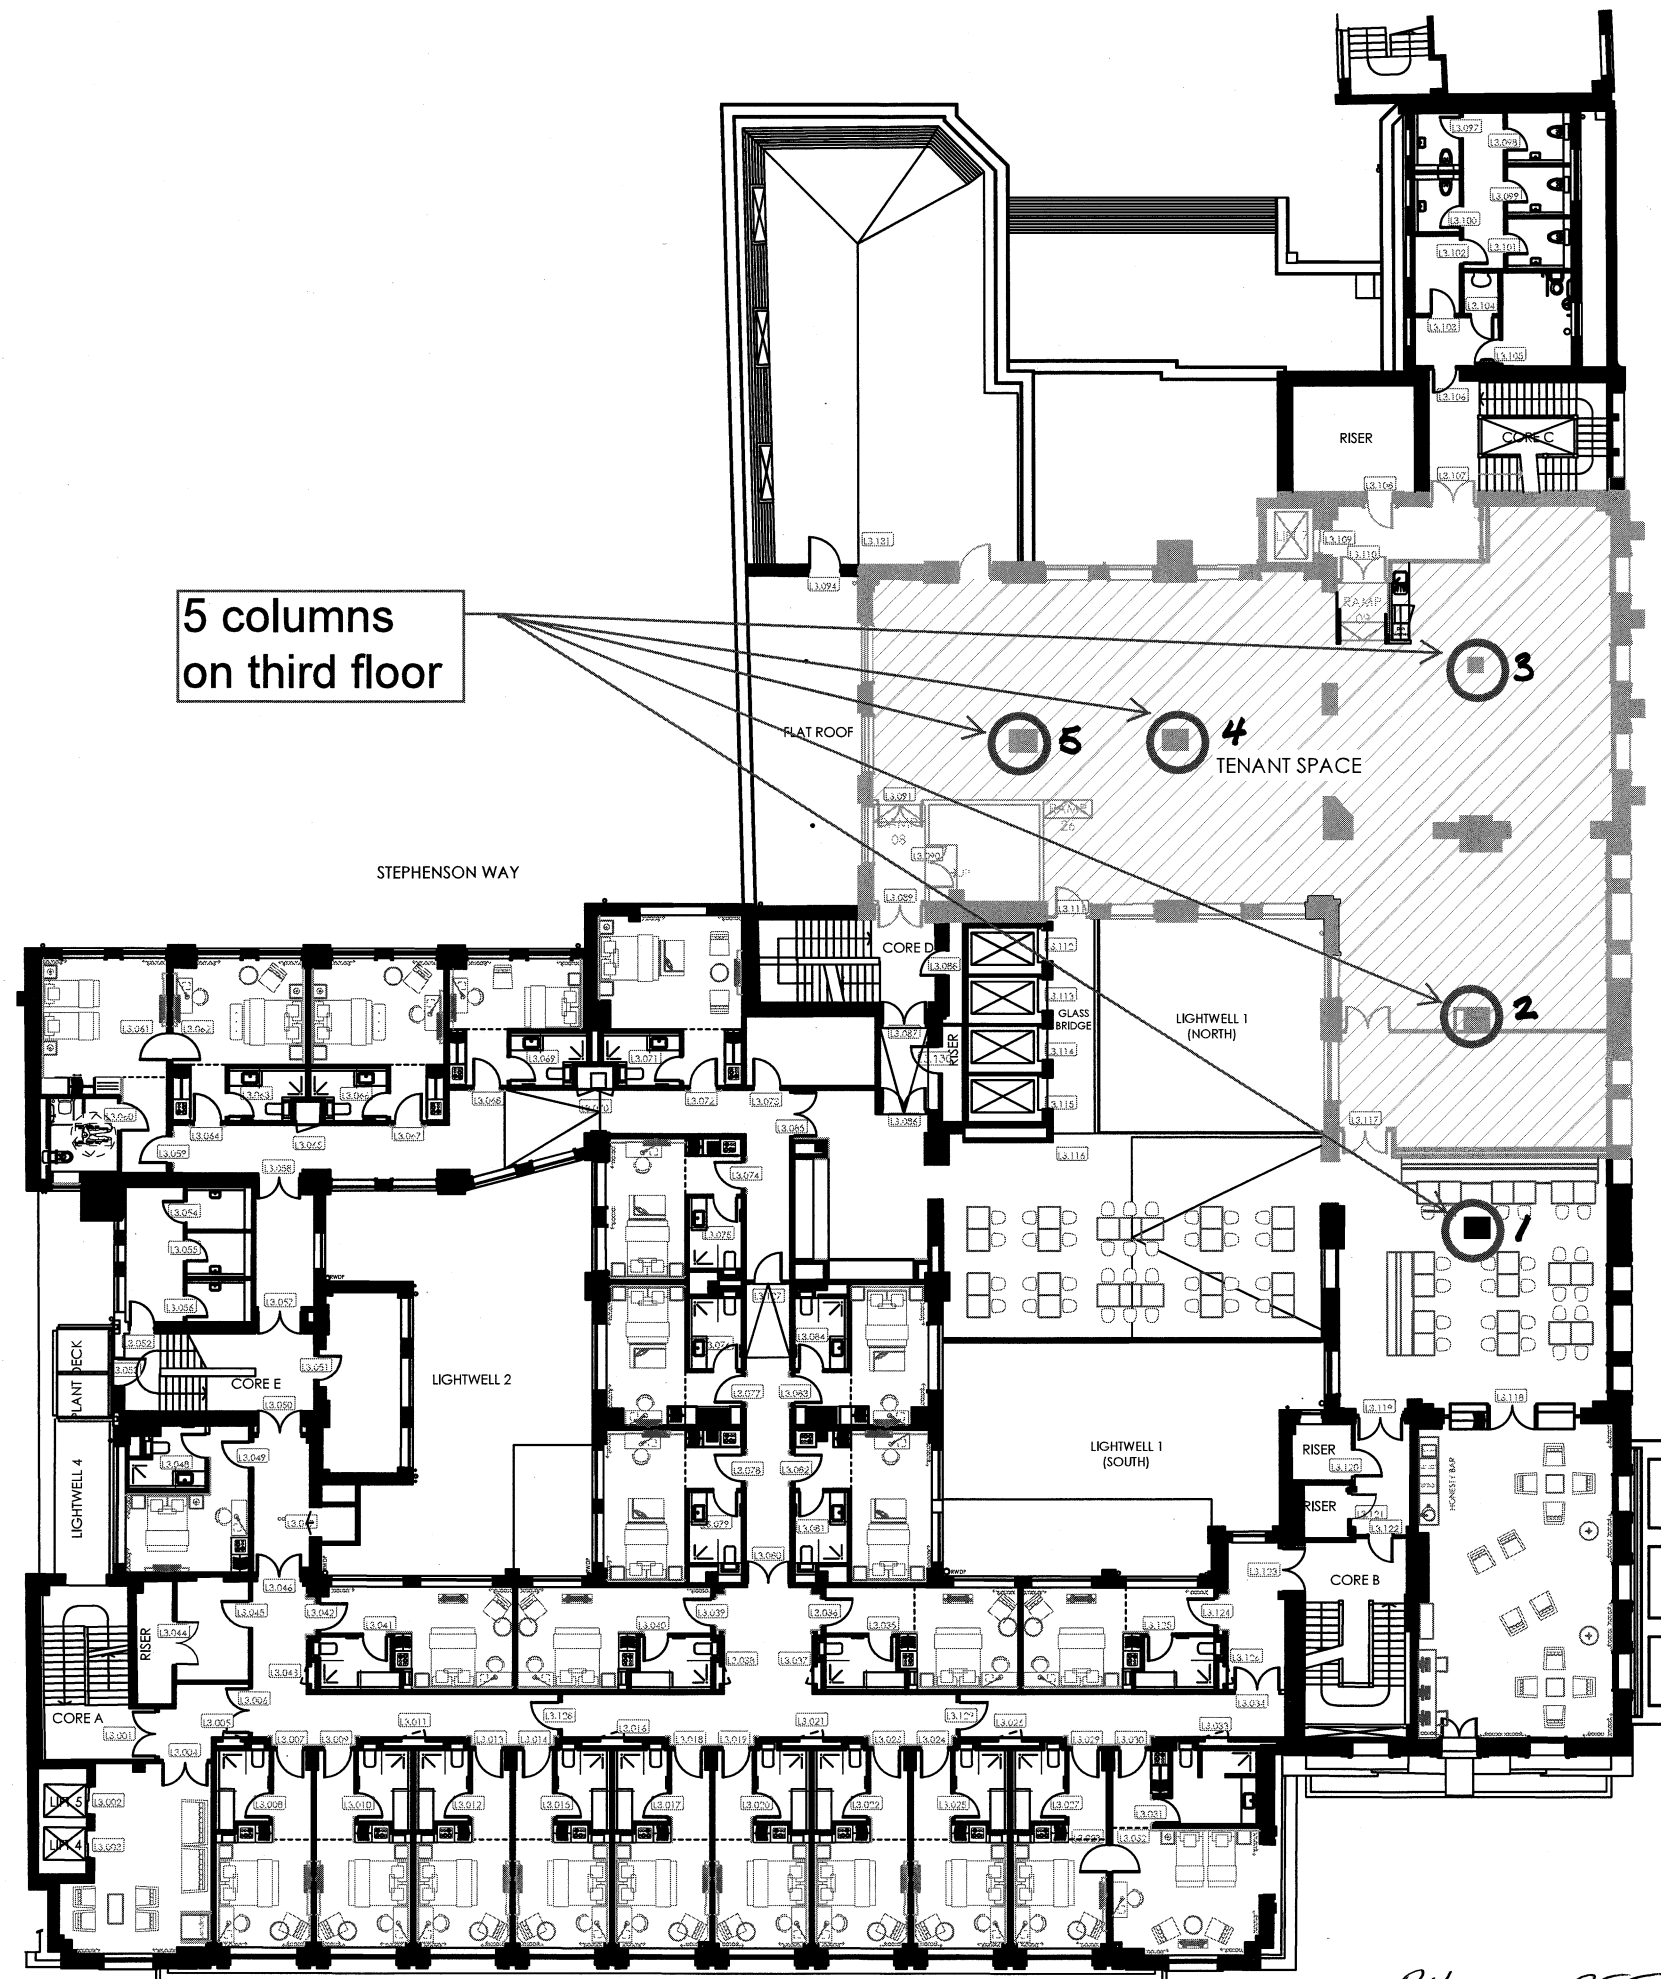
MINI STRUCTURES  
DRG NO  
M19070/SK01

5 columns  
on third floor

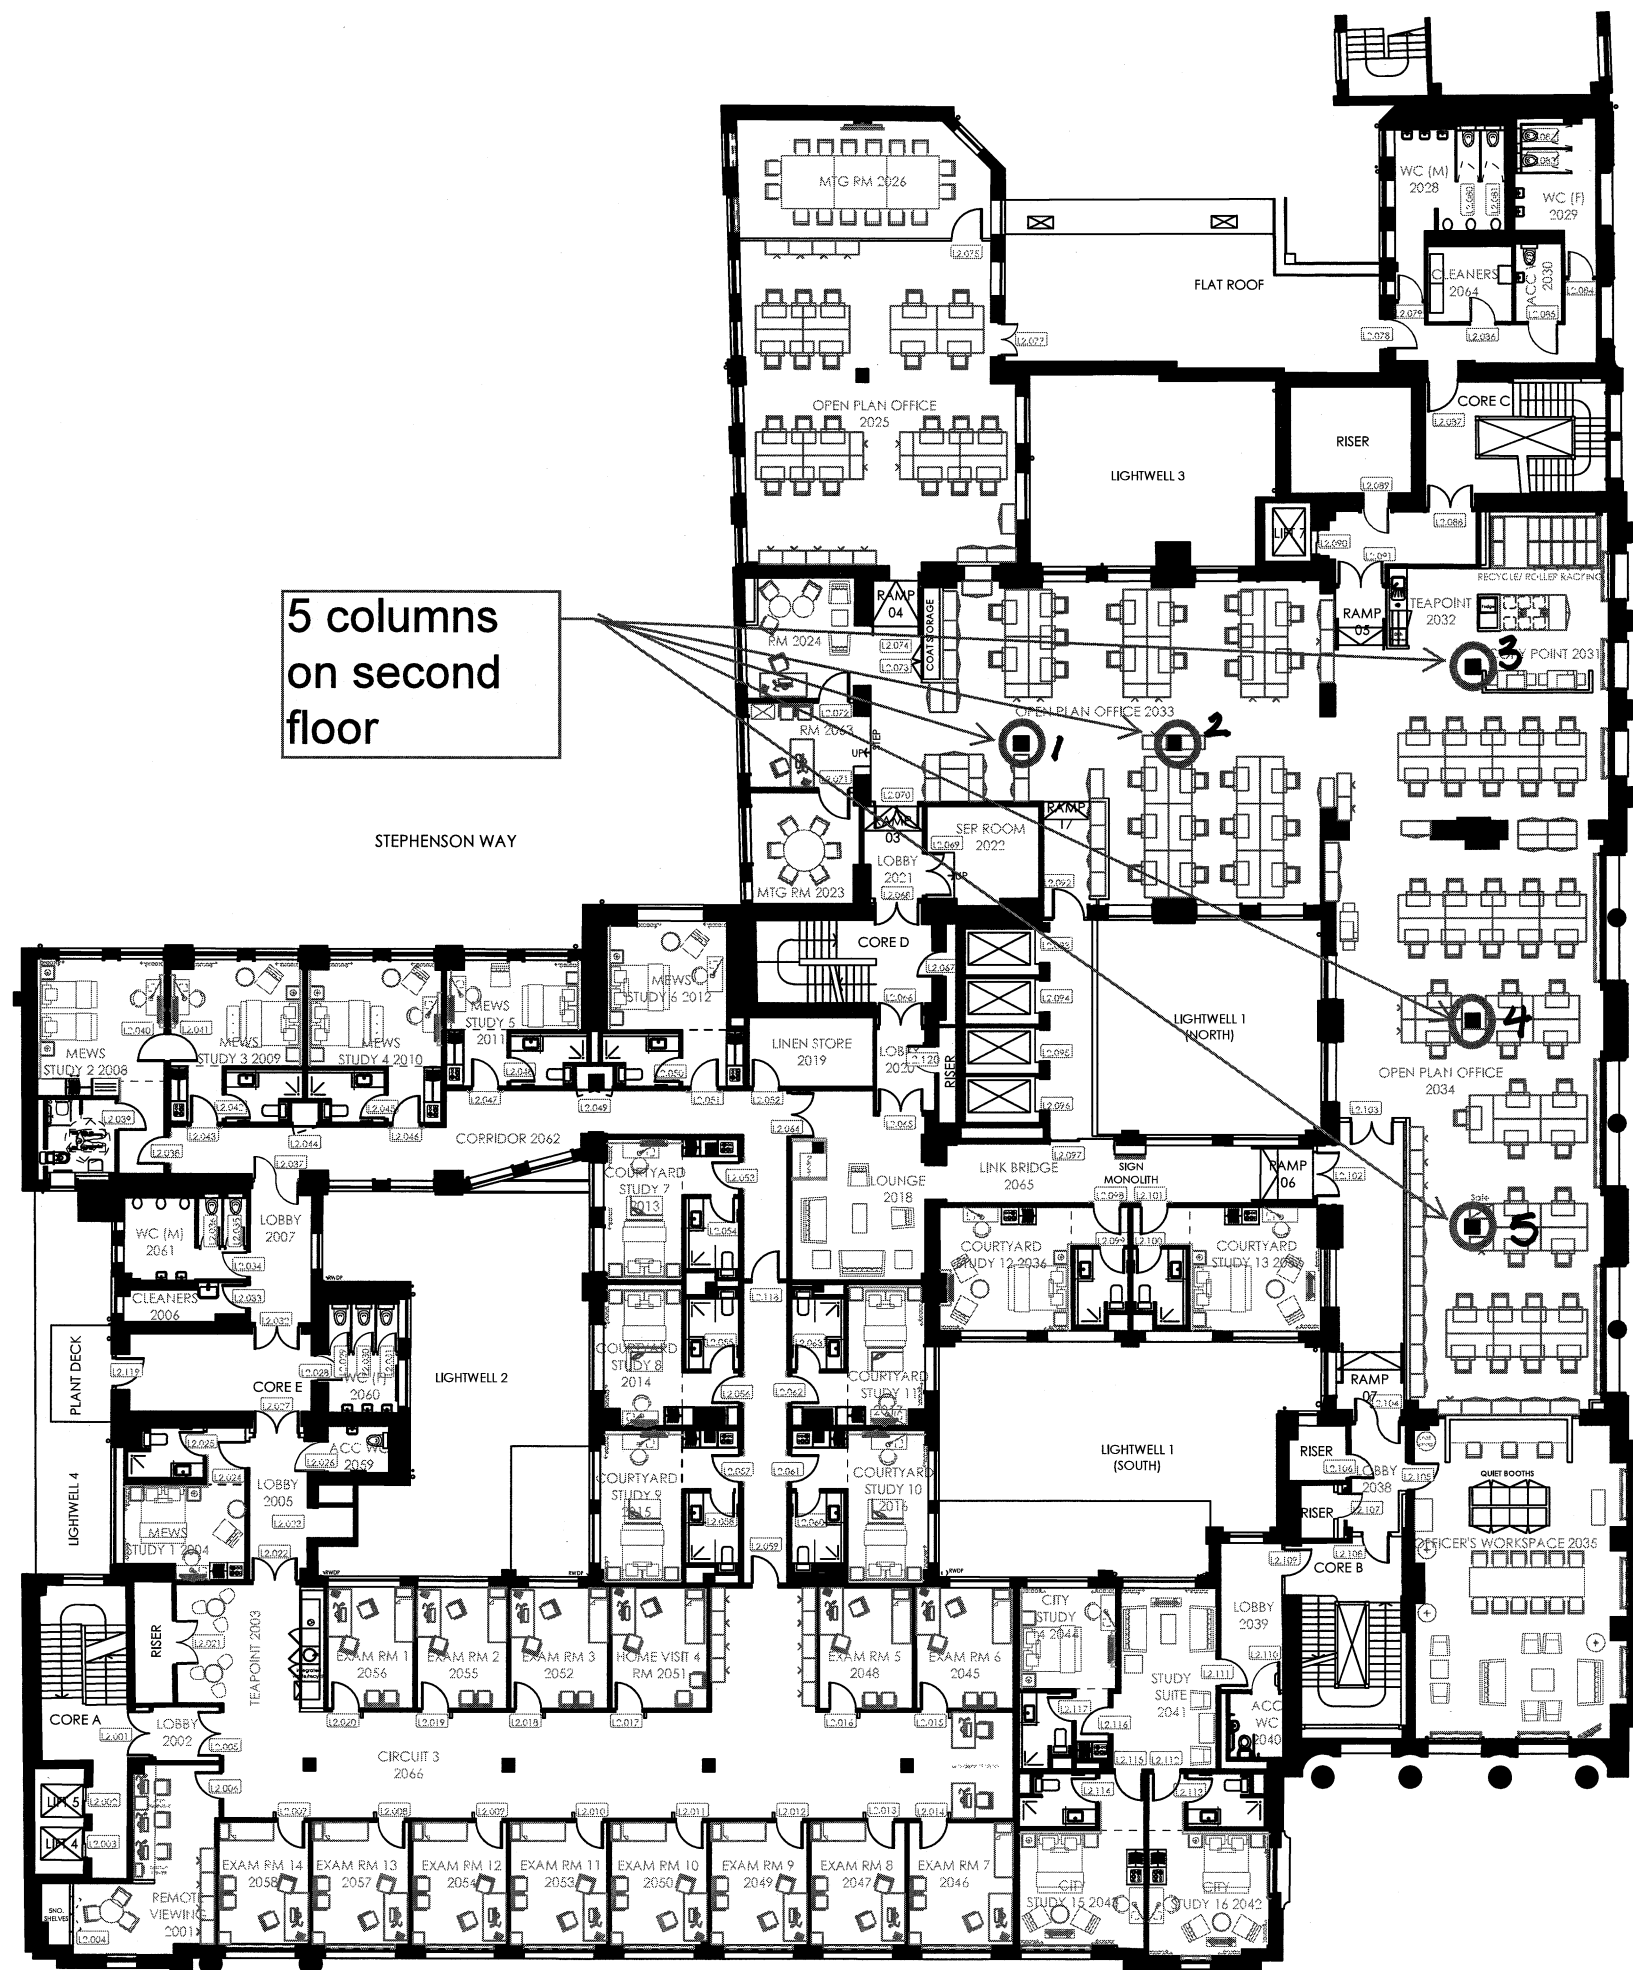
MINI STRUCTURES  
DRG N°  
M19070/SK02

5 columns  
on second  
floor
