Royal College of General
Practitioners.
The Conservation of the
Ceramic faience Piers
Treatment methodology.

Treatment Methodology.

Ref: Conservation Clean, stabilisation and repair to the Ceramic faience Piers,
The Royal college Of General Practitioners.

Conservation Clean, stabilisation and repair to the Ceramic faience Piers, The Royal college Of General Practitioner.

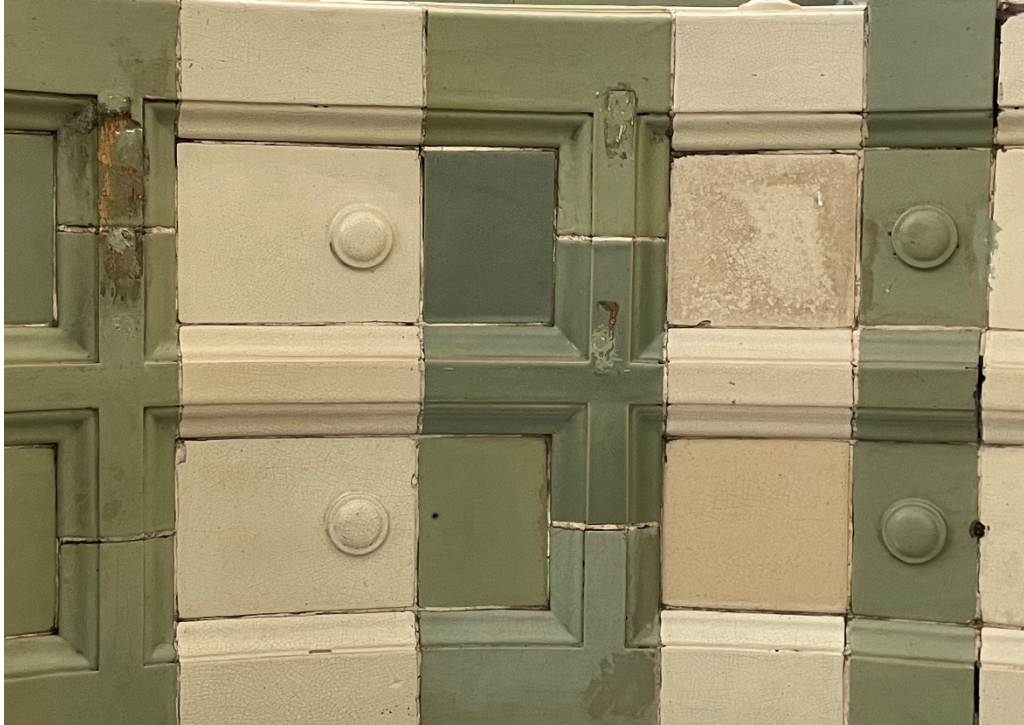
- General layer of surface detritus with some invasive underglaze staining and persistent detritus.
- Glaze fit shows a high degree of evidence for moisture expansion/substrate expansion.
- Localised stress fractures apparent to the modular cornice possible substrate expansion.
- Abrasive and mechanical damage typically concentrated on lower levels.
- Blistering indicative of moisture expansion.
- Water dissolution through the clay/glaze matrix example of trapped water within the concrete system.
- Inadequate, photo-oxidised and degraded remedial and cosmetic repairs.
- Damage caused by Incompatible material replacements.
- Open joints with failed grout.

- Preliminary dry clean using vacuum cleaner and soft brushes to remove all friable and loose surface detritus.
- Identify all fragile areas and hollow sections and face up with rag tissue and a reversible acrylic dispersion to prevent further loss.
- Introduce a dehumidifier and maintain the existing RH constant while wet cleaning is in progress.
- Wash with a non-ionic surfactant and water using micro resin sponges to remove persistent detritus.
- Remove stubborn, integrated stains with a combination of a bespoke Ph compatible sol gel and micro steam cleaner.

- Conduct NDT survey and map and record each pier. Establish moisture parameters are met.
- Record label and remove all loose, detached and broken faience units.
- Using a mixture of B44 to increase hydrophobicity and increase the glass transition of the B72 acrylic resin. Use the adhesive acrylic resin to adhere a reversible nylon mesh scaffold to support each prepared ceramic units reverse

- Solvent wash and Inject all micro fissures and fractures with B44/B72 acrylic resin to stabilise and consolidate the ceramic tiling. Solution Percentages TBD insitu.

- Remove deleterious epoxy resin repairs using a combination of solvents poultice and fine sculpting tools including rotary and diamond micro tools.
- Identify and allow for the production of a series of suitable conservation grade compatible repair recipes to match the existing sections. i.e., U.V stable acrylic resin system.

- Apply a U.V filtered synthetic matt glaze to complete the repair.
- RegROUT using 'soft' nano grout all failed areas.
