CHAN + EAYRS 111 Frogmal, Hampstead NW3 6XR

Zoe Chan Eayrs and Merlin Eayrs			
Project : 111 Frogmal			
TITLE : BLOCK AND SITE PLAN (EXISTING AND : PROPOSED - NO CHANGE)			
Date 04/08/21	Scale 1:50 @A0	Drawing No. BP__	Rev.01

Zoe Chan Eayrs and Merlin Eayrs		
Project : 111 Frogna		
TITLE : CELLAR PLAN EXISTING AND BUILT :		
Date 04/08/21	Scale 1:50 @A0	Drawing No. CRP
		Rev.02
<div><div>0</div><div>1</div><div>2</div><div>3</div><div>4</div><div>5</div><div>6</div><div>7</div><div>8</div><div>9</div><div>10</div></div>

Rose and Associates Sectional Detail of structural retaining wall and slab

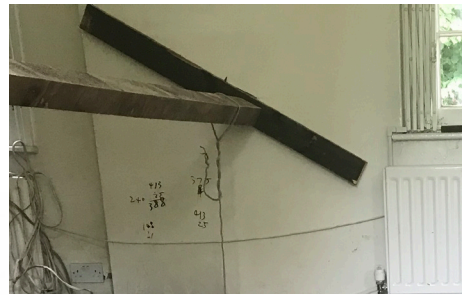
1 Living room walls above cellar propped from inward collapse

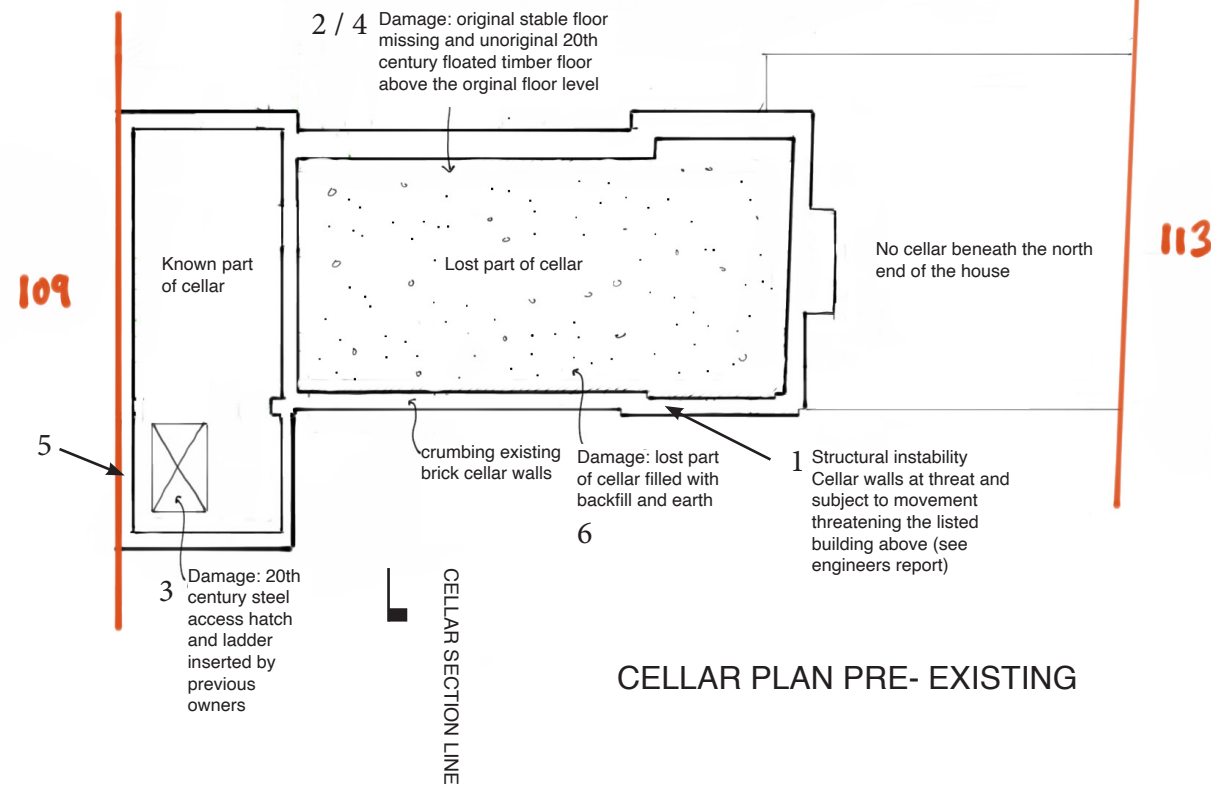
CELLAR PLAN PRE- EXISTING

1. LISTED HOUSE AT THREAT OF INWARDS COLLAPSE- Cellar walls beneath the listed house subject to external earth pressures and at threat of collapse endangering the listed building above

2. 20TH CENTURY DAMAGE: ROTTEN FLOATED GROUND FLOOR- unoriginal 20th century ground floor was rotten and floated 400mm above the original ground floor. This damaged the visual character of the above ground listed building and the legibility of the historic building's use as a stable block to Frogna Grove.

3. 20TH CENTURY DAMAGE: MODERN ACCESS - Pre-existing cellar was accessed through a modern external ladder and steel hatch installed by previous owners in the 20th century

4. 20TH CENTURY DAMAGE: MISSING STABLE FLOOR- the original stable floor beneath the floated timber floor was removed in the 20th century
5. 20TH CENTURY DAMAGE: CELLARS AT FROGNA GROVE SUBDIVIDED WHEN SUBDIVIDED INTO 10 SITES

6. 20TH CENTURY DAMAGE: PART OF CELLAR BACKFILLED

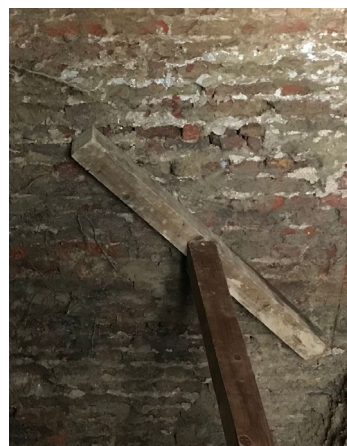
Photo of brick cellar wall propped from inward collapse

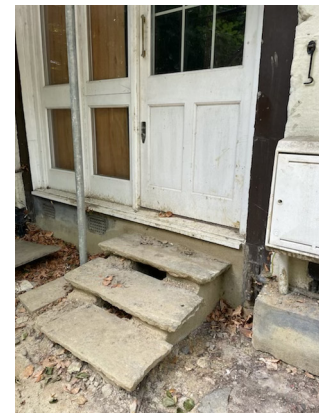
steps up to unoriginal floor damage the legibility of the listed stable block
