# Chalk Farm Gate

Design and Access Statement Engineering Report

Issue P01 – 14 July 2021

## DESIGN AND ACCESS STATEMENT ENGINEERING REPORT

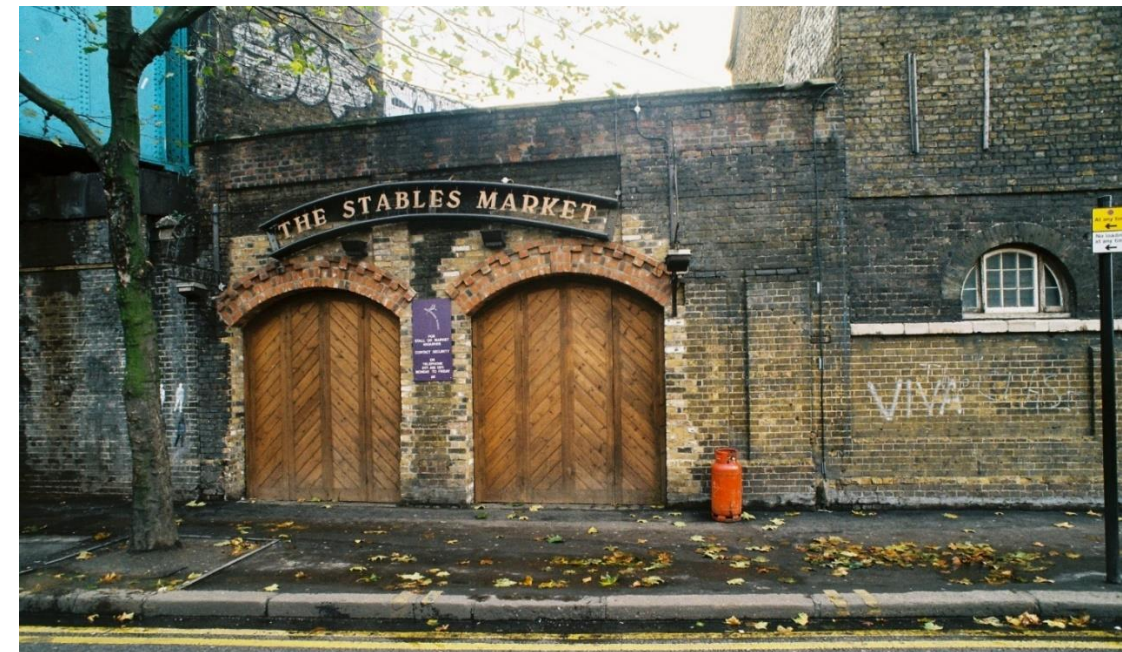
**Figure 4 Chalk Farm Road Entrance street façade in the 1990s**

The entrance wall was also modified creating two main openings topped by masonry arches. The modification is evident from historical pictures of the wall (Figure 4), as the partition between pillars and infill panels of the top part of the wall is not consistent with the arch arrangement. Bricks' colour show a clear difference between the original part of the wall and the later modifications.

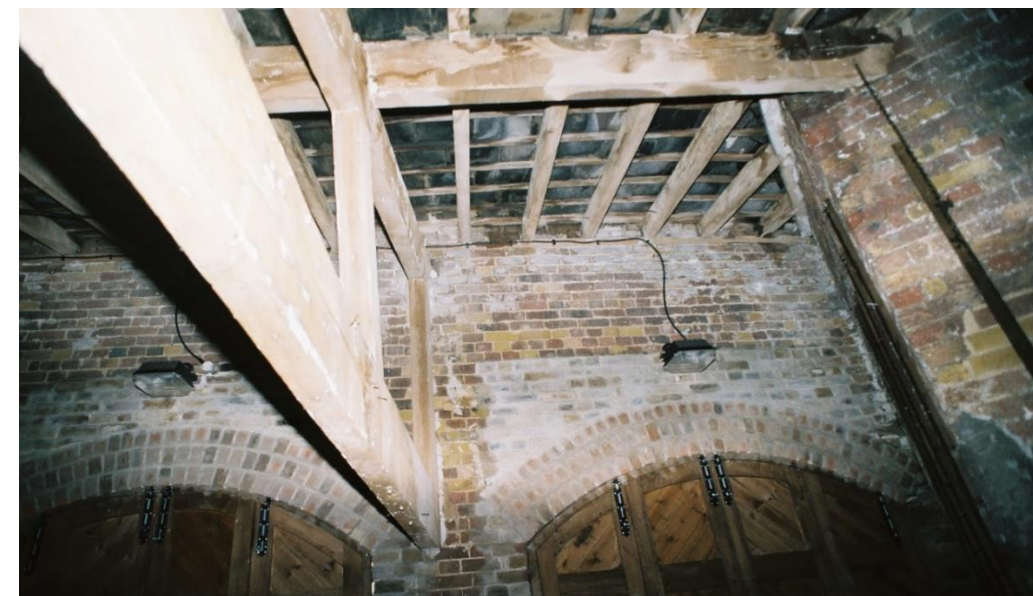
**Figure 5 Chalk Farm Road Entrance inside view 1990s**

The picture taken from the inside (Figure 5) shows the main truss lining up with the masonry pillar and the embedded connection between the truss and the masonry wall. The secondary joists parallel to the truss were also embedded into the wall providing top lateral restraint to the masonry wall.

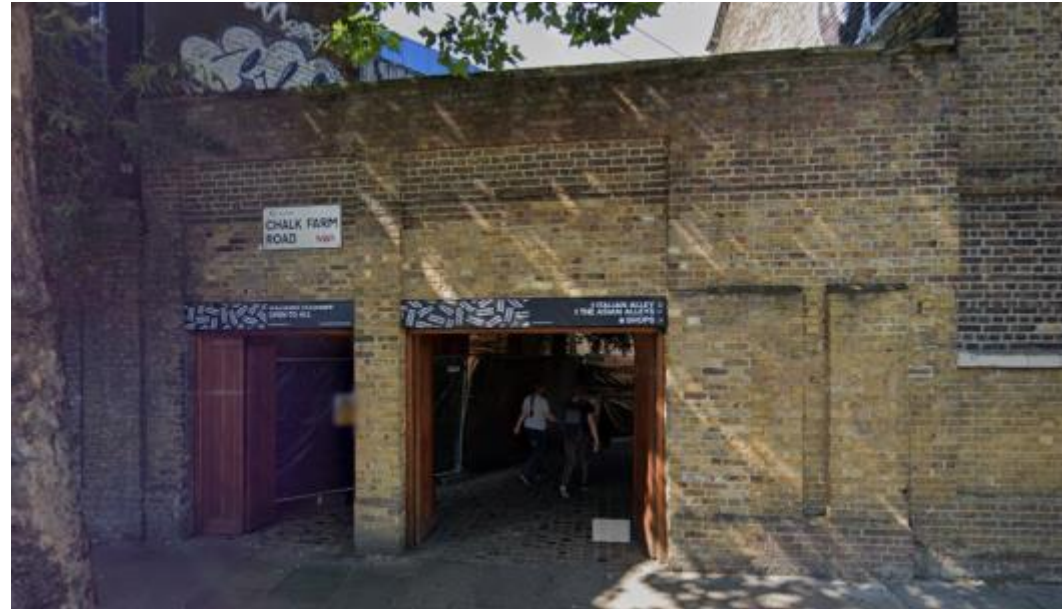
Figure 6 Chalk Farm Road Entrance façade (current state)

Recently, the Chalk Farm Wall has been modified again to achieve visual consistency between the top and the bottom part of the masonry structure. So the previous arches have been replaced by steel lintels and the two entrances have been modified to line up with the original partition of wall (Figure 6).

In the new configuration the central pillar between openings does not provide support to the main truss which therefore was connected to the steel lintel of the bigger opening.

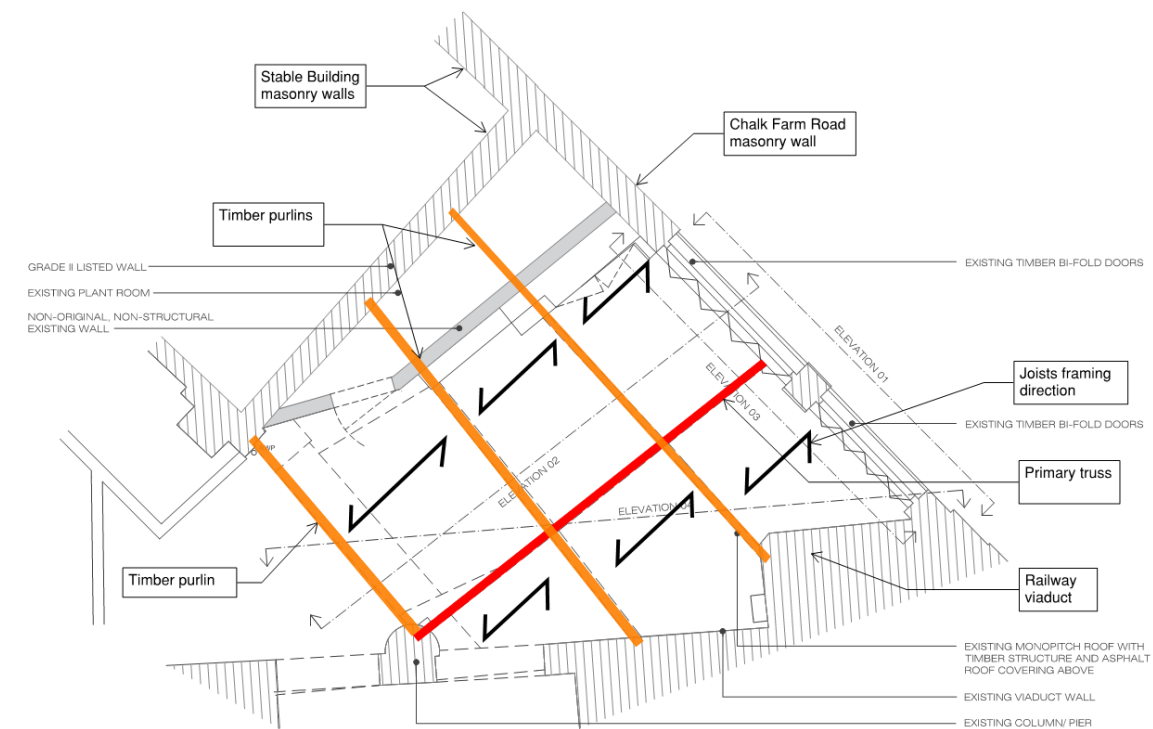
Figure 7 Existing Timber Roof Structure Framing

Timber joists running parallel to the main truss are regularly spaced and supported by the purlins and embedded into the Chalk Farm Wall providing, together with the timber roof, top lateral restraint to the wall (Figure 7).

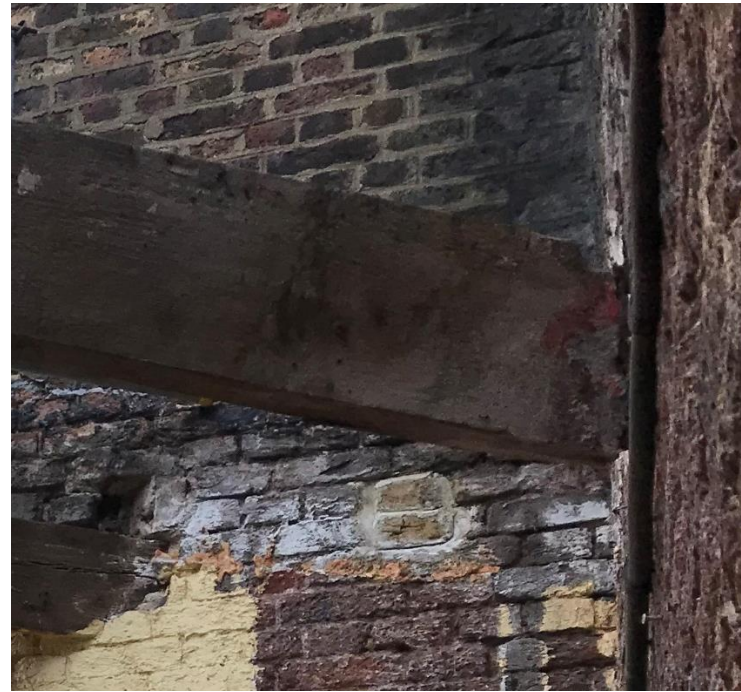
Figure 8 Existing Timber Purlins

As the roof is likely to have about 50 years, it is in a reasonable condition for the age of the structure but at the end of its design life showing signs of distress especially at the connection between the timber purlins and the perimeter masonry structures due to water ingress.

It is evident from Figure 8 the settlement of the bricks under the purlins and the effect of rotting on these timber elements, reducing significantly their capacity (i.e. bearing, shear).

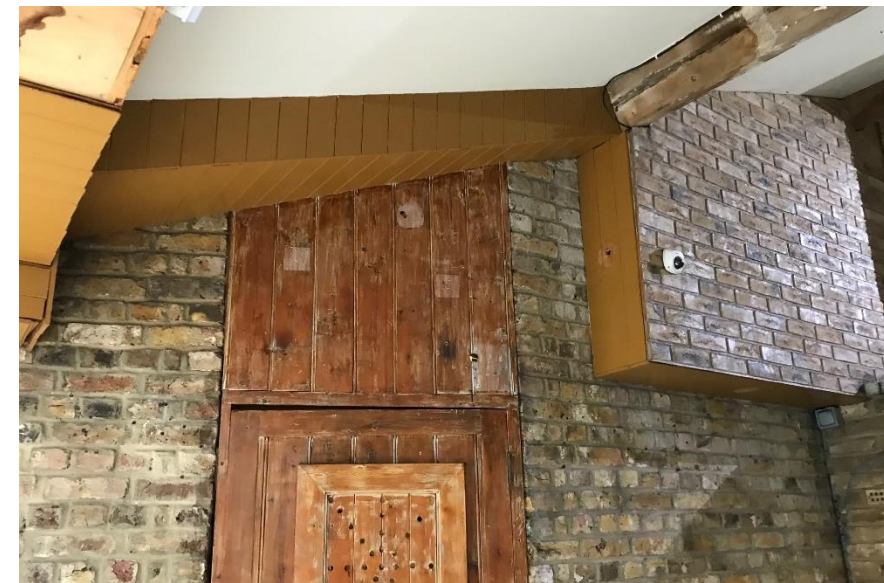
Figure 9 Existing partition wall

On the internal side of the entrance, there is a partition wall panel perpendicular to Chalk Farm Road wall (Figure 9) creating a store room for the Stable Building. This wall is approximately 1.5m from the face of the building and it is thought to have been built in the 90s as part of the works to create a new entrance from the road (see Section 3).

As the wall is a later addition to the site is likely to have been built on top of the granite setts without a proper foundation and the visual assessment confirms that the wall has no connection to any of the adjacent masonry structures or the roof.

The proposal is to demolish the existing roof structure together with the partition wall and replace them with a new timber roof supported at the existing masonry walls and at a new intermediate frame built in place of the partition wall.
