Subsidence Tree Report

For B Maule & Co Ltd

4 Downshire Hill, London, NW3 1NR

Insured:	Mrs. Z Hersov
Insurer:	TBC
Insurer Ref:	TBC
Maule & Co Ref:	20195429
Our Reference:	03229Rv2
Consultant:	Keiron Hart (BSc Hons, C.Env, F.Arbor.A, MICFor, MEWI)
Visit Date:	14.1.2020
Report Date:	20.1.2020

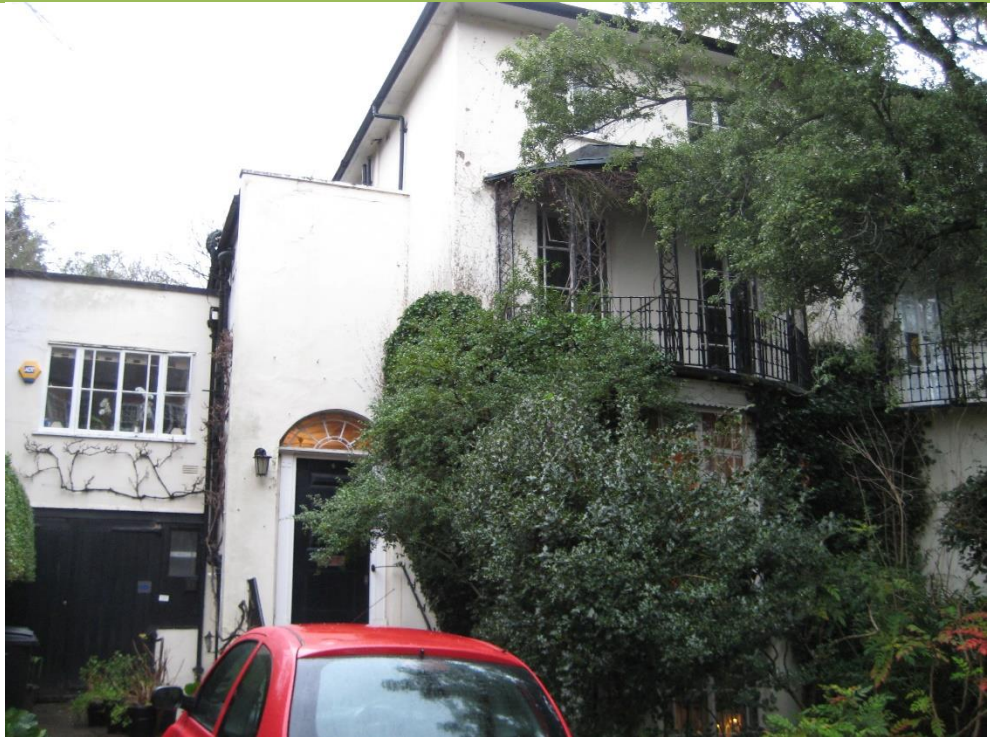
The property with SG1, T3 & CG1 as well as the side extension (left)

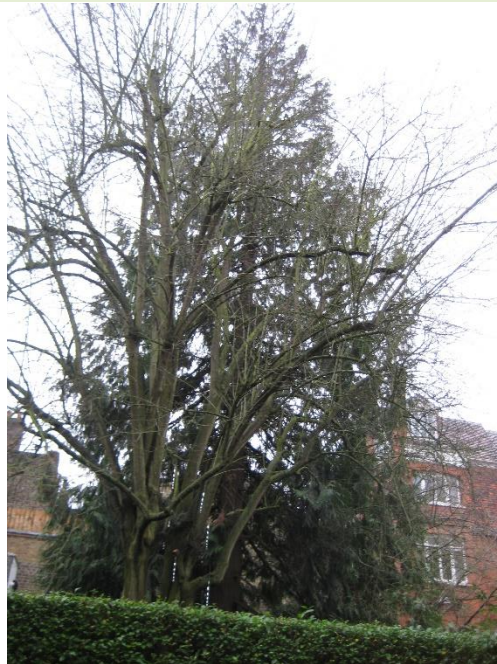
Level monitoring shows the point of greatest movement to be towards the front left-hand corner and this suggests T5 (Lime) (note: this tree could be an *Acer* spp as there was no close access to inspect) and

T6 (Cypress) will be the dominant causes in the movement. It is also possible that TG1 (Magnolia & Sweet Bay) and T7 (Cypress) are also causal in the movement given their size relative to the affected part of the building.

It seems likely given the 3rd party ownership of T5, T6 & T7 that additional site investigations may be required in an effort to secure the roots needed to show causation from the relevant trees. T5 appears a Purple Leaf Plum (*Prunus* spp) but access would be required (or an in leaf inspection) to confirm.

T5 & T6 beyond

Whilst no roots from these trees were recovered their size and proximity is such that they should be removed. This approach gives the best opportunity for stability to return. In summary they are just too large and close for pruning to afford a suitable option.

Tree No.	Species	Age Cat	Approx. Height (m)*	Distance to Building (m)	Ownership	Observations	Subsidence Risk Action	Recommended Tree Work
T5	Purple Leaf Plum	A	14	4.5	Unknown	Established 3rd party tree	Current Claim	Remove and treat stump to inhibit regrowth
T6	Cypress	A	20	9	Unknown	Large 3rd party tree.	Current Claim	Remove
T7	Cypress	A	16	7.1	Unknown	Large 3rd party tree.	Current Claim	Remove
TG1	Magnolia and Sweet Bay	A	6	2.7	No 4	Established trees	Current Claim	Remove and treat stumps to inhibit regrowth

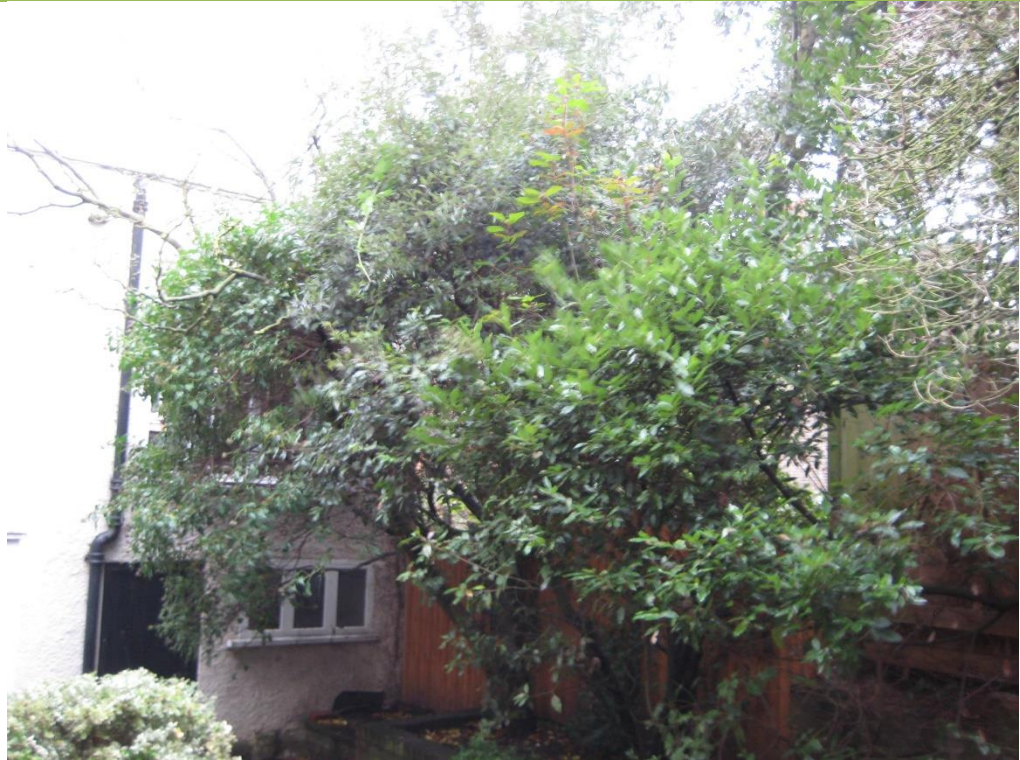
TG1 to the rear

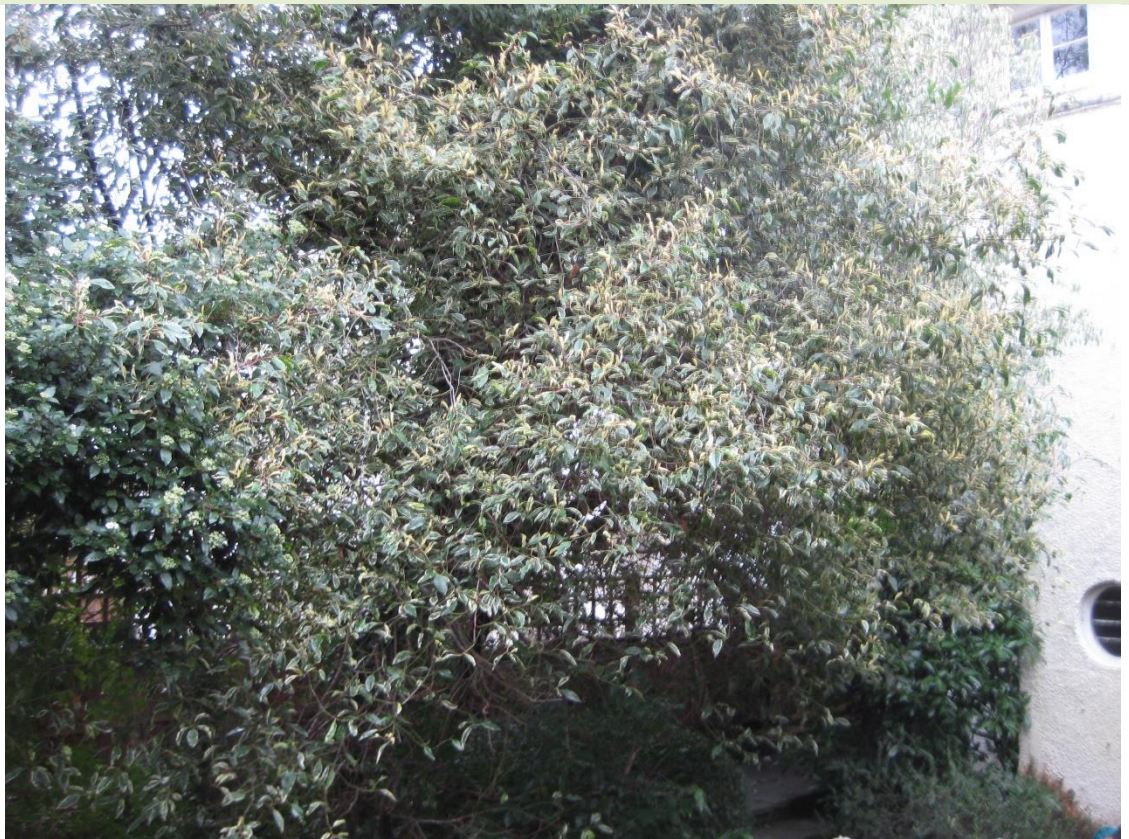
TG2 to the rear

Tree No.	Species	Age Cat	Approx. Height (m)*	Distance to Building (m)*	Ownership	Observations	Subsidence Risk Action	Recommended Tree Work
TG2	Pittosporum and Bay	A	8	4	No 4	Established trees.	Action to Avoid Future Risk	Do not allow to exceed current dimensions
TG3	Elder, Sumac, Cypress	A	6	11.7	No 4	Mixed species planting.	Action to Avoid Future Risk	No works
CG1	Ivy & Russian Vine	A	6	0	No 4	Established climber.	Action to Avoid Future Risk	No works
SG1	Holly	A	2.2	2.9	No 4	Small shrubs	Action to Avoid Future Risk	Do not allow to exceed current dimensions
Tree Age Category: A = Younger than property; B = Similar age to the property; C = Significantly older than property
