SITE VISIT/MEETING NOTE

Ref: 21-0256
Client/Site: Seacon Ltd/28 Redington Road, Hampstead
Date: 20th May 2021
Venue: 28 Redington Road, Camden
Attendees:

Ref	Description
1.0	Purpose of Meeting <p>The meeting was a site visit for the consented construction and partial demolition of 28 Redington Road in Hampstead (Camden Borough Council Ref: 2019/6407/P) and to confirm that works were being undertaken in accordance with the approved Arboricultural Method Statement (AMS) (Ref: 20-3573).</p>

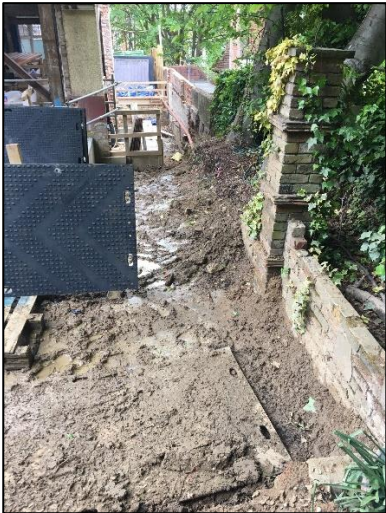
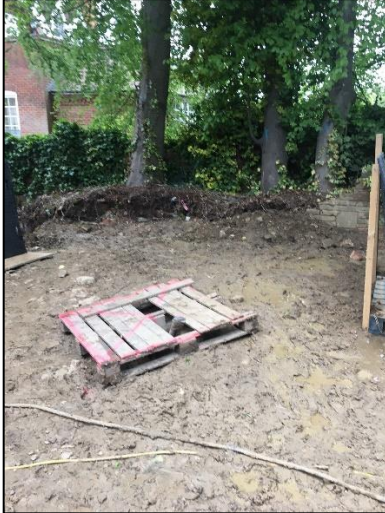
</div> <p><i>Plate 1 & 2 Completed bore hole in area of removed patio adjacent tree T7-11</i></p>

SP stated that the TPP, had shown existing hard standing adjacent to T7-11 as being retained to protect the RPA of these trees. SP discussed with BF the protection required for this area. BF stated no works or storage would be necessary and he would erect TPF around the RPA.

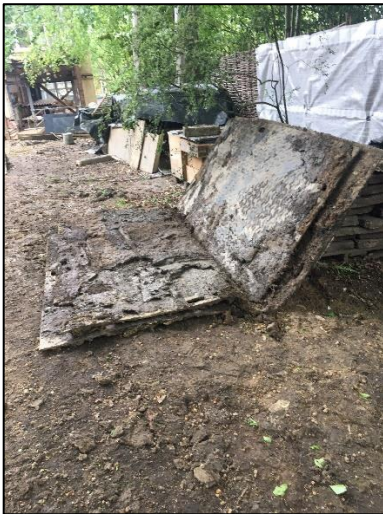
This area had been used for the storage of the lifted patio slabs, SP confirmed that as they had been stored on pallets and were to be reused on site, the impact to the retained trees would be minimal and it was acceptable for them to remain until reused. BF confirmed the ground protection mats in this area were from the GSHP bore hole works and were to be removed from site shortly.

Plate 3 - TPF erected around T13 and T14 (materials stored on loadbearing system)

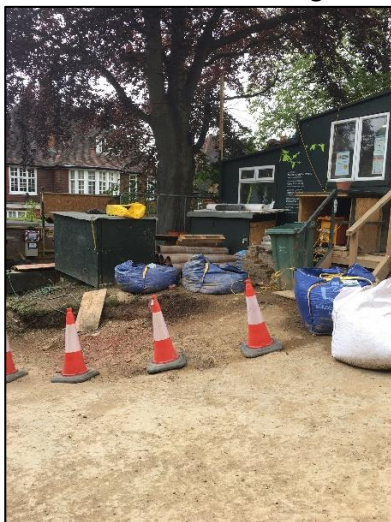
SP noted that the fencing that was missing adjacent T1, and the removal of lightweight materials identified at the previous ACoW visit had not been completed. BF confirmed it would be carried out straight away.

Plate 4 – Materials stored in CEZ and fencing missing adjacent T1.

4.0	<p>Actions</p> <ul style="list-style-type: none"> • BF to erect TPF fencing and send photos to SP. • SP advised fencing would need Tree Protection Signs and on-site contractors should be informed of the propose of the fencing during induction. • SP also recommended BF take regular photos of TPF for a photographic to record that is has been retained in place and added to a tick list of daily checks or similar. • BF to send current drainage drawing for review. • BF to liaise with SP over trenching works for GSHP or any on site works affecting retained trees. • SP to liaise with DTET (where required) regarding trenching routes. • SP to review tree protection measures on next site visit. ACoW visits would not be likely until excavation for drainage works, or landscaping with on site works within the house. • BF to contact SP with any tree related queries during construction works or inform SP of works programmed which effect the CEZ.

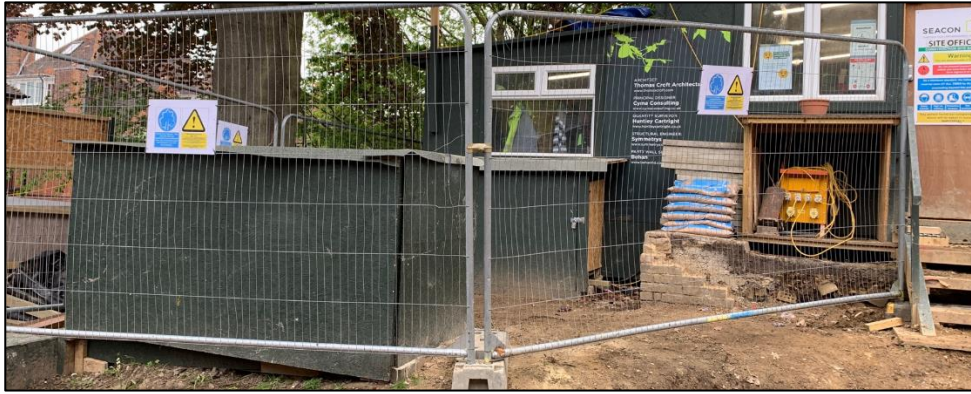
5.0	<p>Actions Carried Out</p> <p>BF provided SP with photos of corrective measure to clear materials and erect TPF adjacent T1 on the following day Friday 21st May, and confirmation other works would be carried out on Monday.</p>

Plate 5- TPF adjacent T1

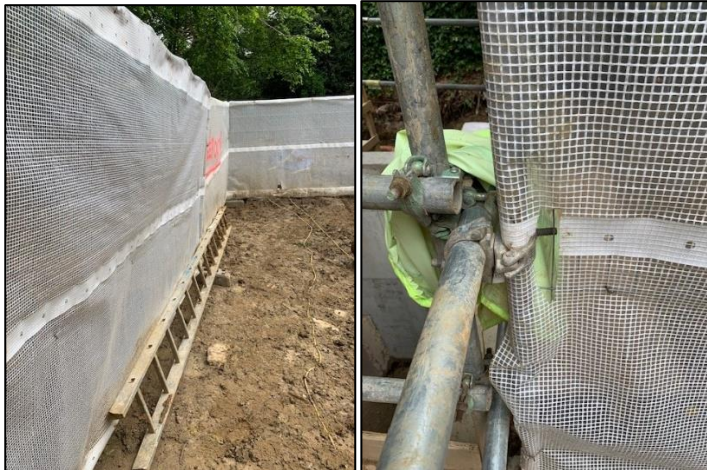
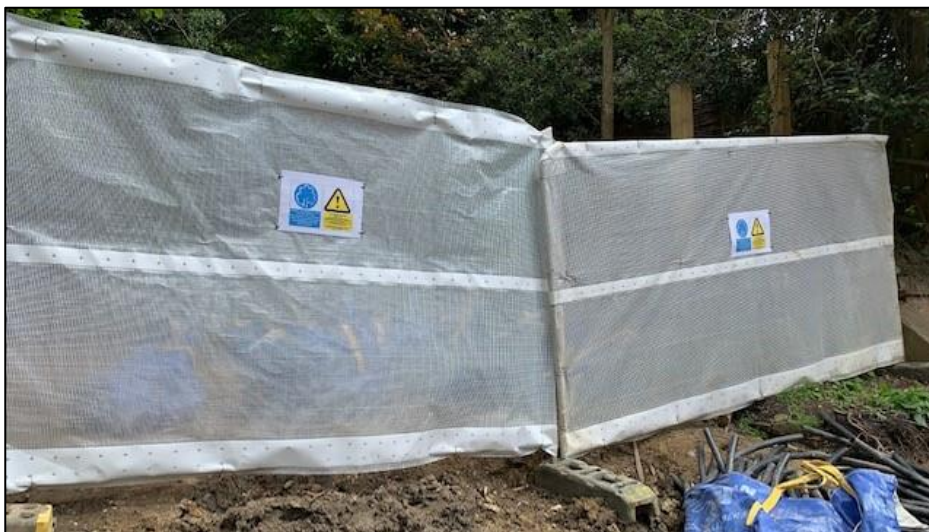
BF provided additional photos on Wednesday 26th May, of the TPF to protect the RPA for trees T7-10, and trees to the rear of the site T11-T43. BF confirmed that although the original discussion was to put up hording fencing with a gate access. This could not be done due to requiring a UXO survey. Therefore, herras fencing wired and secured with swivels connected to scaffold had been used. SP confirmed this was appropriate.

Plate 6-8-TPF for Trees T7-T43
