## No. 48 Bedford Row

### Design and Access Statement including Heritage and Structural Statements for the Staircase Removal and Reinstatement.

## **Condition assessment of timber staircase at 48 Bedford Row, London**

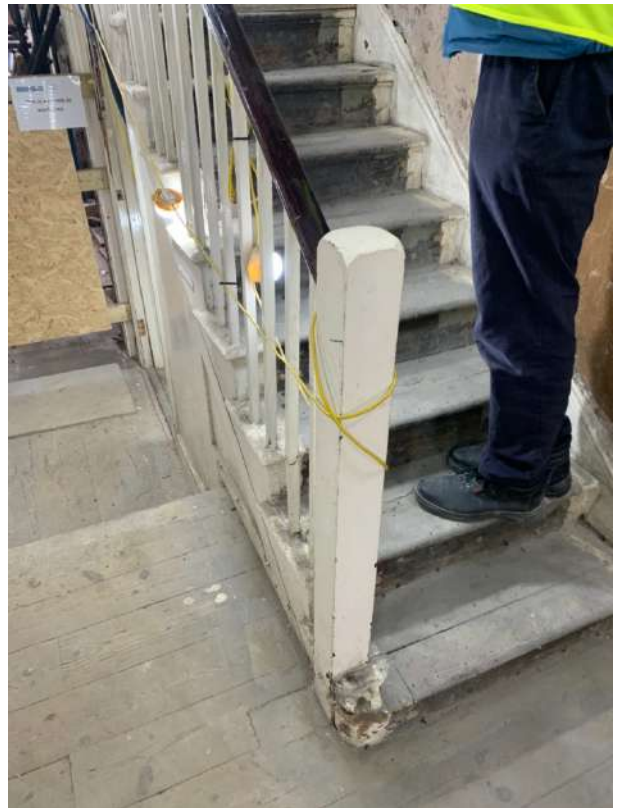
Figure 2. Existing 48 Stair at Ground Level

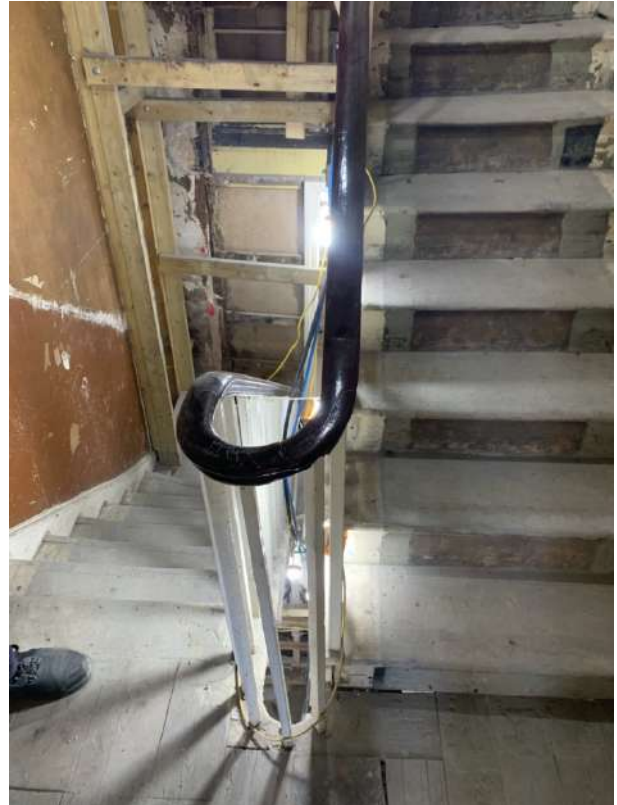
Figure 3. Existing 48 Stair at First Floor Landing

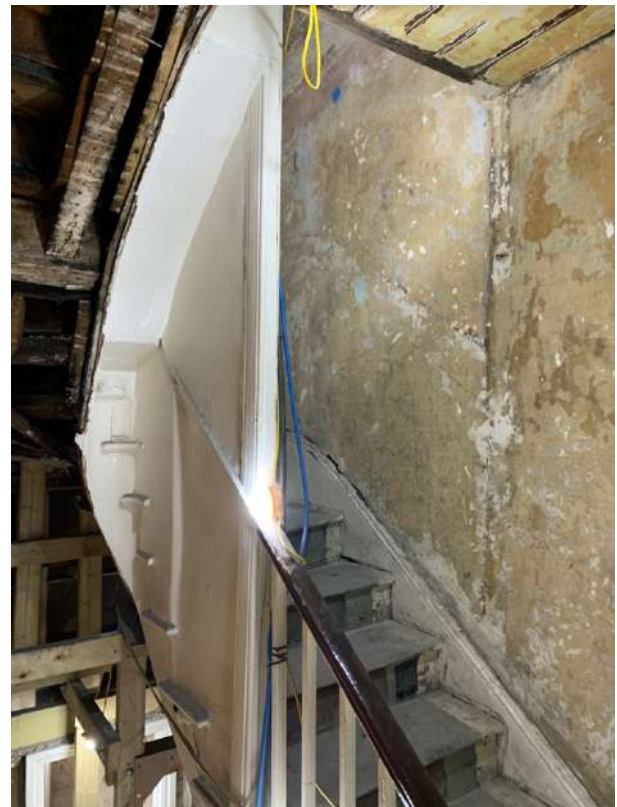
Figure 4. Existing 48 Stair Servants Doorway on flight to 3rd Floor

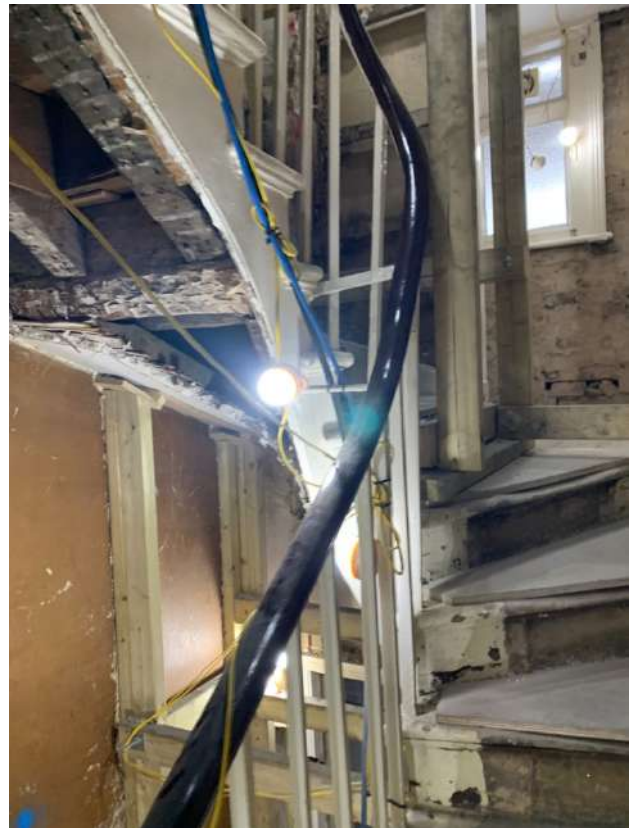
Figure 5. Existing 48 Stair view of door frame for old servants door on third floor flight.

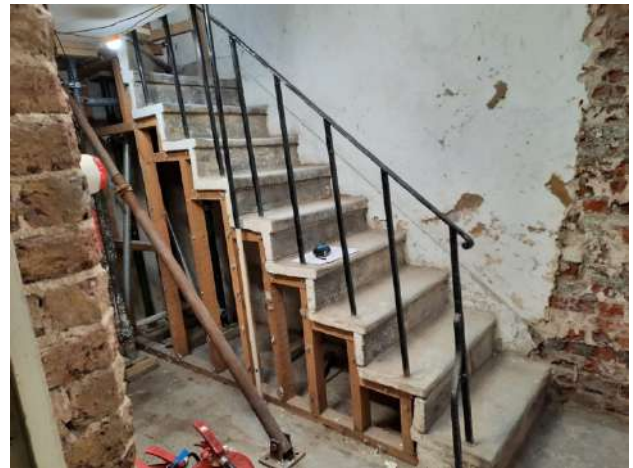
Figure 6. Existing Basement Stair in 48 with metal spindles.

*Given all of the above considerations, we have recommended the steel spindles. It should be noted that these are already used for the basement section of the staircase.”*

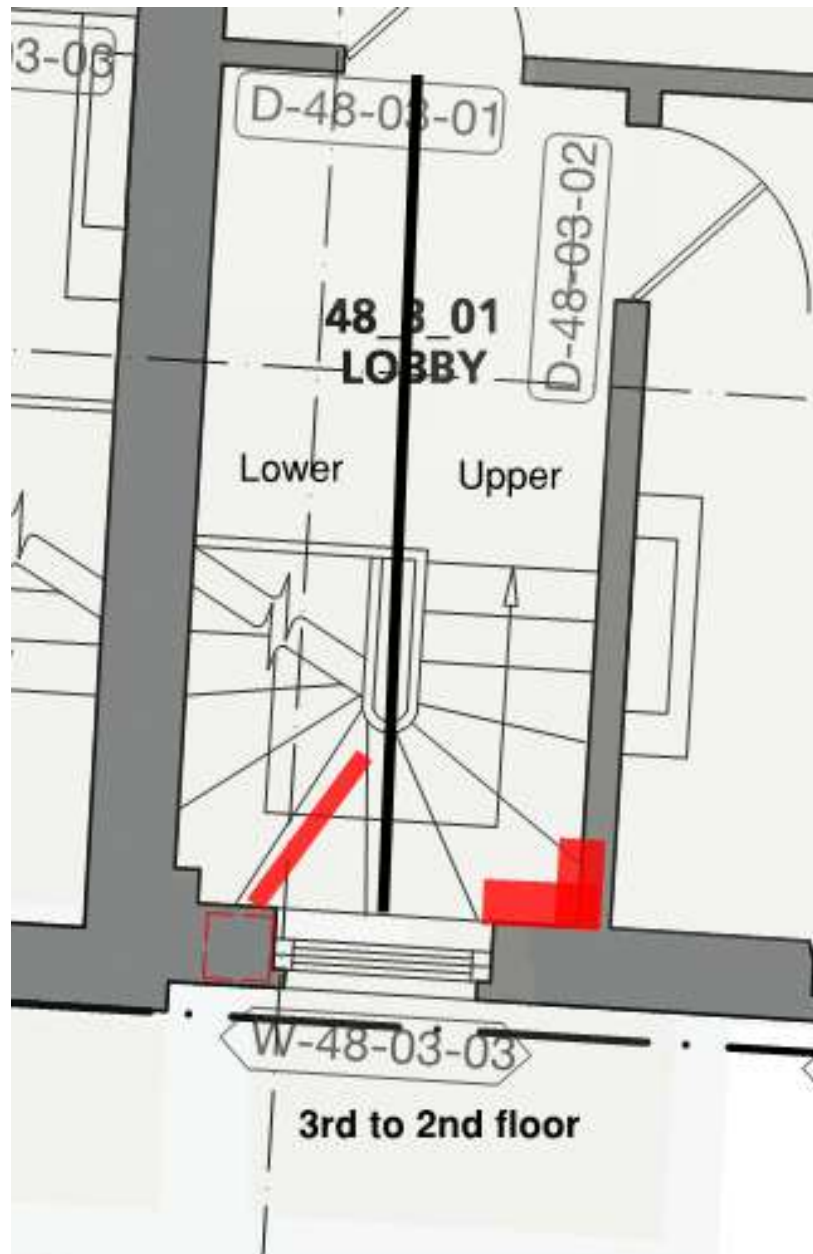
Dry rot was observed to the winder joist extending in to the pocket on the South external wall as shown in Figure.1 in Appendix I.

**Fig.1** 3<sup>rd</sup> to 2<sup>nd</sup> floor upper and lower flights highlighted with fungal decay.

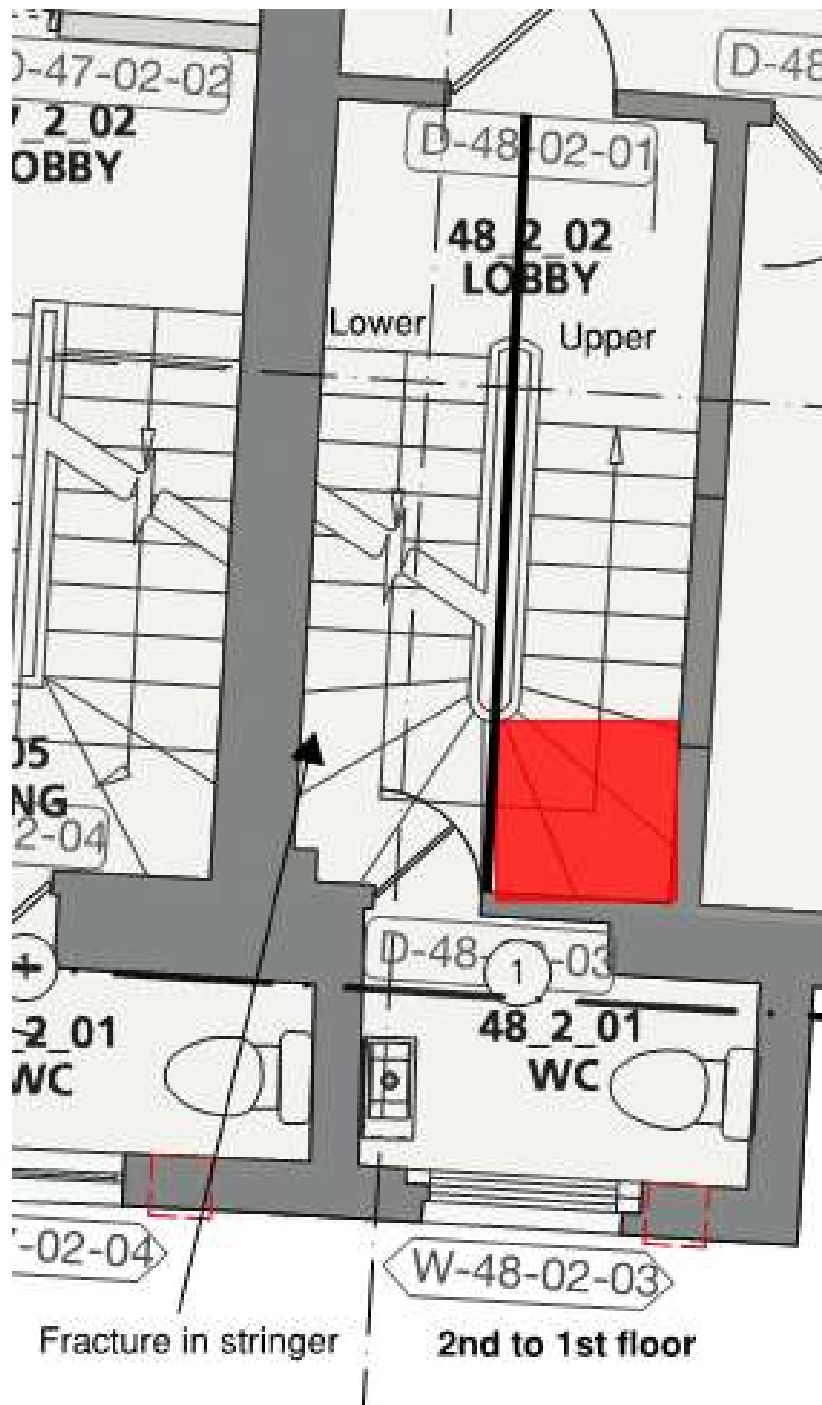
**Fig.2** 2<sup>nd</sup> to 1<sup>st</sup> floor upper and lower flights highlighted with fungal decay.

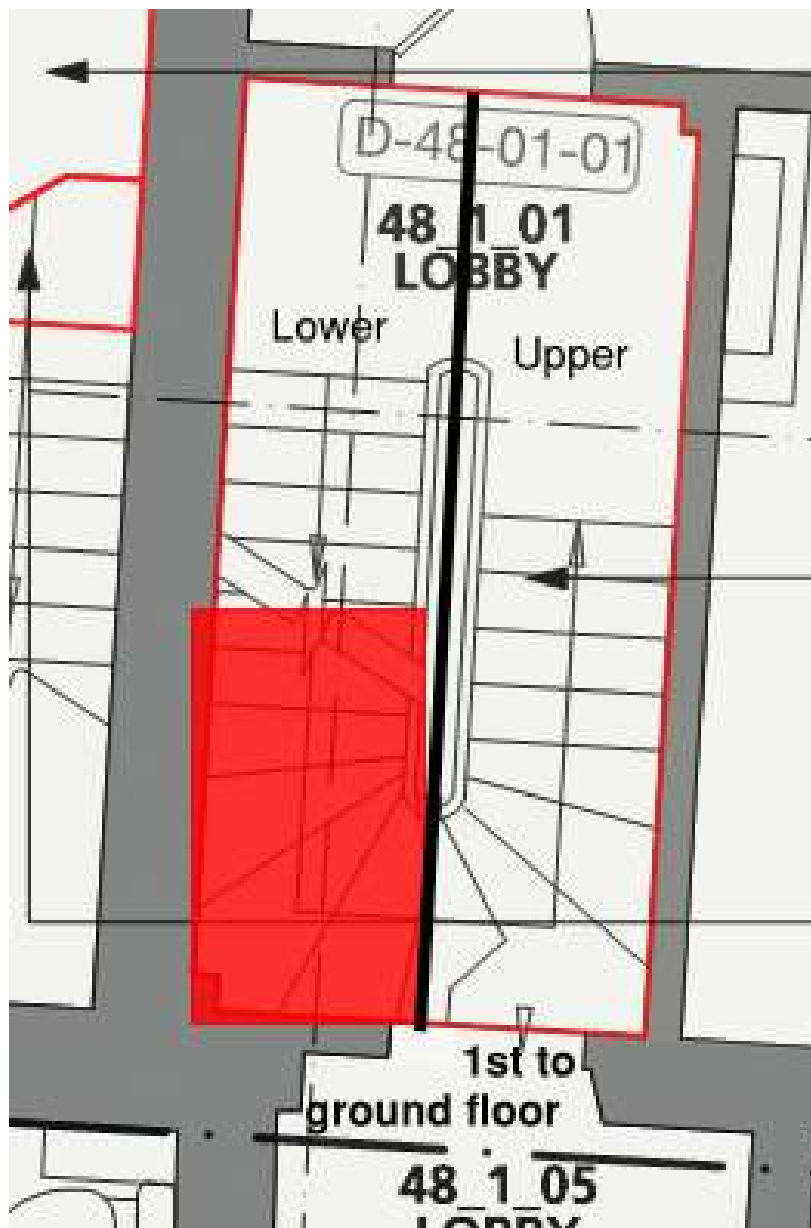
The top half of this section had extensive dry rot to over half the flight. All elements in this location were effected including the stringer, risers, treads, spine and winder joists.

**Fig.3** 1<sup>st</sup> to ground floor upper and lower flights highlighted with fungal decay.

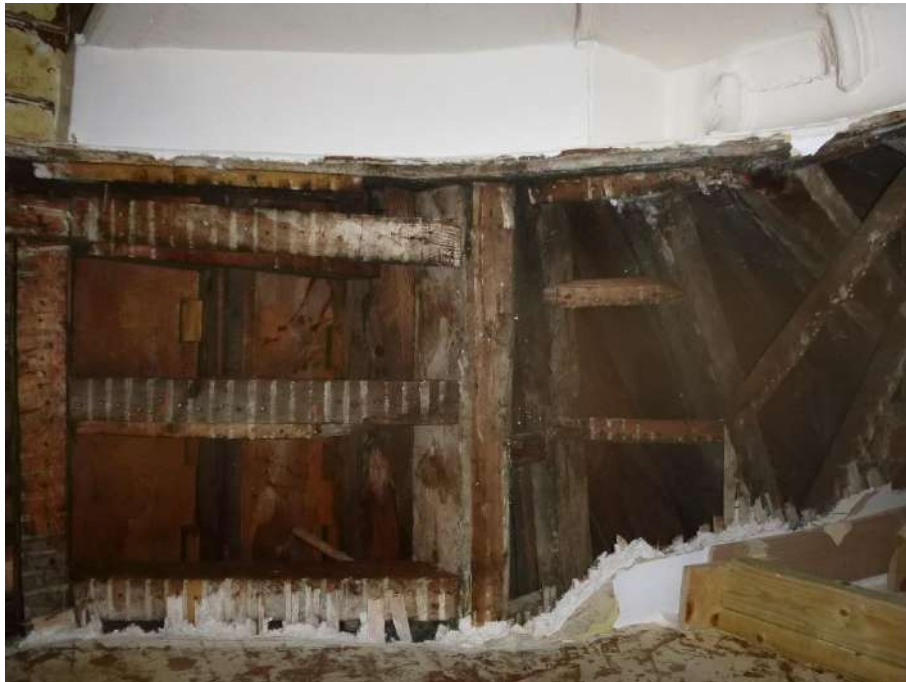
Fungal decay was observed in the stringer on the East flank of the stairs from the South external wall extending 400mm. The fungal decay was active dry rot and visible dry rot mycelium was observed to the wall laths adjacent to this location as shown in Photograph.1.

**Photograph 1.** Underside of upper stair winder from 3<sup>rd</sup> to 2<sup>nd</sup> floor.

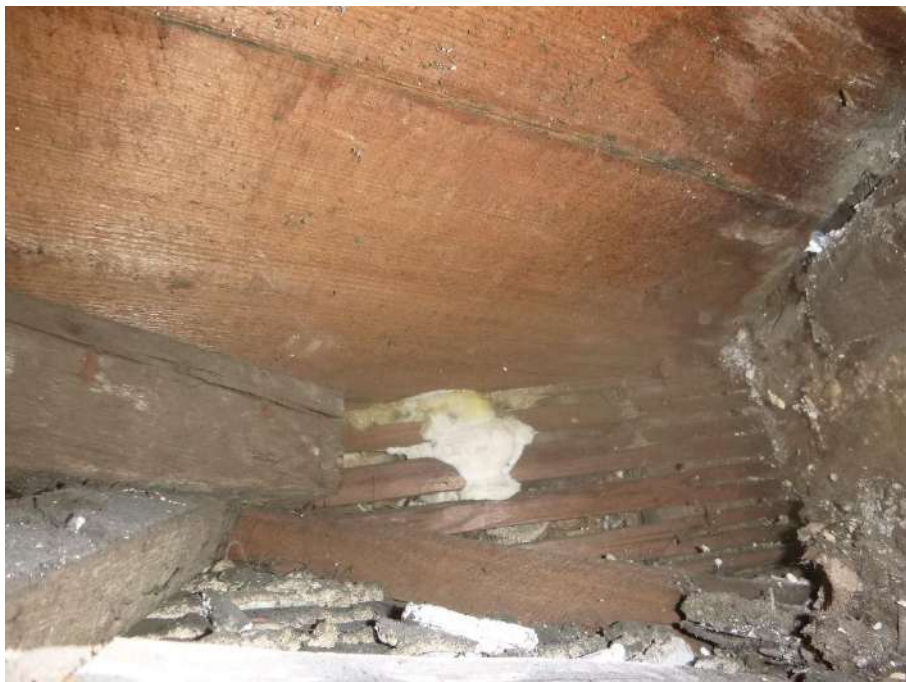
Treads adjacent to the fungal decay observed on the stringer were decayed for 20mm from the stringer as shown in Photograph.2.

**Photograph 2.** Visible mycelium on wall laths adjacent to stringer on upper flight of 3<sup>rd</sup> to 2<sup>nd</sup> floor.

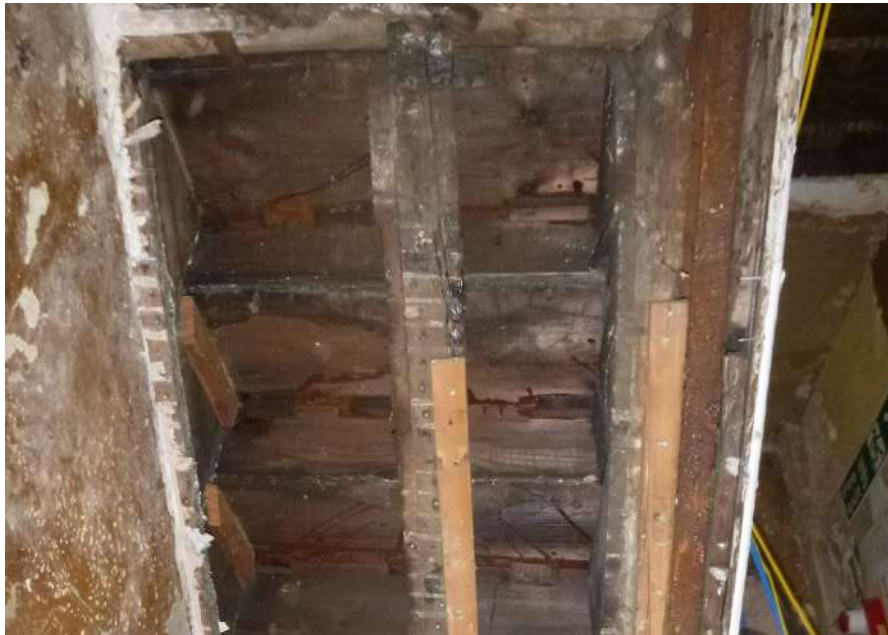
**Photograph 3.** Underside of lower flight of 3<sup>rd</sup> to 2<sup>nd</sup> floor section.

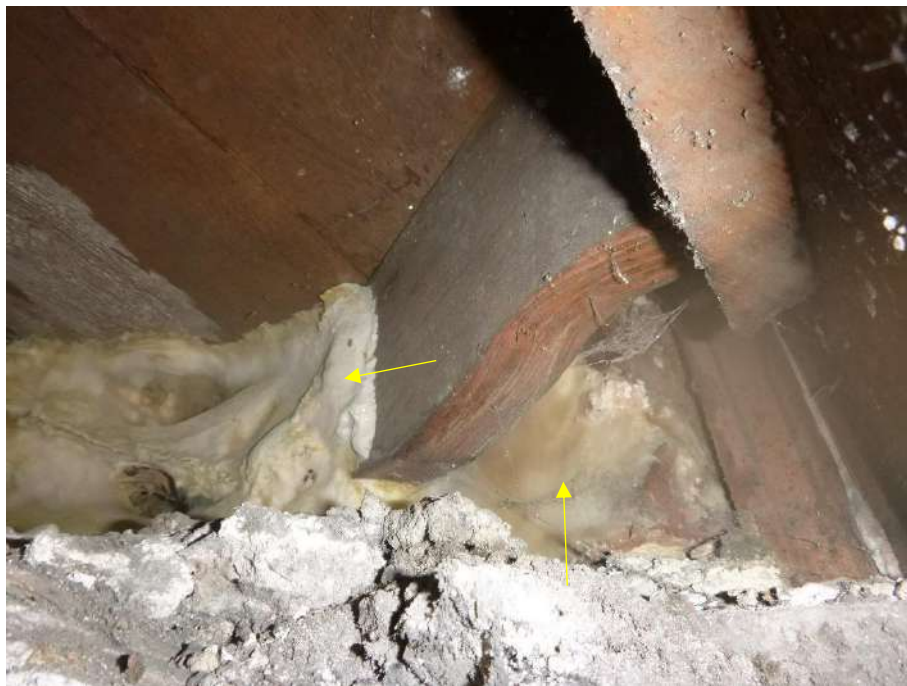
The stringer along the East flank was sound and dry but had a gap behind and it was not clear how this element was fixed/ supported. Historic dry rot was observed extending 600mm from the South external wall as shown in Photograph.4.

**Photograph 4.** Historic fungal decay in the upper flight of the 2<sup>nd</sup> to 1<sup>st</sup> floor staircase.

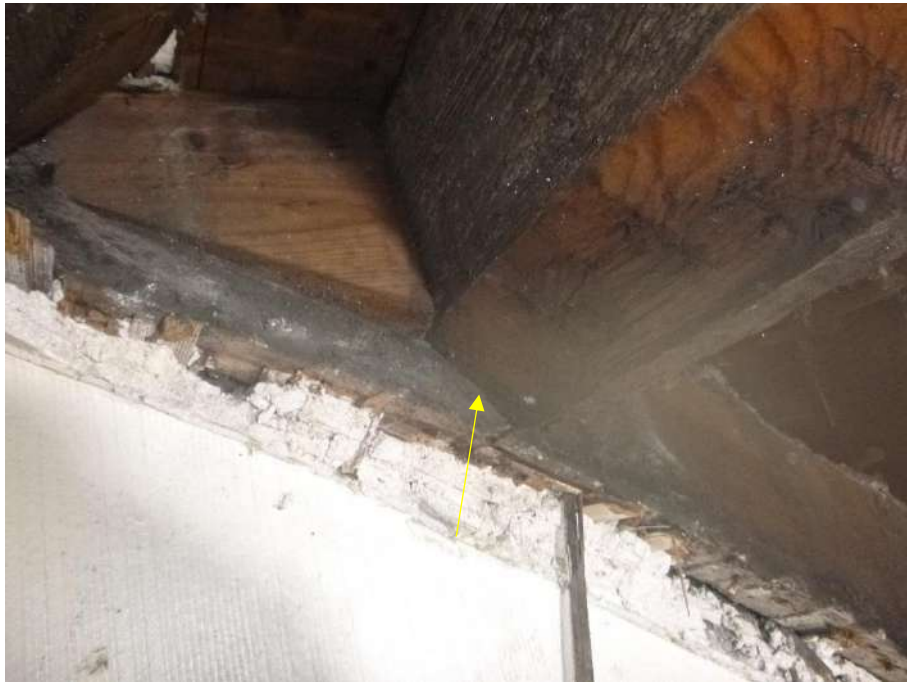
Stringers were sound and dry. A fracture was observed in the stringer shown in Photograph.5 and Appendix I.

**Photograph 5.** Fracture in the stringer in the lower flight of the 2<sup>nd</sup> to 1<sup>st</sup> floor staircase.

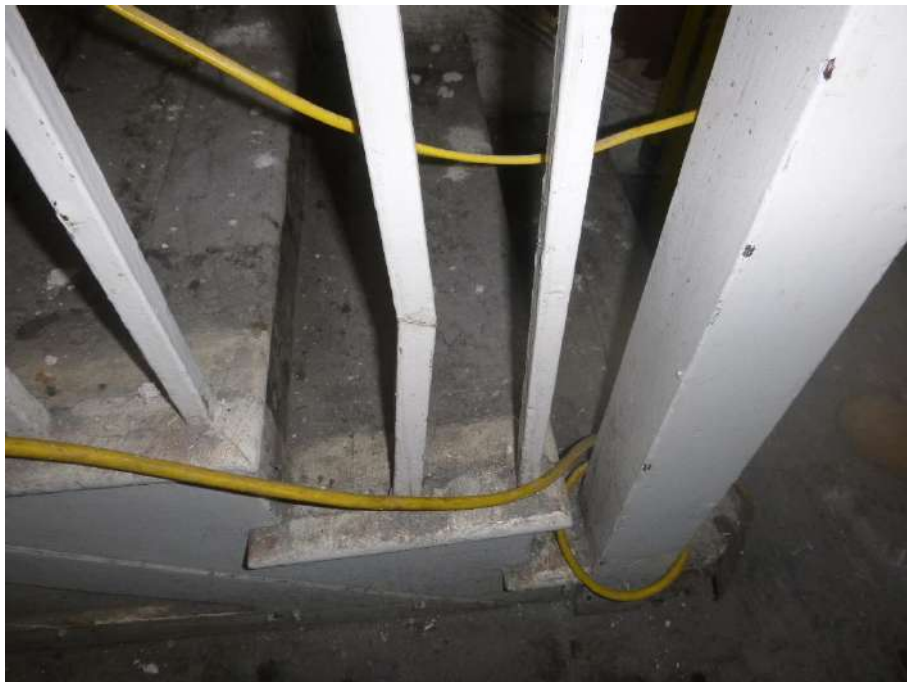
The 2<sup>nd</sup> baluster from ground floor level was broken as shown in Photograph.6.

**Photograph 6.** Broken baluster in the lower flight of 1<sup>st</sup> to ground floor staircase.

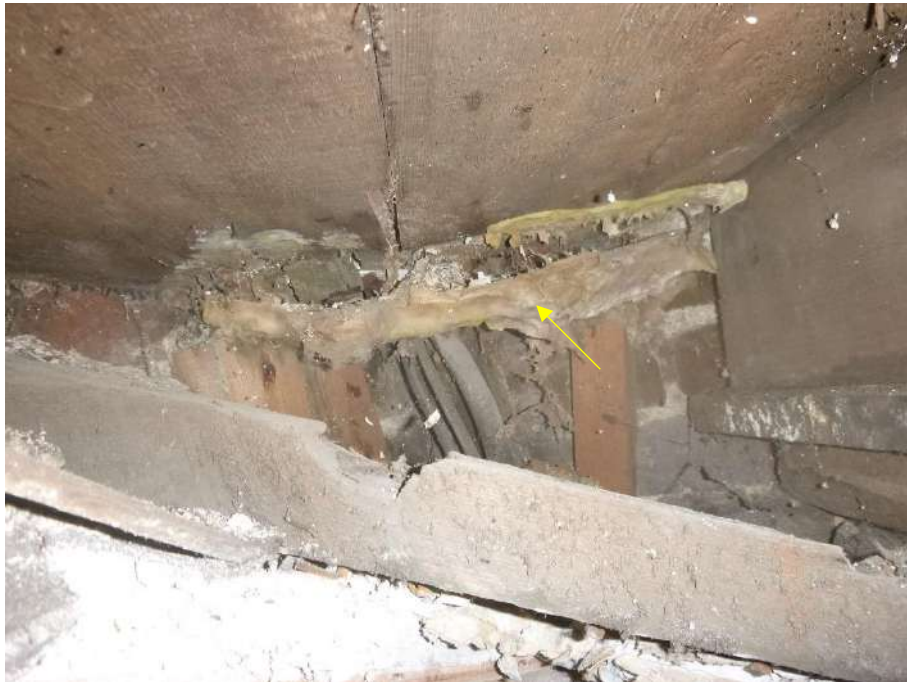
**Photograph 7.** Visible historic dry rot to the underside of the lower flight of the 1<sup>st</sup> to ground floor staircase.

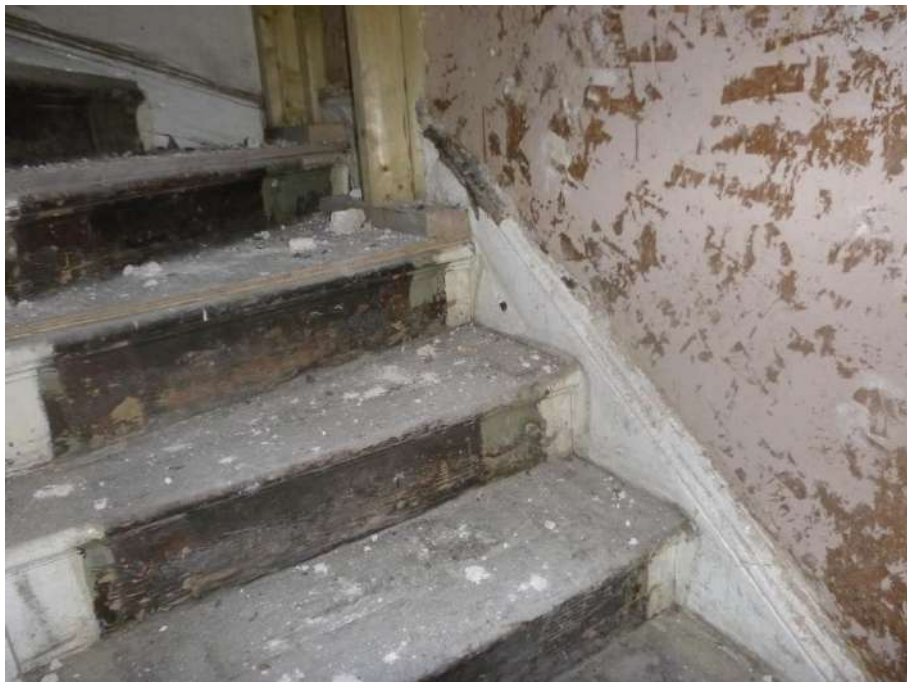
**Photograph 8.** Lower flight of 1<sup>st</sup> to ground floor subject to extensive fungal decay.

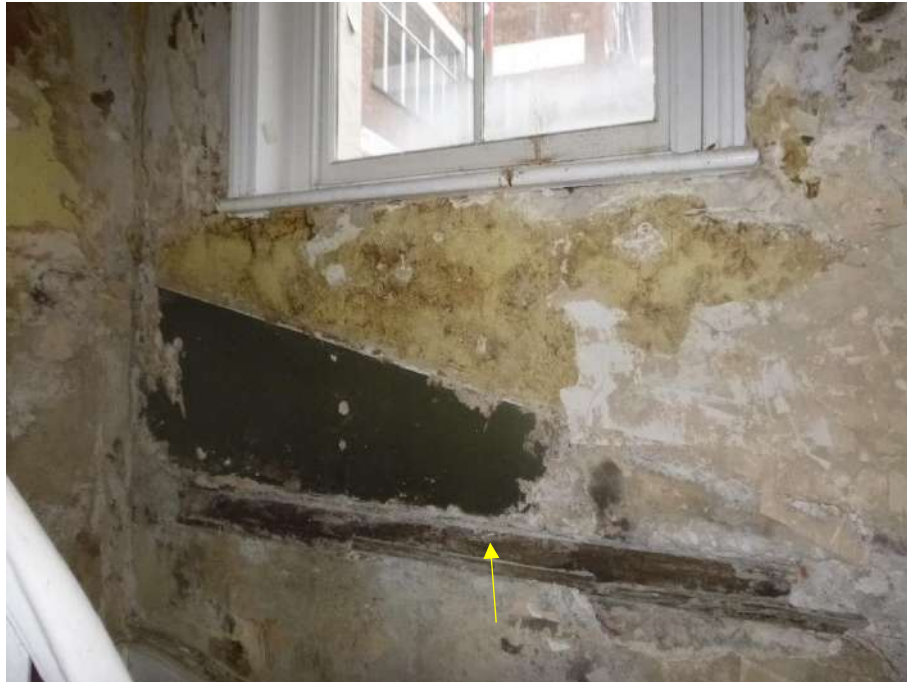
The lintel between the 3<sup>rd</sup> and 2<sup>nd</sup> floors 700mm below a window had extensive fungal decay along its length shown in Photograph.9.

**Photograph 9.** Lintel between the 3<sup>rd</sup> and 2<sup>nd</sup> floors.

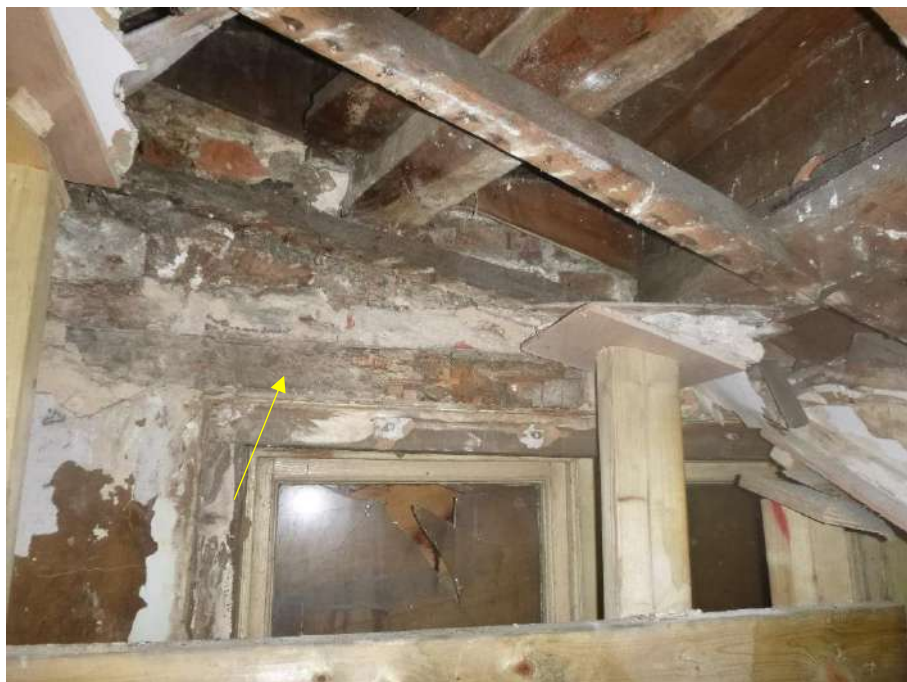
The lintel between the 2<sup>nd</sup> and 1<sup>st</sup> floor had extensive fungal decay along its length shown in Photograph 10.

**Photograph 10.** Lintel between the 2<sup>nd</sup> and 1<sup>st</sup> floors.

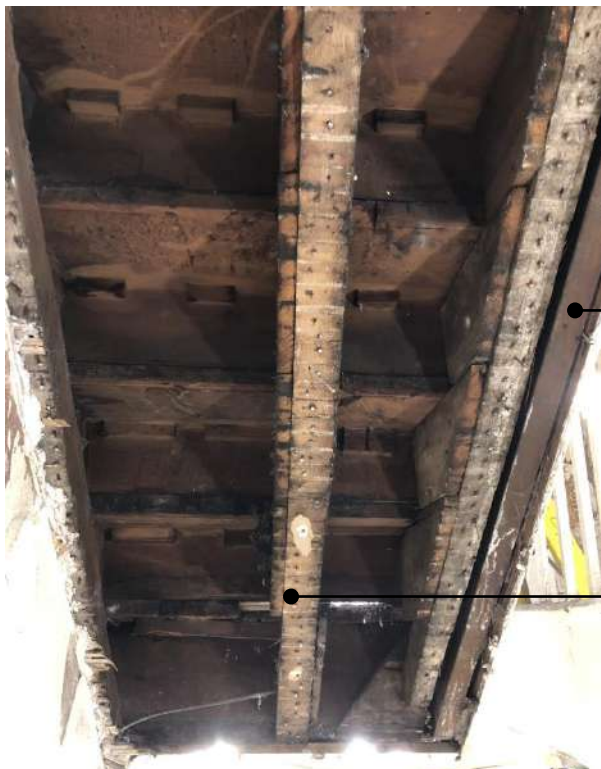
**S1.1** Soffit finishes were stripped to inspect the supporting structure underneath

Rolled Steel Joist (RSJ) cranked to suit the profile of the stair identified. One end is supported by the rear wall (on a lintel – tbc) and the other on a similar sized steel joist as shown on S1.2

Damp was noticed throughout, with more damaged/rotten elements closer to the rear wall, previously identified to have water ingress.

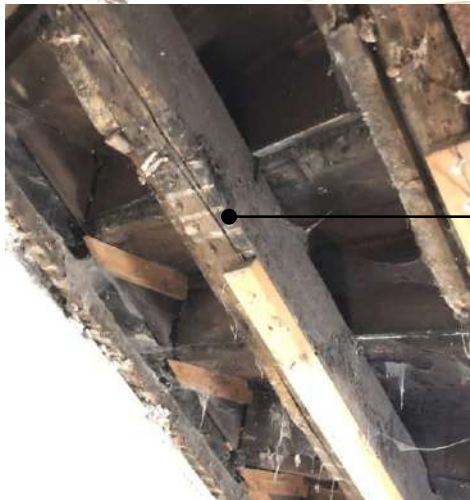
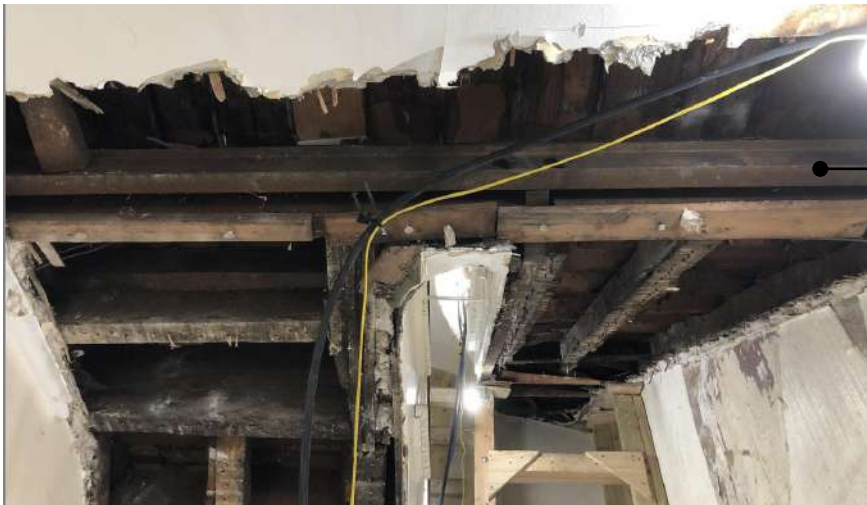
**S1.2** RSJ spanning off masonry walls, supporting cranked RSJ plus timber stringers as shown on S1.1.

The RSJ here is of an I-section profile, 100 deep x 45mm wide with a 4mm flange thickness.

Minor rusting of the steelwork was identified, and the RSJ on level 1 had significant lateral bending due to lack of restraint (via blocking).

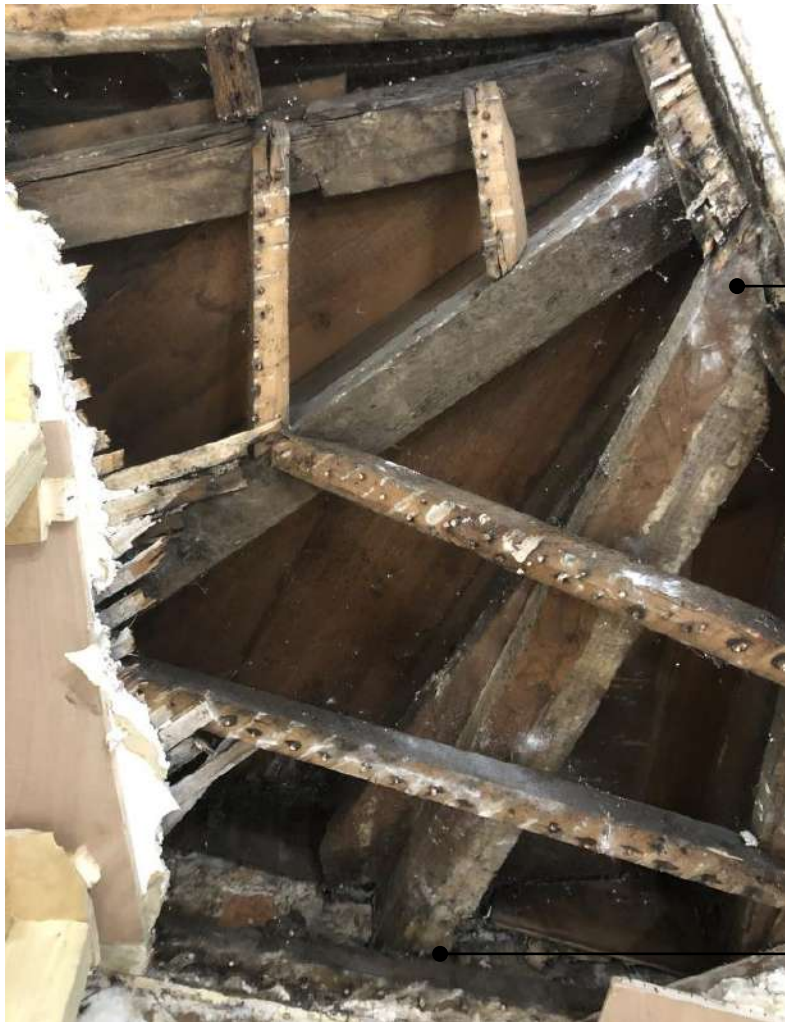
**S1.3** Profiled timber joists with packing pieces to make up the profile of the stair.

It is not clear how the free end is supported. **It is suspected that the beams are currently cantilevering and held in place only by the various edging/packer pieces tying the stair together.**

One end is supported off the rear masonry wall, over a suspected concrete lintel. **Signs of water ingress and associated rot/decay was prevalent.**

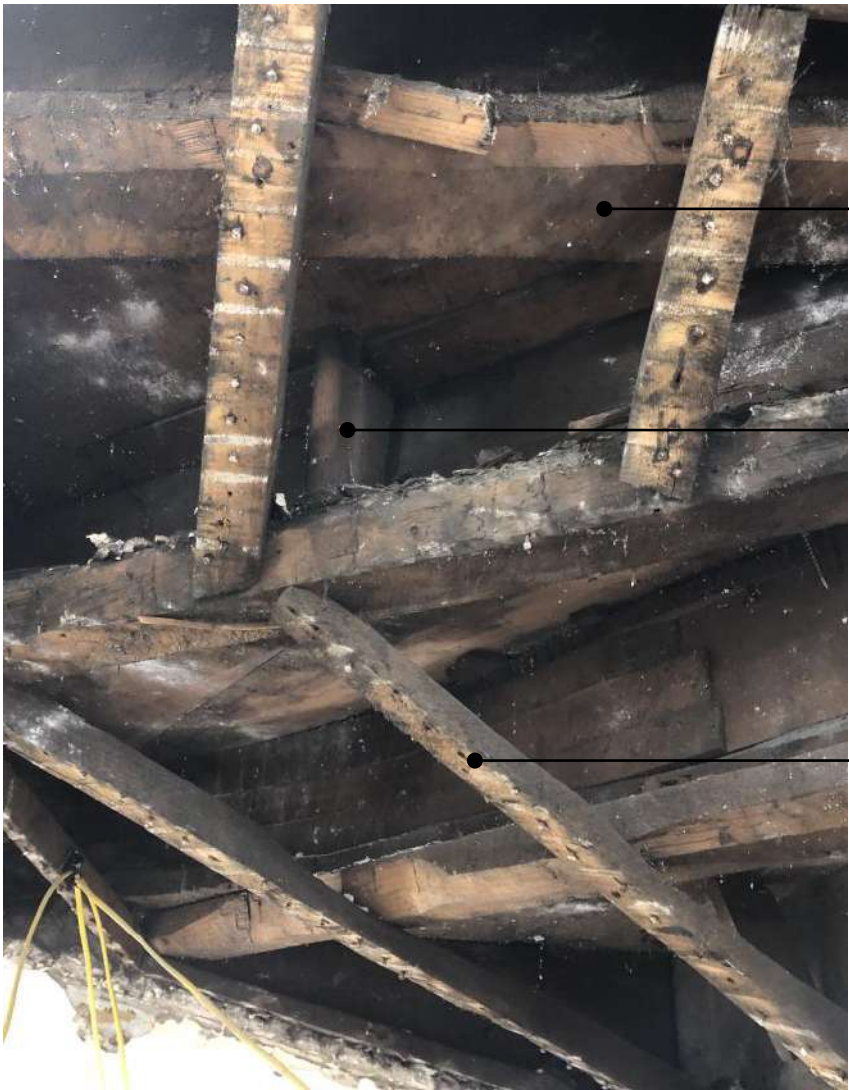
**S1.4** Timber beams to suit profile of stair as S1.3

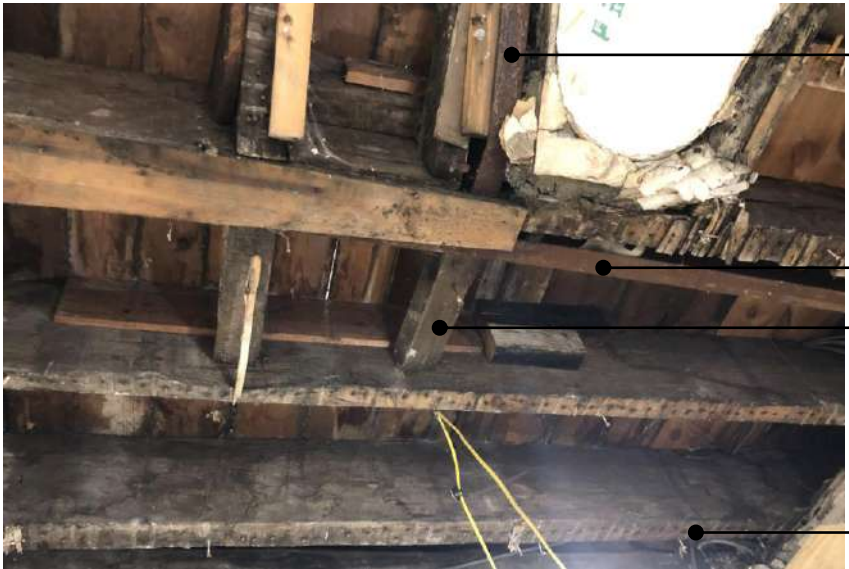
**S1.4**

Cranked steel RSJ

Main timber floor joists running parallel to RSJ. Measured 240mm dp x 50mm wide

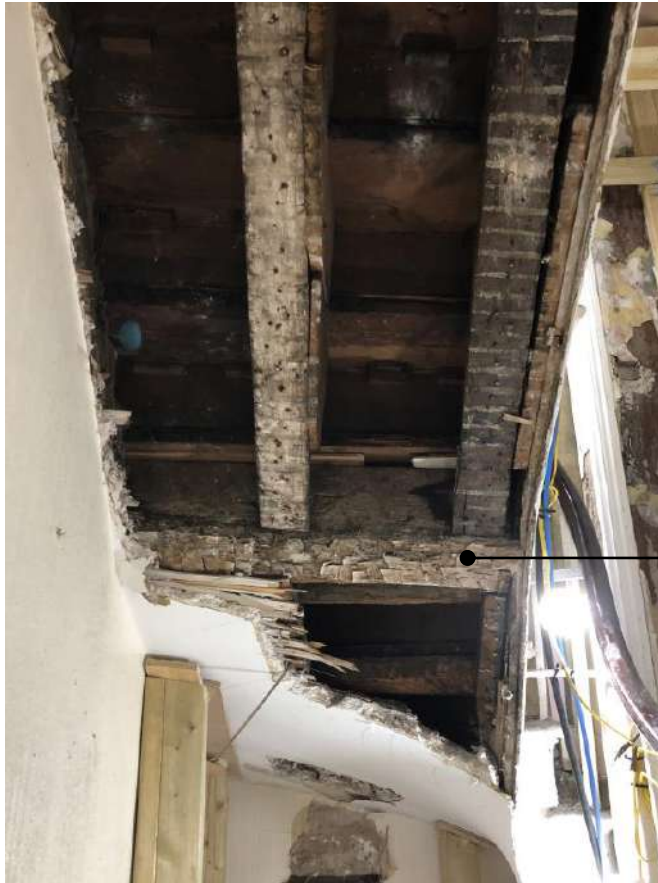
**S1.5** A steel RSJ was not identified on the alternate flight, as it is suspected that the timber beam shown is supporting the timber stringers as a cantilever.

This is likely the reason for the noticeable deflection of the structure.

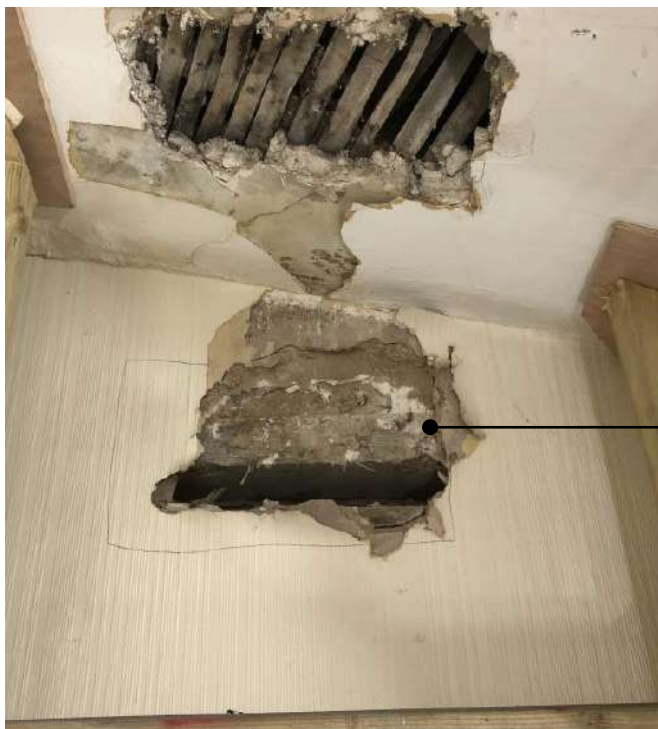
**S1.6** Rear wall with a lintel identified over a stud partition. The stair support beams in S1.3 are generally embedded within the masonry that sits over this lintel.

It has been confirmed via subsequent visits that this is a timber lintel with significant signs of water ingress and dry rot. Elements are to be replaced.

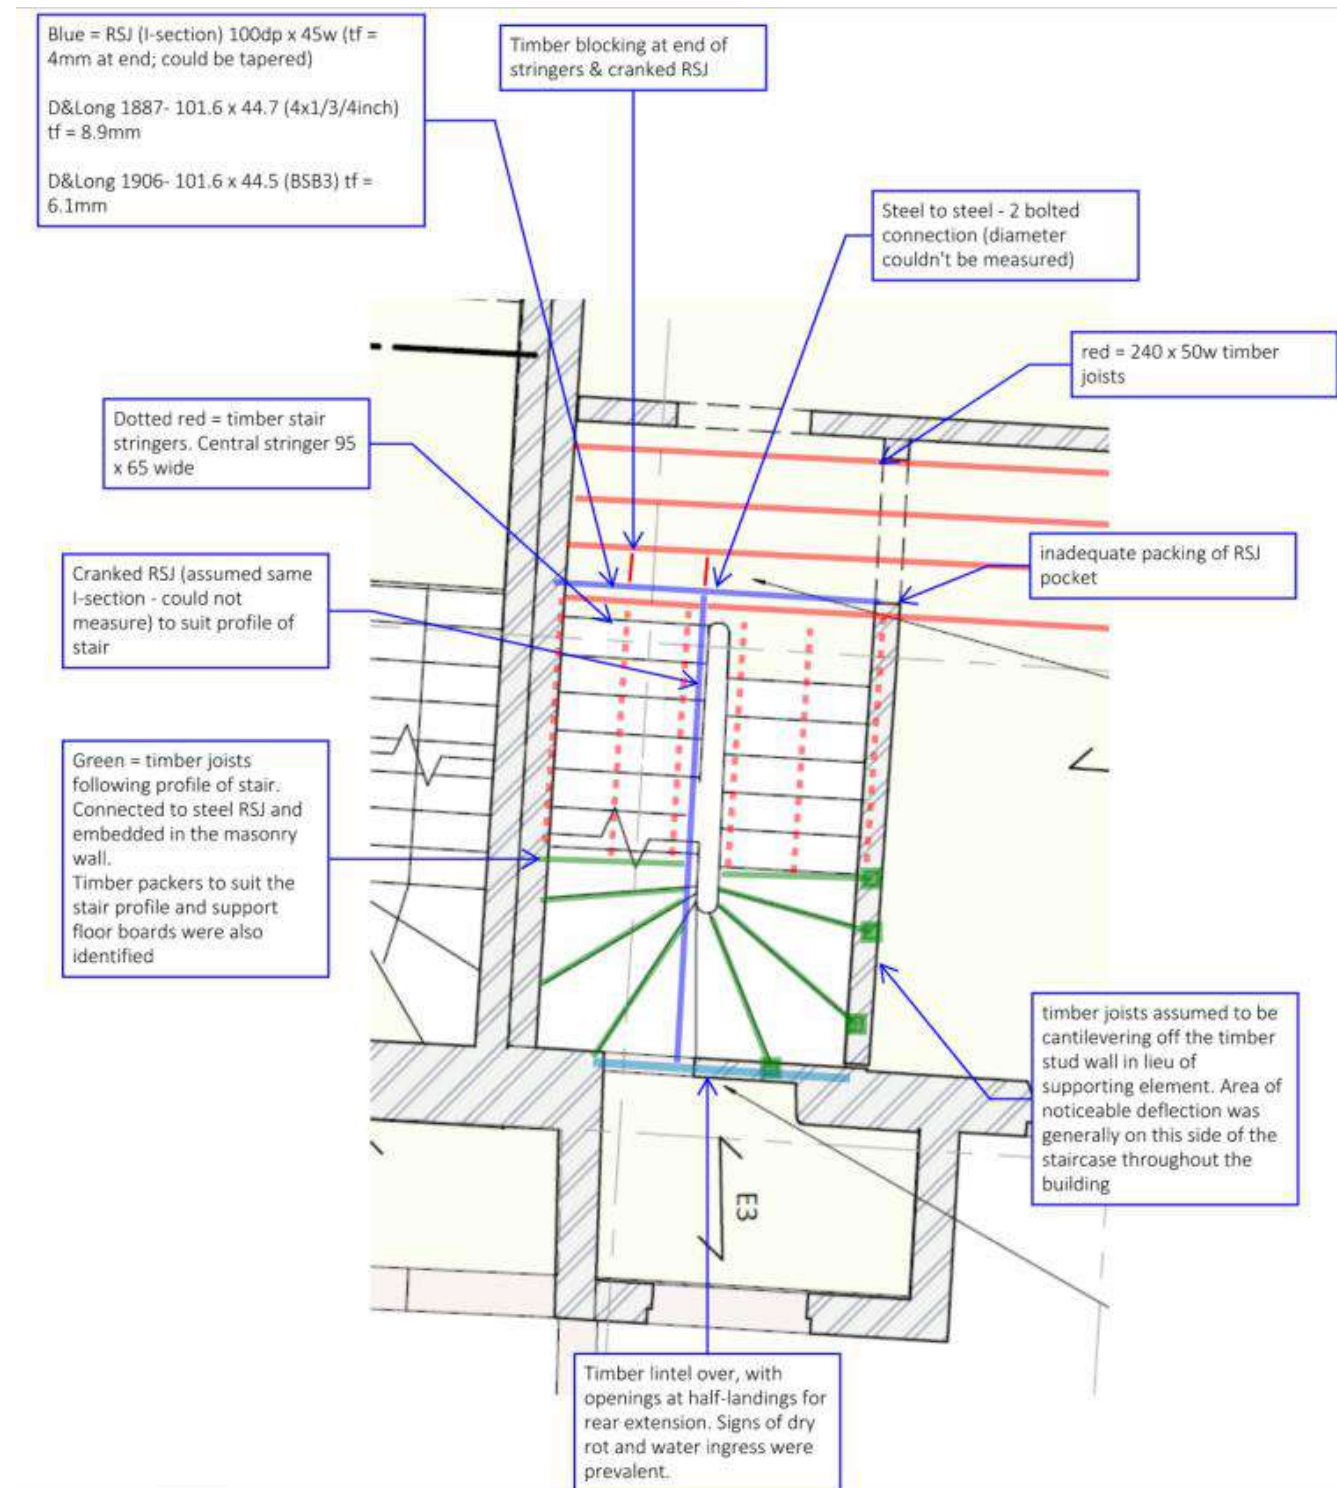
- + The image shown summarises the observed framing arrangement of the stair.
- + It was observed that the steel RSJ elements installed are required to support the timber joists that form the profile of the stair.

- + Excessive deflection on the flight to the right-hand side of the image is attributed to the timber joists being un-supported on one end i.e., cantilevering off the timber stud wall. **It is assumed that another steel RSJ was likely required to support these joists, which are not present (mirror of the opposite flight).**
