Project: 49 Willow Road, London NW3

Ref : 2136 Structural Inspection210705A

## **1. Introduction**

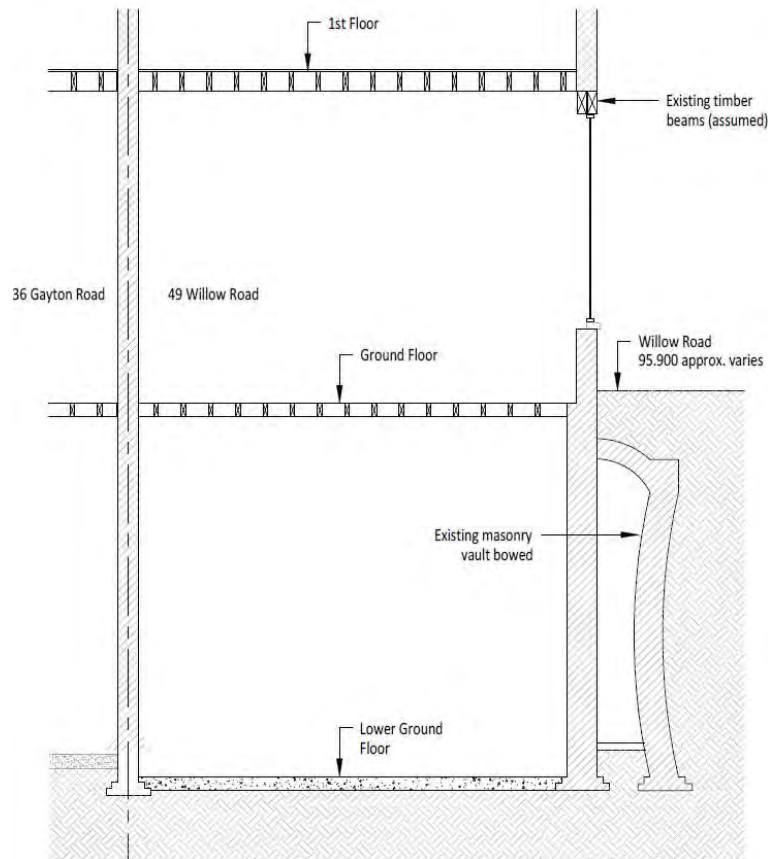
Figure 4: Section showing vault construction

- 2.5. The vaults are located below the pavement and extend from the party wall at 36 Gayton Road to the kiln room along Willow Road (see figure 3). The vaults are offset from the building façade and the space between the front wall of the building and the vault walls is approximately 550mm clear.
- 2.6. The vaults are constructed in masonry with a brick arch built bonded to the façade at the top, near the surface; and there is approximately 300 to 500 millimetres of earth covering overhead. The height of the wall is approximately 3.3m high (see figure 4).

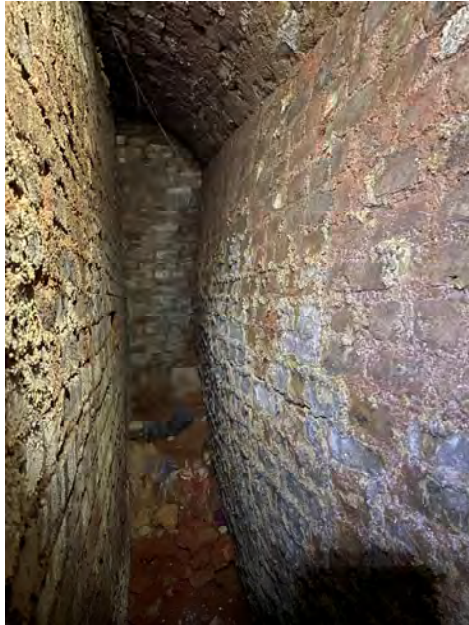
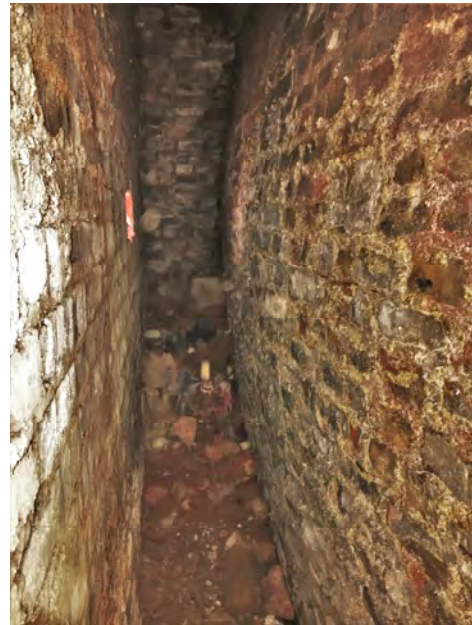
- 3.1. There is a significant bulge in the vault wall along Willow Road and a measured survey confirms this to be some 150mm out of vertical. Open bed joints are present in the brickwork indicating that there is no bonding between the bricks and mortar (See photos 2-4).

Photo 2: Severe bulge in vault wall

Photo 3: Severe bulge in vault wall

- 4.1. The vaults were constructed in 1880s and are therefore some 140 years old. They have deteriorated much over this time and are now past their serviceable life.
- 4.2. The lime mortar is providing little to no bonding to the masonry. The vaults are acting as a gravity structure retaining the footpath and road using self-weight to provide stability.
- 4.3. Owing to the extensive bowing in the wall along Willow Road, stability cannot be assured. The bulges in the walls are likely to increase over time leading to collapse. This is therefore a safety concern for the occupiers, pedestrians and the motorists.

- 4.4. The time frame for this is not predictable but it could be imminent along Willow Road side. It is therefore imperative that the remedial works to reconstruct the vaults are undertaken at the earliest opportunity.
- 4.5. In order to avoid the disruption to the pavement, remedial works could be undertaken from within the building at lower ground floor level.
- 4.6. The masonry arch is in compression and not subject to adverse bending moments so this could be retained to avoid digging up the pavement. The soffit could be strengthened with sprayed concrete (shotcrete).
- 4.7. The remaining wall and foundations could be rebuilt with reinforced concrete design to sustain footway and traffic loads constructed in sequence from within the lower ground floor of the building.

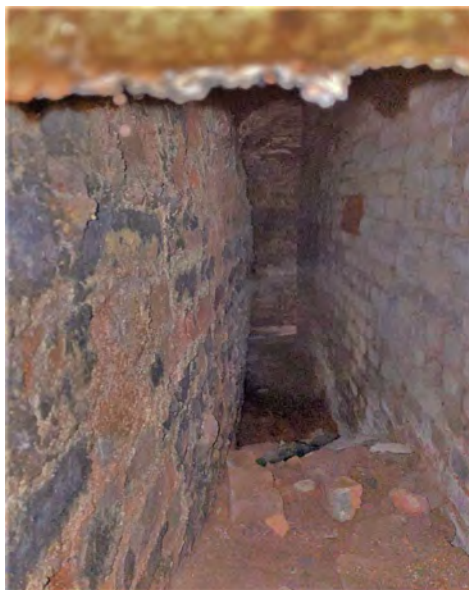
Photo 4: Vault looking south

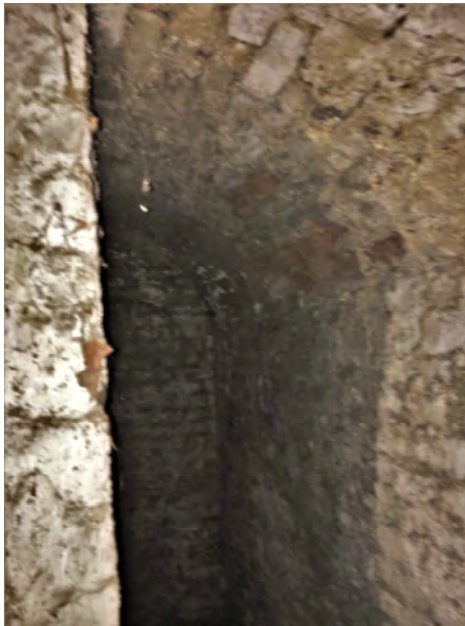
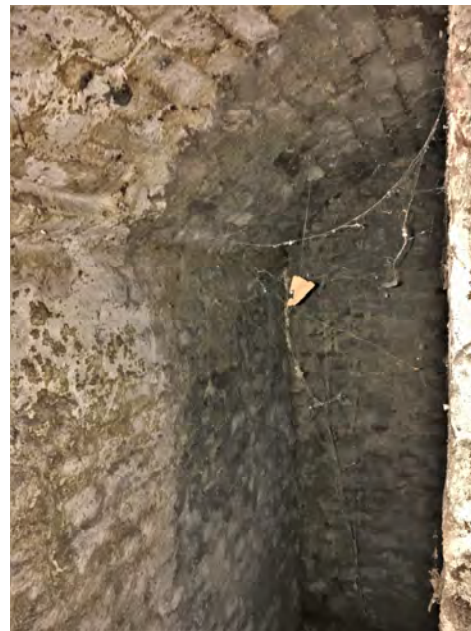
- 3.2. The vault along Gayton Road is in a better condition although there is a slight bulge in the wall which is not as severe as that along Willow Road (see photos 5 & 6).

Photo 5: Vault along Gayton Road looking east towards Willow Road

Photo 6: Vault along Gayton Road looking west.

- 3.3. Although the bricks appear to be satisfactory, the lime mortar has little strength and some areas are friable and soft to the touch.
