## SITE INVESTIGATION FACTUAL REPORT

Report No: [REDACTED]  
Client: Sedgwick International UK - Maidstone  
Site: Camden Arts Centre, Arkwright Road  
Client Ref: [REDACTED]  
Date of Visit: 07/05/19

Home Emergency Response - Subsidence Investigation - Drainage Services – Crack & Level Monitoring – Property Video Surveys

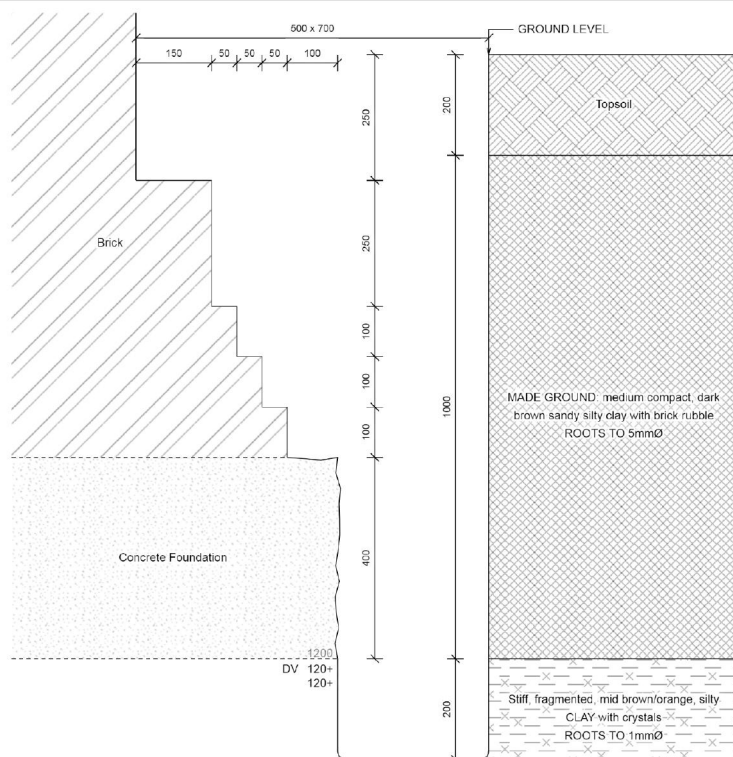
TRIAL PIT REF: TP2

For Strata below 1400mm see Bore Hole log
