## Dartmouth Park Hill Service Tunnel Report

C&I New In-Patient Facility

Camden and Islington NHS Foundation Trust

## INVESTIGATIVE WORKS TO INSPECTION CHAMBER AND TUNNELS AT DARTMOUTH PARK HILL MENTAL HEALTH UNIT TO PEDESTRIAN RAMP PLUS PEDESTRIAN RAMP TO FORMER GENERATOR FUEL TANK REPORT No. WI/WH/0016

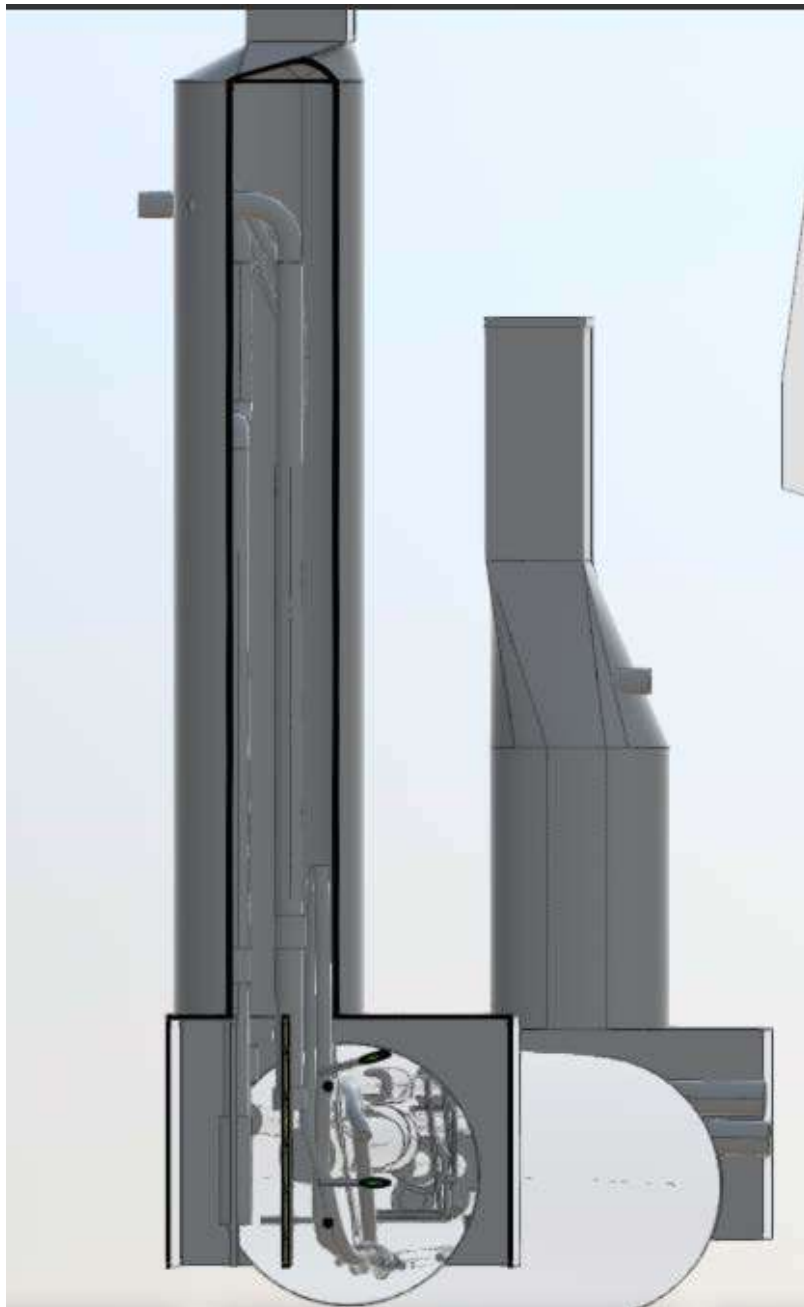
*Figure 2. Inspection chamber located adjacent to Highgate West – demonstrating a heavily congested area with little space to pull required cables and not possible to route the durasteel that is providing the necessary protection*

The locations of the existing services and the depth of the inspection chamber do not accommodate the necessary spatial requirements for the new services and compartmentation required between primary and secondary supplies.

BAM would recommend that an alternative route will need to be investigated with the possibility of a trench running across Dartmouth Park Hill, however this is subject to further discussions with the necessary parties.

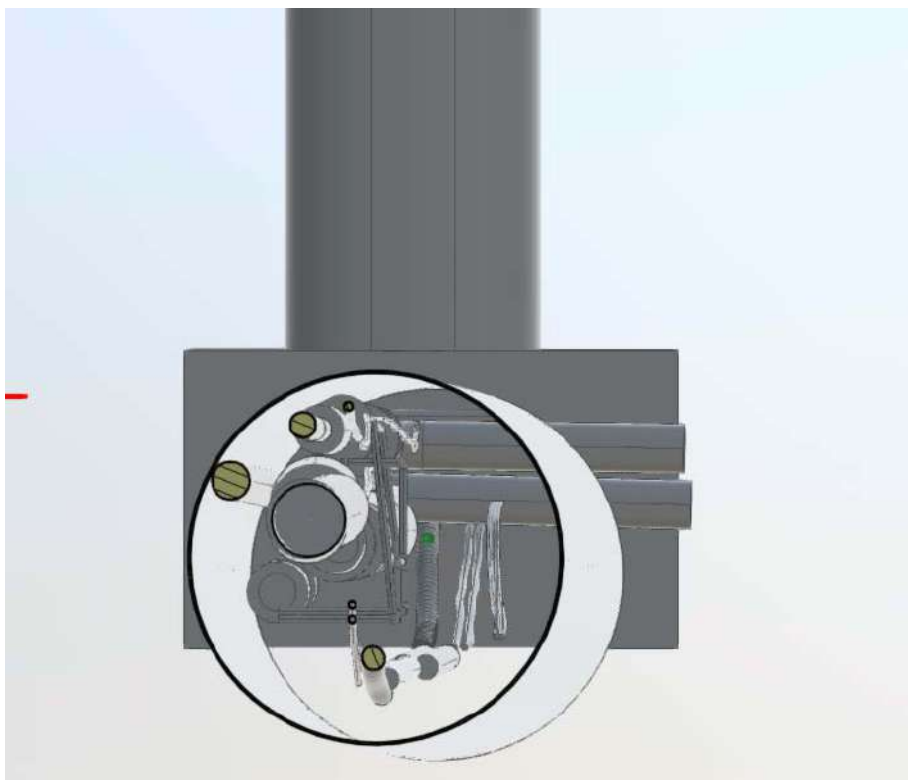
*Figure 3. Main pipe routes modelled along tunnel – some cables/pipes were unable to be modelled due to the wear and damage within the tunnel*

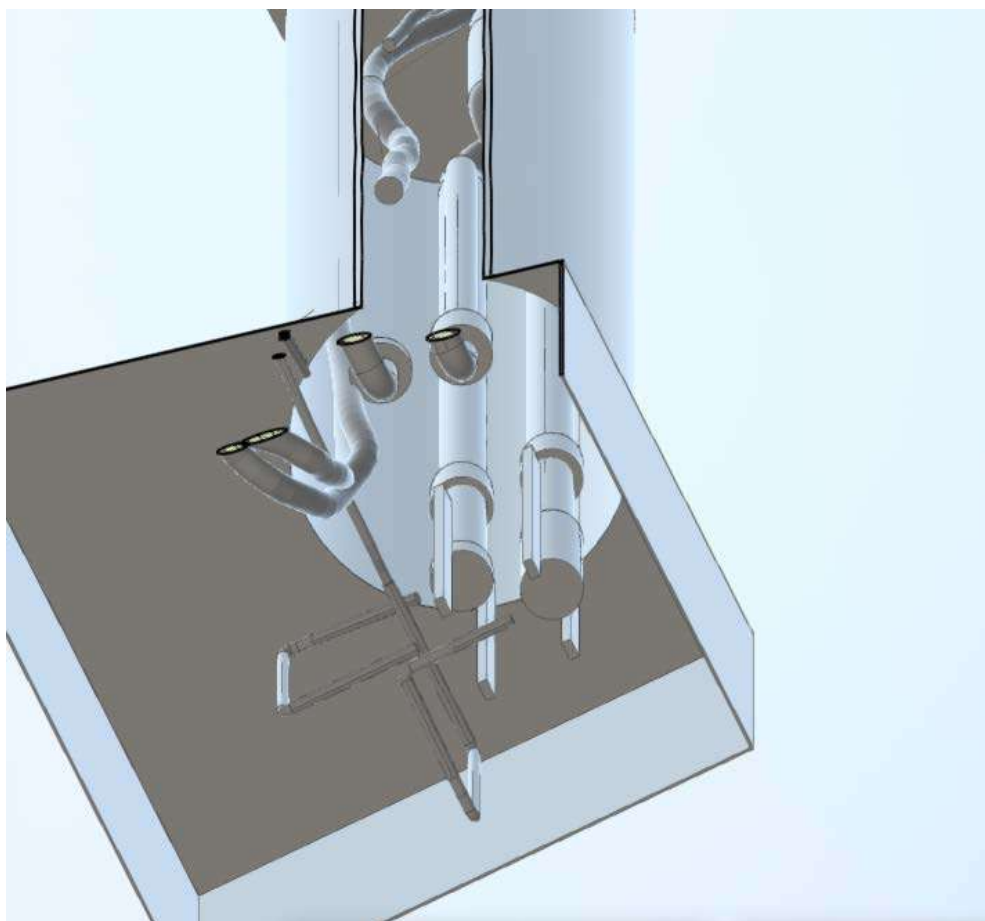
*Figure 4. Inspection chamber to side of new facility showing complex run of pipes contributing to difficult spatial fit of new cables*

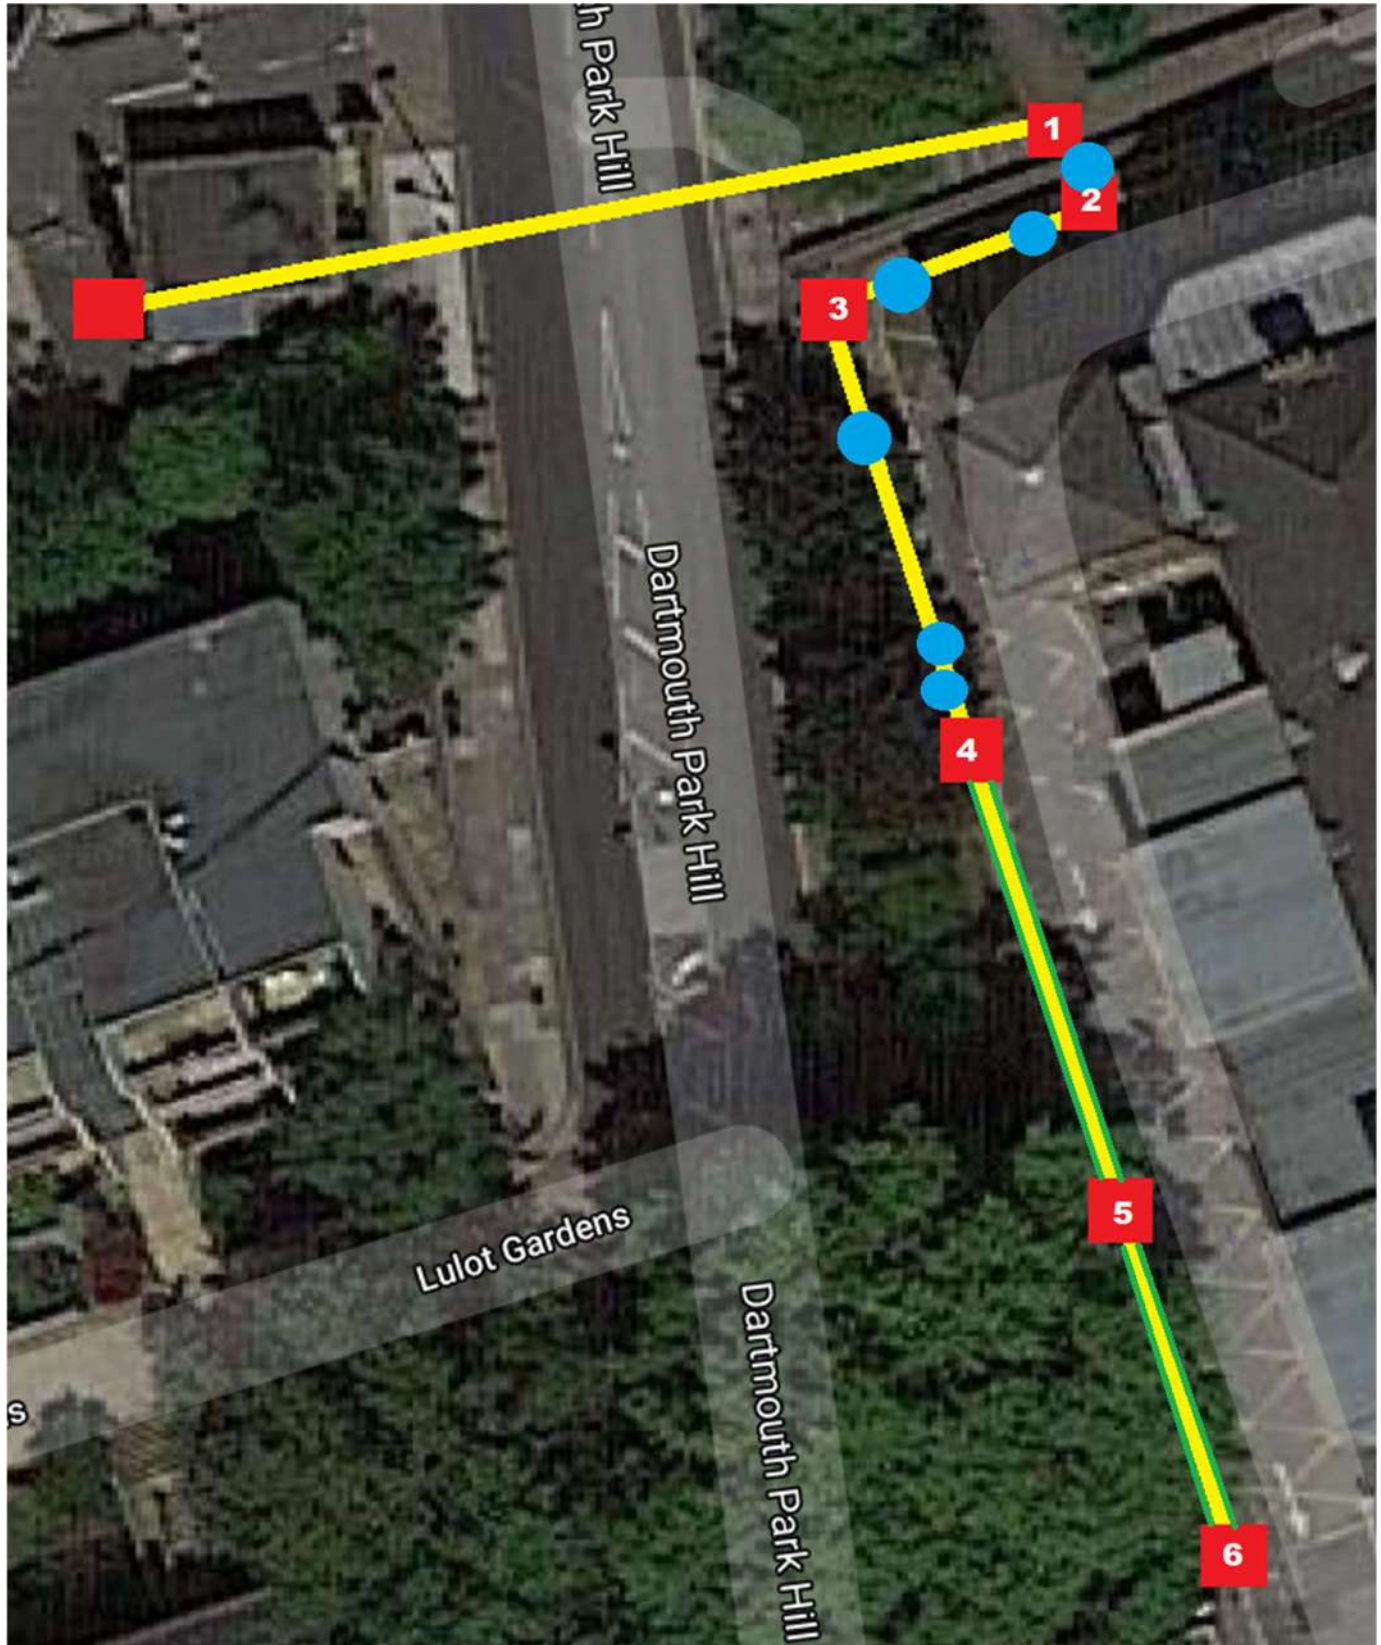
## *Locations of tunnels and inspection chambers*

- The tunnel is in average condition and there are signs of wear. The concrete lintels in the ceiling have started to rust and is cracking/blowing the concrete. There are also a lot of tree roots of mixed diameter. The tunnel is very damp.

*Red squares indicate manhole chambers, yellow lines indicate tunnel run, blue circles indicate areas of excessive corrosion to lintels, green lines indicate areas of large tree roots entering tunnel area.*

- **Medium Term (Applicable to Perimeter Roadway Tunnel)**
  - Replace corroded lintels in sections in 5 no. areas within 12 months as this roadway is the main exit from the Hospital.

- Ensure no heavy loads i.e. crane, HIAB, mobile works platform, stabilisers/jacks are sited on tunnel.
  - Removal of tree roots between Manhole 4 and Manhole 6.

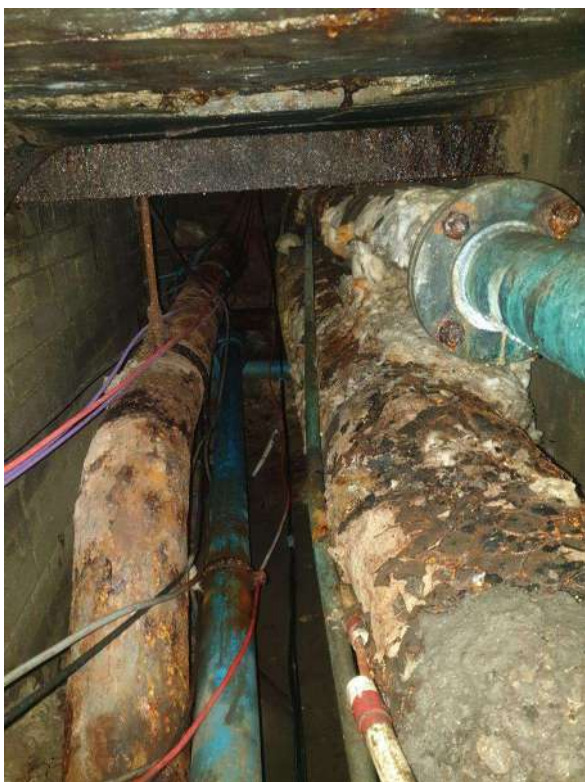
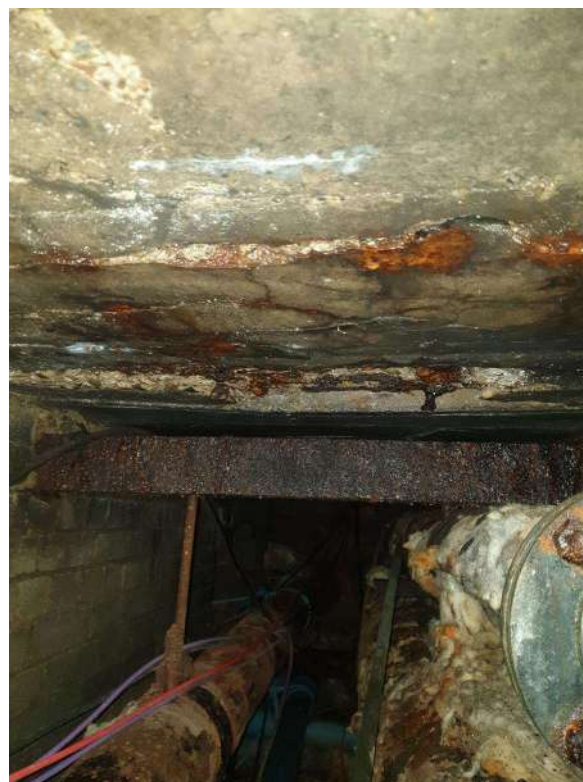
The water level filled the tunnel between the Whittington Hospital and the Mental Health Unit and has flooded causing corrosive deterioration of the segmented tunnel/shaft. In the perimeter road tunnel section, (parallel to Dartmouth Park Hill), there are 5 no. patches of corrosion evident to the lintel forcing the base/tunnel roof. These will need to be replaced in the short to medium term.

**MH2 LOOKING TOWARDS MH1 – CORROSION BEGINS 2 METRES IN FROM MH2 TOWARD MH1**

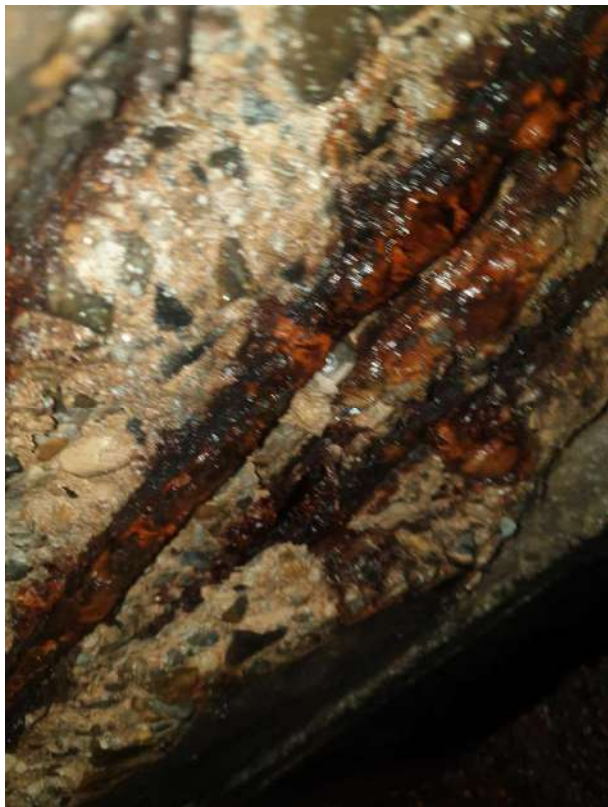
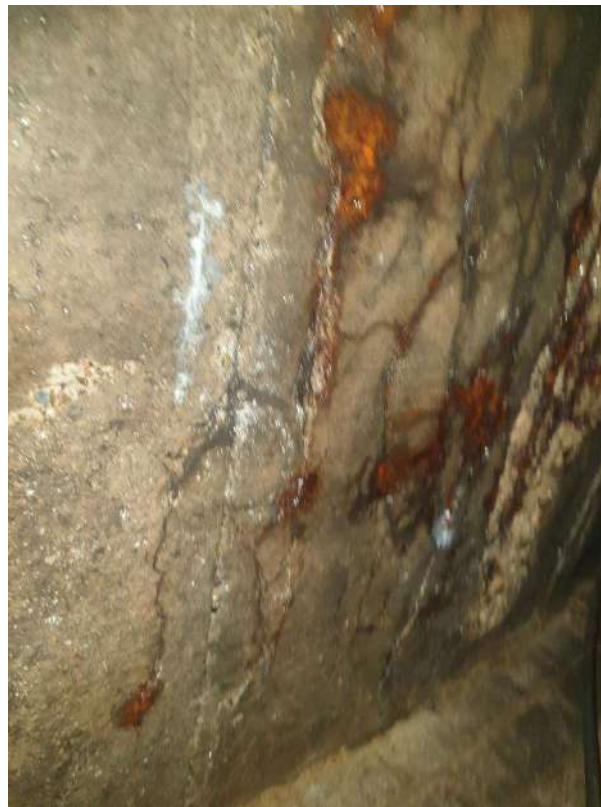
**MH2 LOOKING TOWARDS MH1 – CORROSION BEGINS 2 METRES IN FROM MH2 TOWARD MH1**

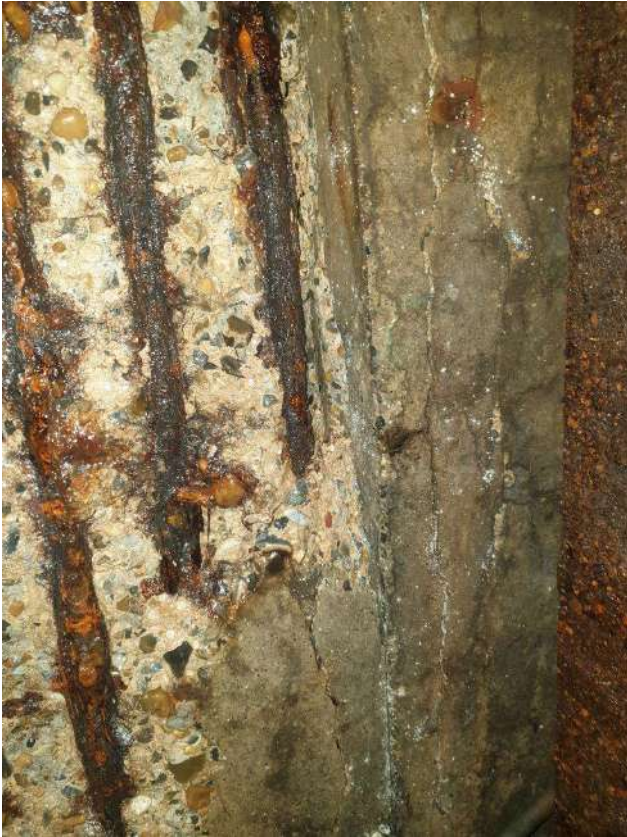
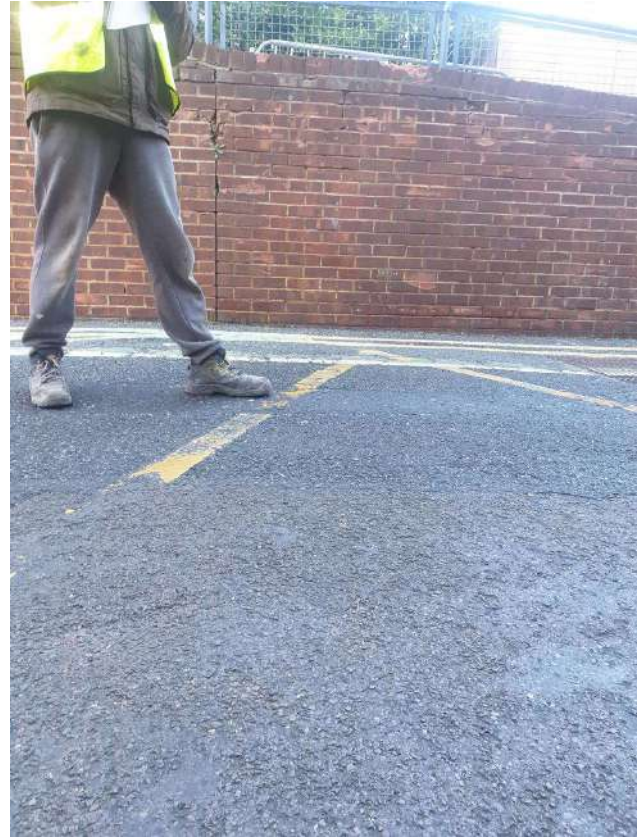
MH1 TOWARDS MH2 – APPROXIMATE LOCATION ON ROADWAY SURFACE OF CORROSION

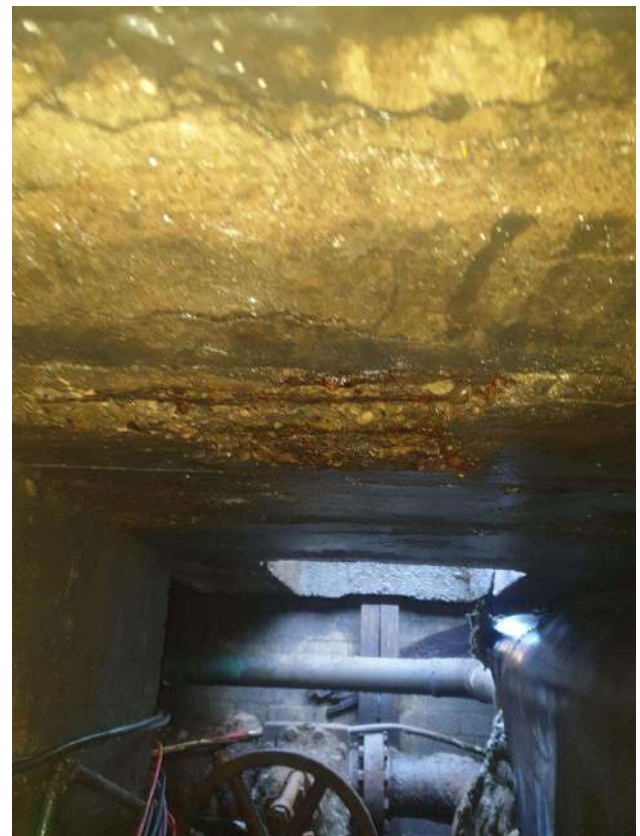
CORROSION BEGINS 2 METRES FROM MH2  
TOWARD MH3

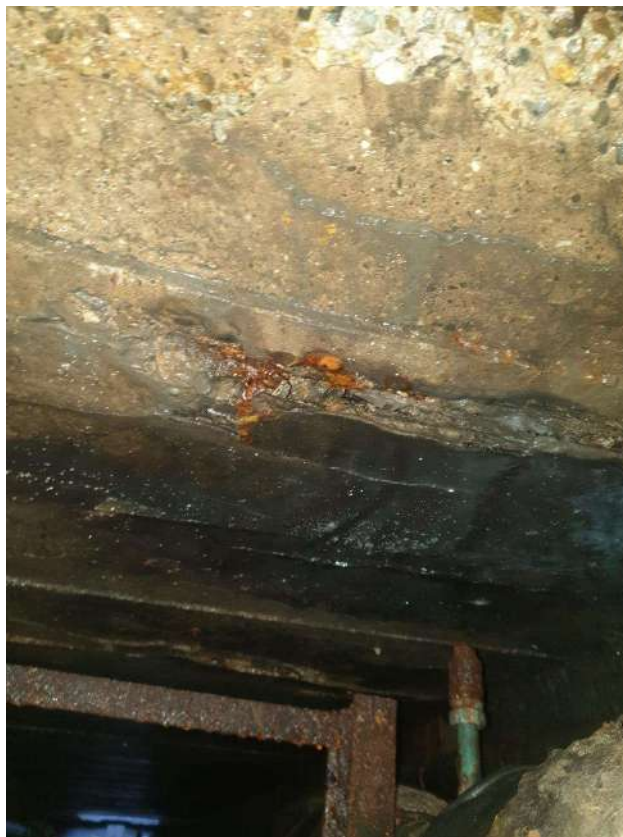
**CORROSION BEGINS 2 METRES FROM MH3  
TOWARDS MH2**

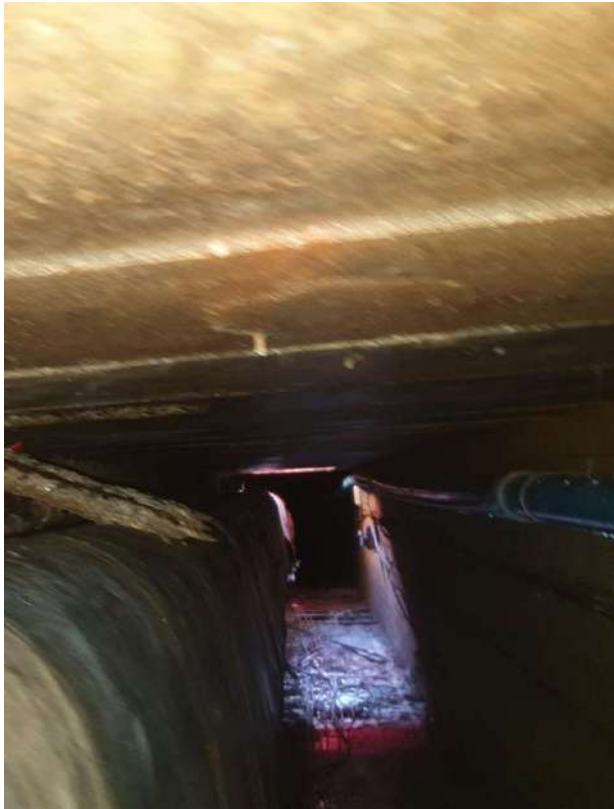
**TWO DAMAGED LINTELS FIVE METRES  
FROM MH3 TOWARDS MH4**

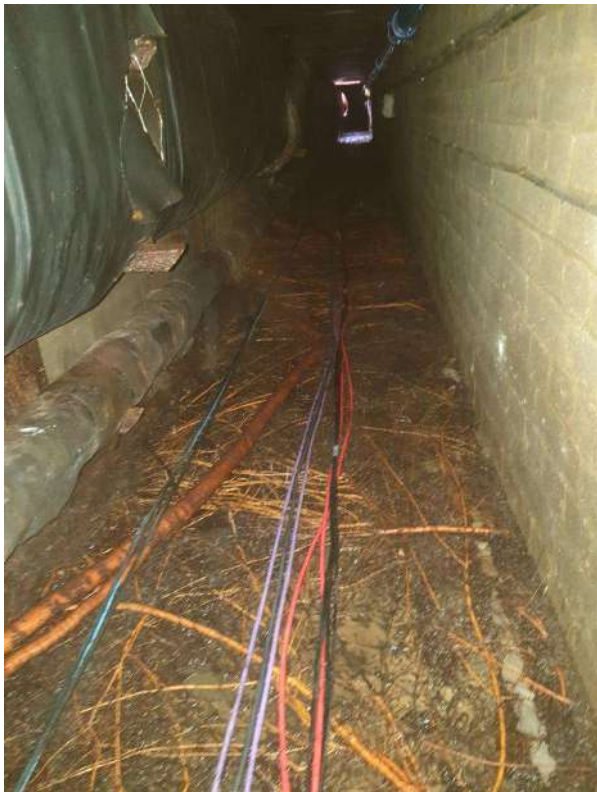
**MH4 TOWARDS MH5 – SMALL TREE ROOTS,  
ENTIRE LENGTH OF RUN**

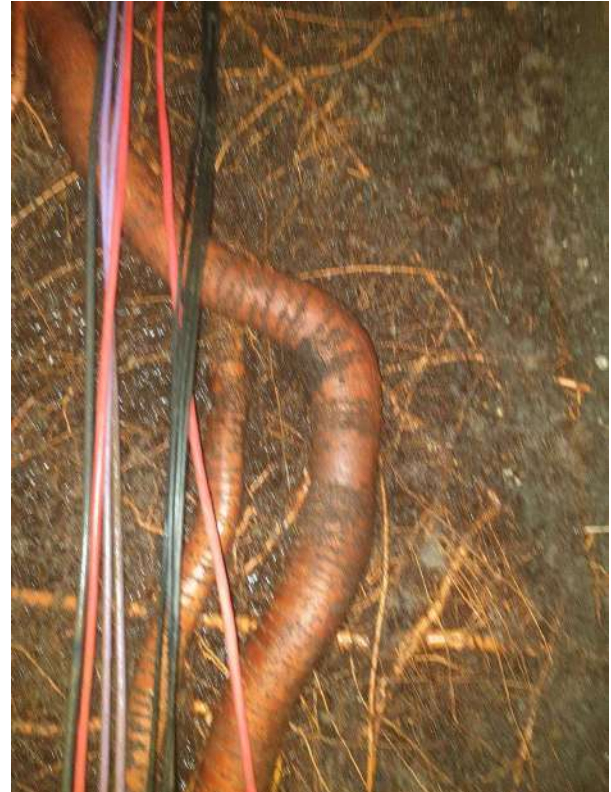
**MH6 TOWARDS MH5 – ENTIRE LENGTH OF  
RUN**
