76 Lawn Road NW3

Structural Appraisal of the
stability of the front garden wall

R11438-RO1

27 July 2021

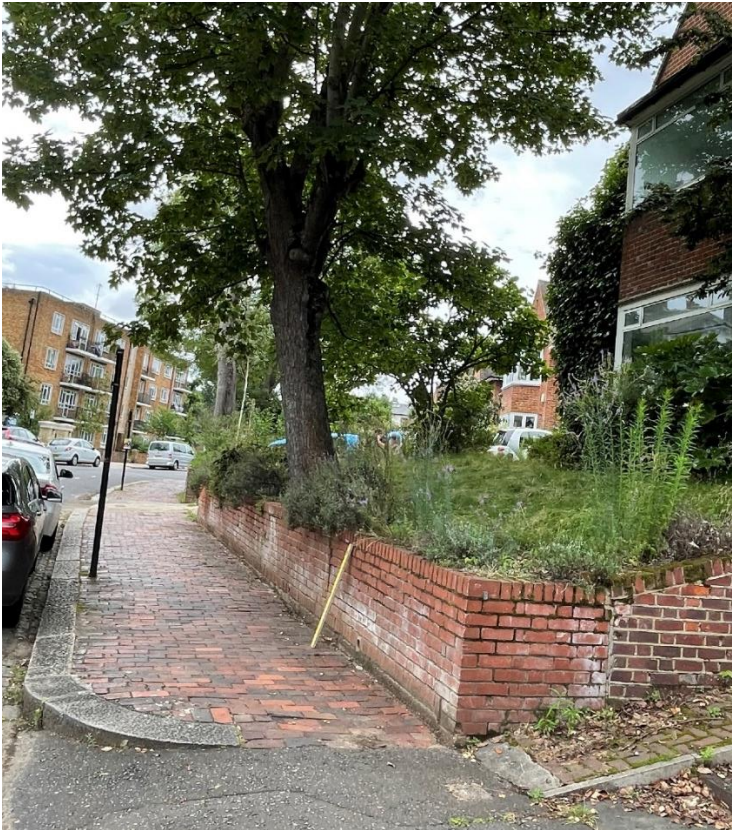
The garden wall varies slightly in height between 0.9m and 1m above the pavement. It retains a height of earth of about 0.8m and the garden slope which rises at an angle of about 15 degrees to the horizontal. A large tree is located in the front garden against this wall. The wall is severely distressed in the vicinity of the tree (photo 1).

Photo 1 -View of front garden wall and tree

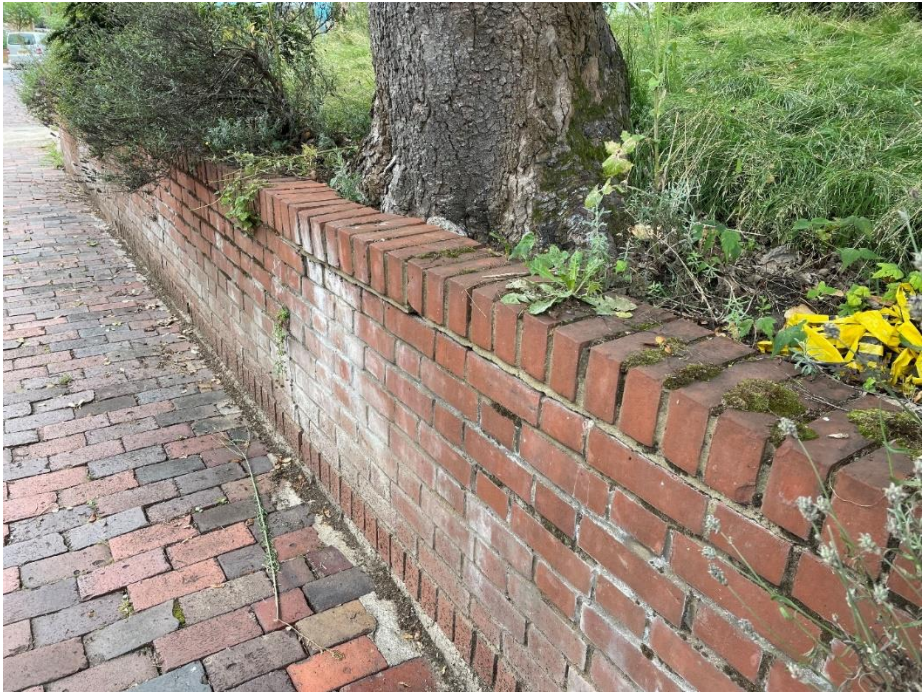
The wall is leaning outwards; maximum movement is severe at the location of the tree where the out of plumbness is of the order of 80mm to below the brick on edge coping. The coping itself has been forced further outwards by a further 30mm. The brick on edge coping has also lifted significantly in the vicinity of the tree forming a horizontal crack. The tree trunk is in contact with the wall (photo 2),

The outward movement appears to have been caused by the physical growth of the tree trunk.

Photo 2 - Leaning wall at tree location

It is therefore recommended that the tree is removed and the wall reconstructed

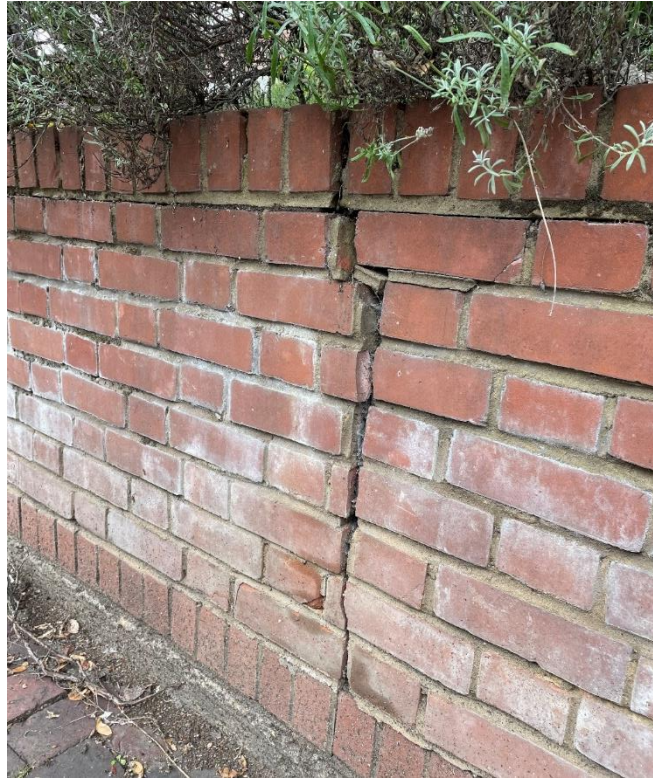
There is a large vertical crack at a distance of about 2.4m from the tree towards the drive that tapers from 12mm at the top to hairline at the bottom (photo 3). The wall on the tree side of the crack is leaning further out than that on the other side of the crack.

The tapering cracks indicate uplift of the wall and this is likely to have been caused by the physical growth of tree roots beneath the wall.

Photo 3 – Vertical tapering crack at approximately 2.4m from the tree towards the driveway

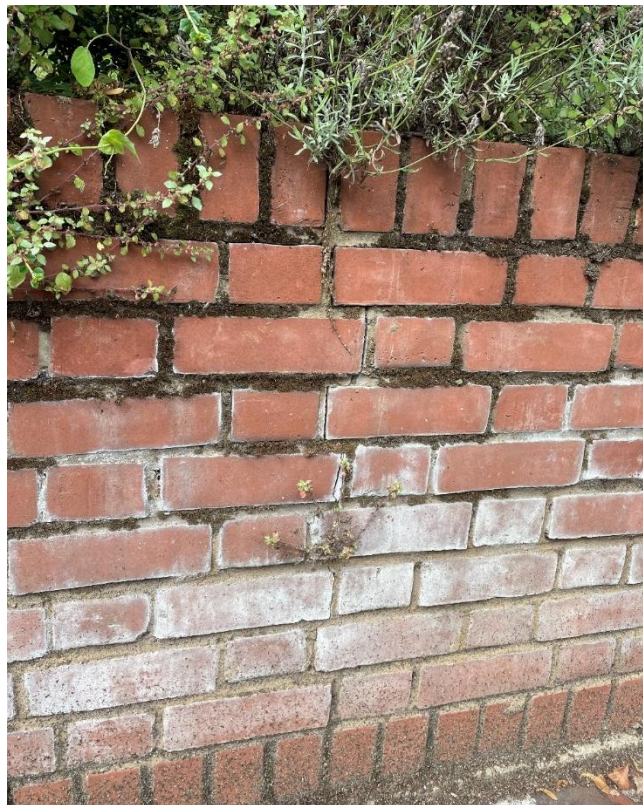
Another crack at a distance of about 2.3m on the other side of the tree tapers from 5mm to hairline at the bottom (photo 4).

Photo 4 – Tapering vertical crack at about 2.3m the other side of the tree

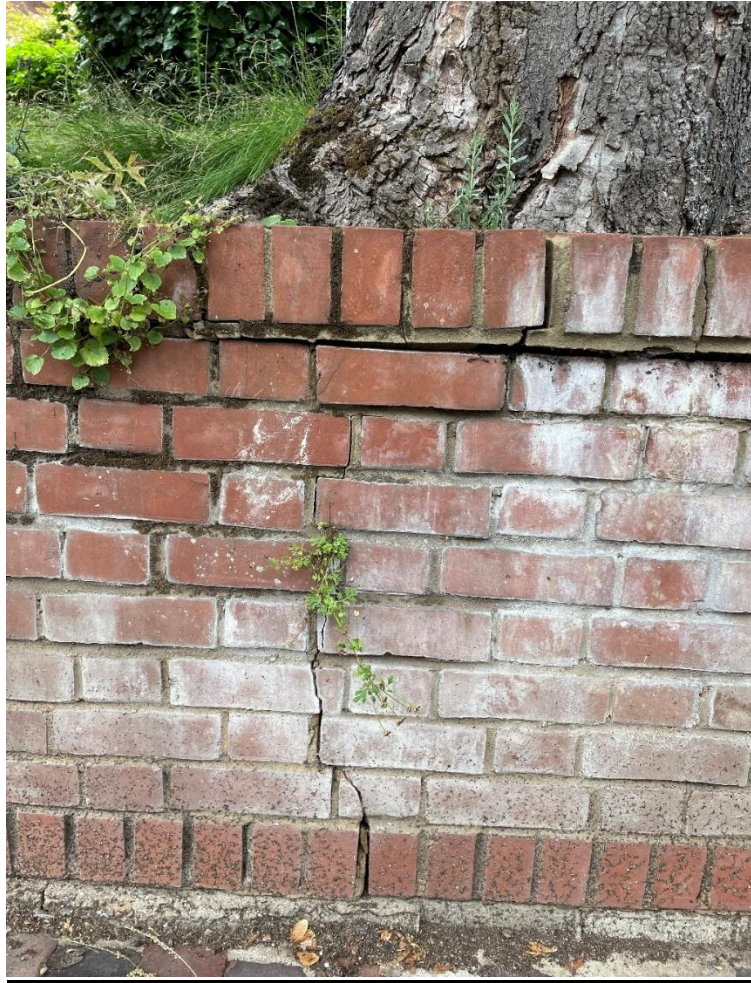
Photo 5 – Cracking at the tree location
