## **PARLIAMENT HILL FIELDS LIDO, London**

### **Repair Works to Sun Terraces; Design, Access & Heritage Statement**

6 August 2021

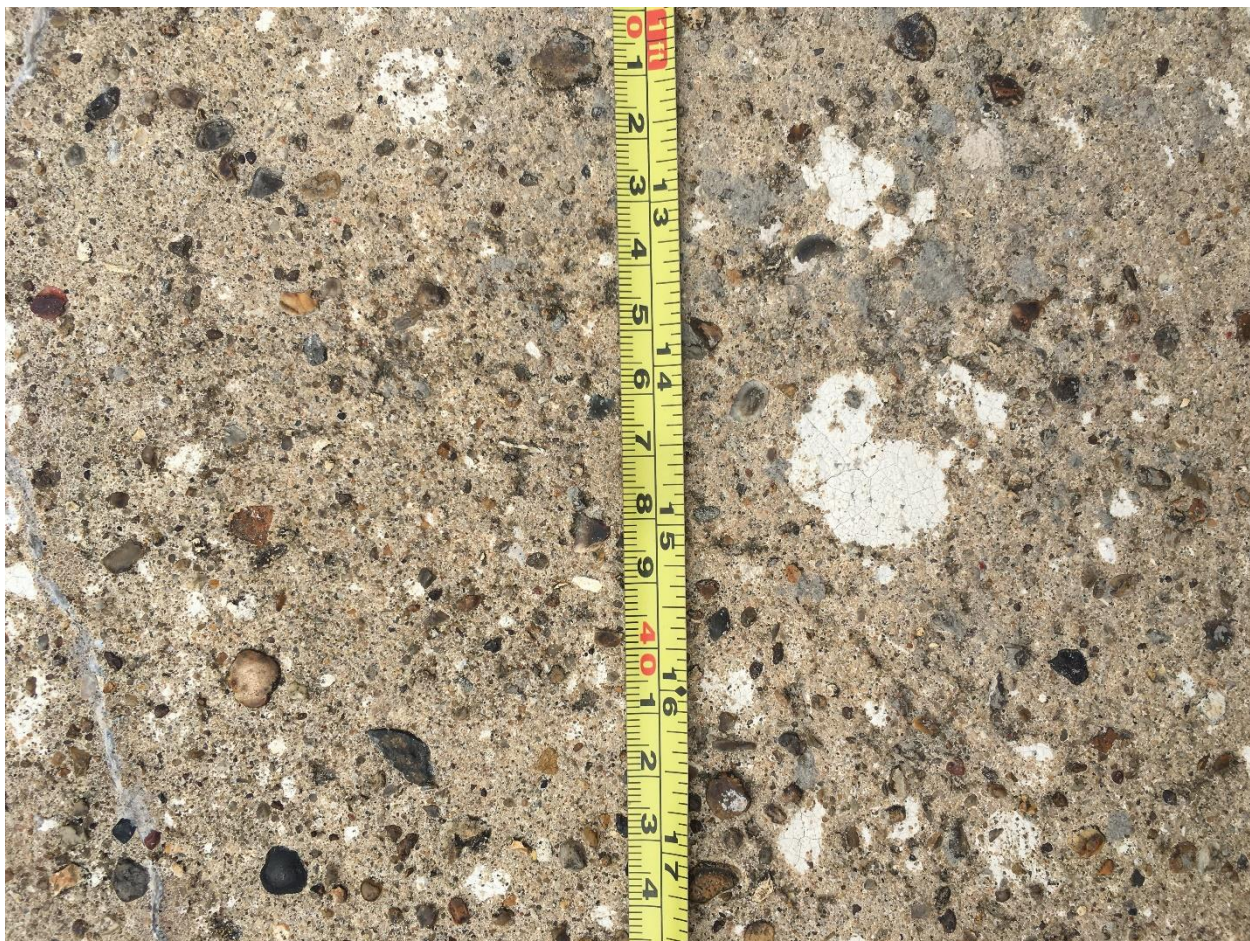
Isolated areas of the terraces have been cleaned with a hot water / steam clean to determine the original appearance. The surface of the screed is of an exposed aggregate finish, with aggregate consisting of particles of small brown, orange and white stones, flint and chert generally of 3 to 5 mm size but with some inclusions of up to 10 mm. The binder is light beige in colour.

*Cleaned surface of terrace showing aggregate and binder*

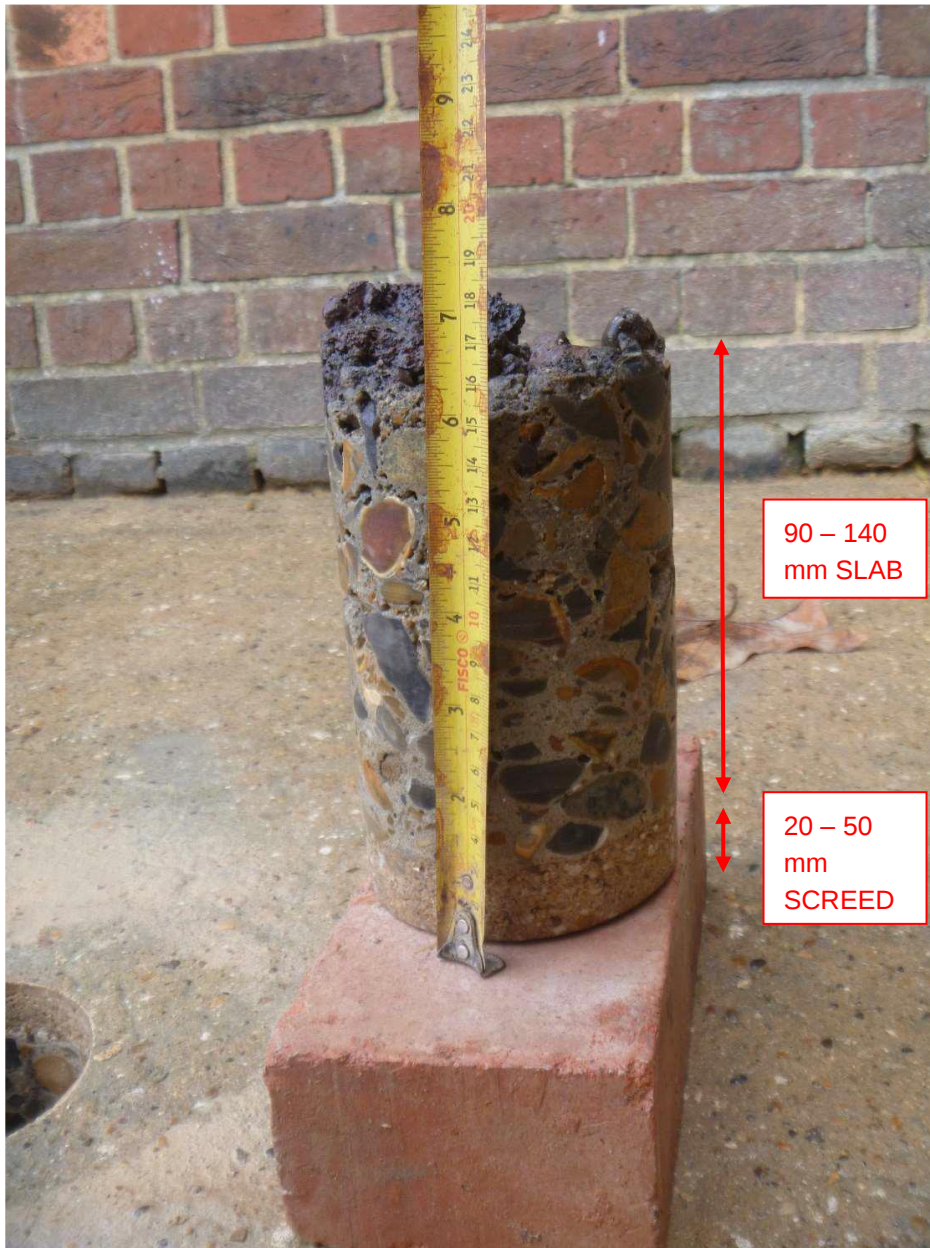
Concrete core samples extracted in 2019 indicate that the construction of the terraces is of an unreinforced concrete slab with a thickness varying between 90mm-140mm. Directly over this is an additional concrete screed thickness of between 20mm-55mm. Inspection of the core void in the concrete slab indicated a thin layer of clinker subbase above a soft clay of unknown depth. A steel bar of approximately 25mm diameter could be pushed by hand into the clay up to 500mm depth.

Core sample from concrete slab (from Patrick Parsons report, January 2020)

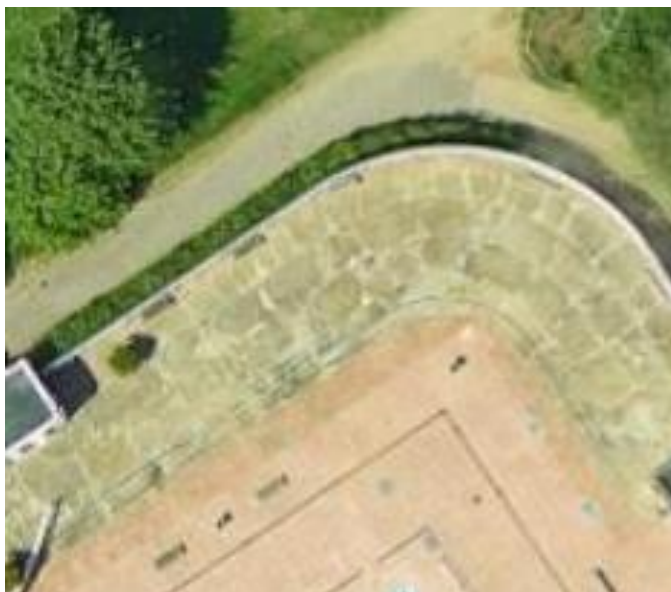
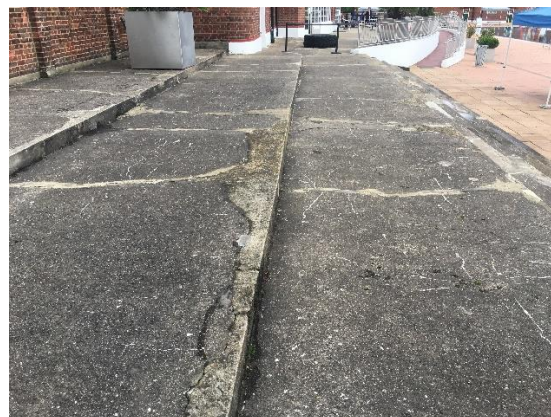
The Lido terraces are therefore founded directly onto soft London Clay with a limited sub-base. Variation in ground water will lead to swelling and shrinkage of the bearing strata. London Clay has a high plasticity and, when saturated, is prone to a high-volume change potential. Given that extensive leakage of the pool was recorded until 2005 when the stainless-steel liner was installed, it is likely that the ground would have been permanently saturated during all seasons. Since the repairs and lining of the pool, the clay will dry and shrink during the summer with swelling occurring during the winter months. This is likely to introduce some movement to the terrace slabs, resulting in cracking to some degree.

There is a general lack of movement joints within the screed, reflecting the general lack of understanding of the behaviour of concrete at the time of construction in 1938, when concrete technology was in its infancy. This inability to accommodate thermal expansion is also likely to lead to cracking. The original day joints are at approximately 9 metre centres, with subsequent self-determined cracking occurring at approximately 2 to 2.5 m centres where a pattern can be detected.

*Aerial detail (left) and terrace image showing self-determined cracking occurring at approximately 2 to 2.5 m centres*

Movement / stress relief joints are proposed to be introduced to the new areas of screed. As a general rule, cracking within screeds takes place in 'squares'; the bay length is roughly equivalent to the width. Advice is that this can be extended, but that bay length should preferably not exceed bay width by more than a multiple of 3:2. Bay proportions exceeding 3:2 are at increasing risk of stress relief cracking when the difference becomes greater.

Movement / stress relief joints will be formed by laying separate bays. Ultimately the frequency of joints will be determined by the requirement to provide joints over cracking in the existing substrate, to accommodate movement. This will be determined once the screed has been removed. Movement joints will also be provided longitudinally at the junction between risers and treads following the existing joint pattern of every other step. Movement joints will be finished with a polysulphide mastic joint, colour-matched to the adjacent screed.

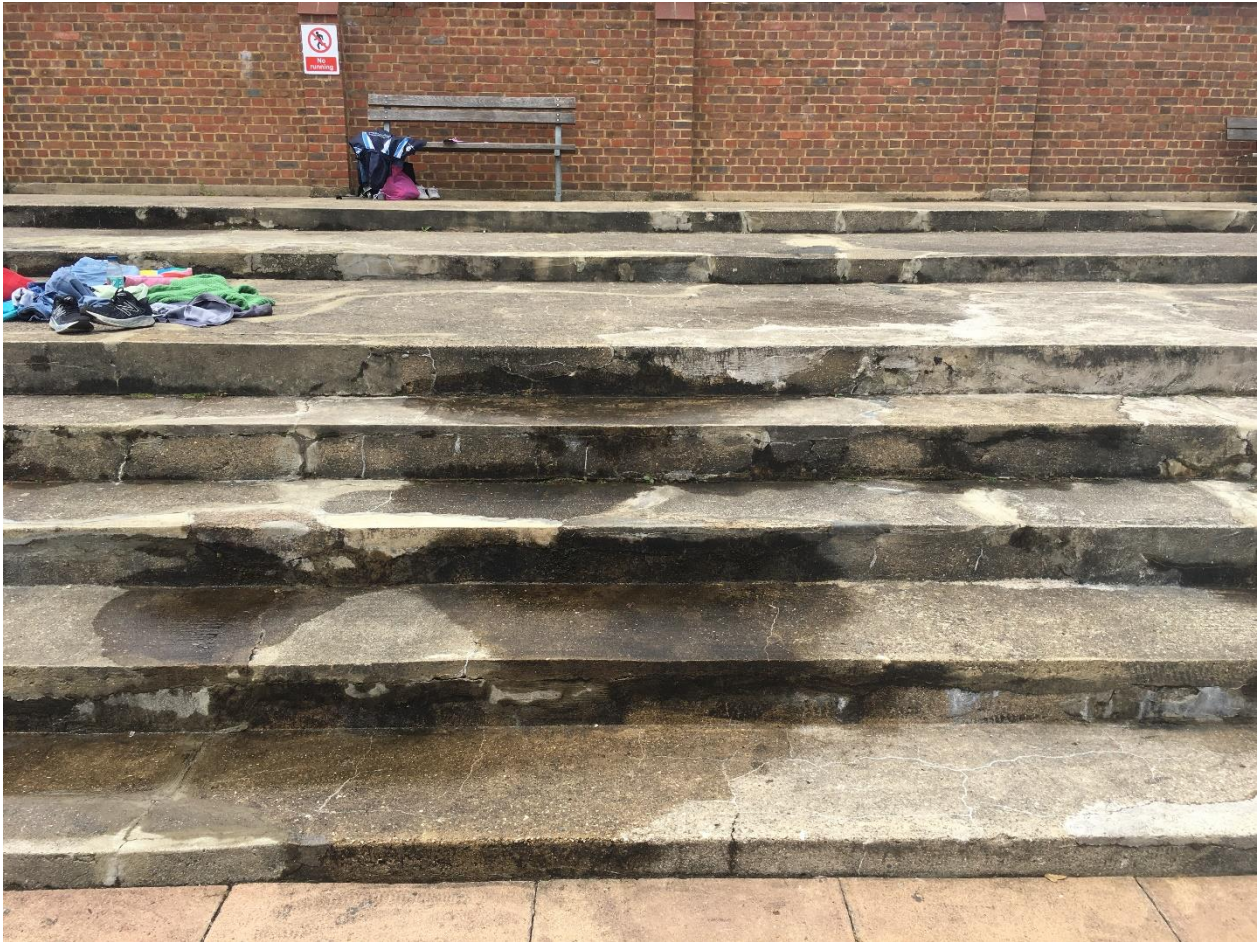
The concrete terracing has suffered from extensive surface and increased depth cracking over an extended period. Some spalling of the terracing has occurred, particularly to the step risers and nosings.

Over the majority of the terracing, the surface is crazed with no specific cracking pattern or direction. Cracking within the steps occurs both perpendicularly and longitudinally along the treads and risers, where it appears to allow water to seep through from the sub-base.

*Cracking within the steps occurs both perpendicularly and longitudinally along the treads and risers, where it appears to allow water to seep through from the sub-base*

Consequently, it is proposed to replace the screed by removing the existing repairs and top layer of existing screed to expose the substrate, cleaning down and removing all loose material. Dependent on the condition of the substrate, repairs will be carried out using a like-for-like concrete mix.

Bonding between the new screed and the substrate will be enhanced through the application of a bonding primer prior to relaying the screed using a bespoke mortar to match the existing in terms of colour, texture, aggregate size and type. The screed will be washed down whilst the concrete is still 'fat' to expose the aggregate finish to match the original, or the same effect achieved by treating the surface with a mild abrasive TORC system as widely used on historic buildings to clean stone and masonry.

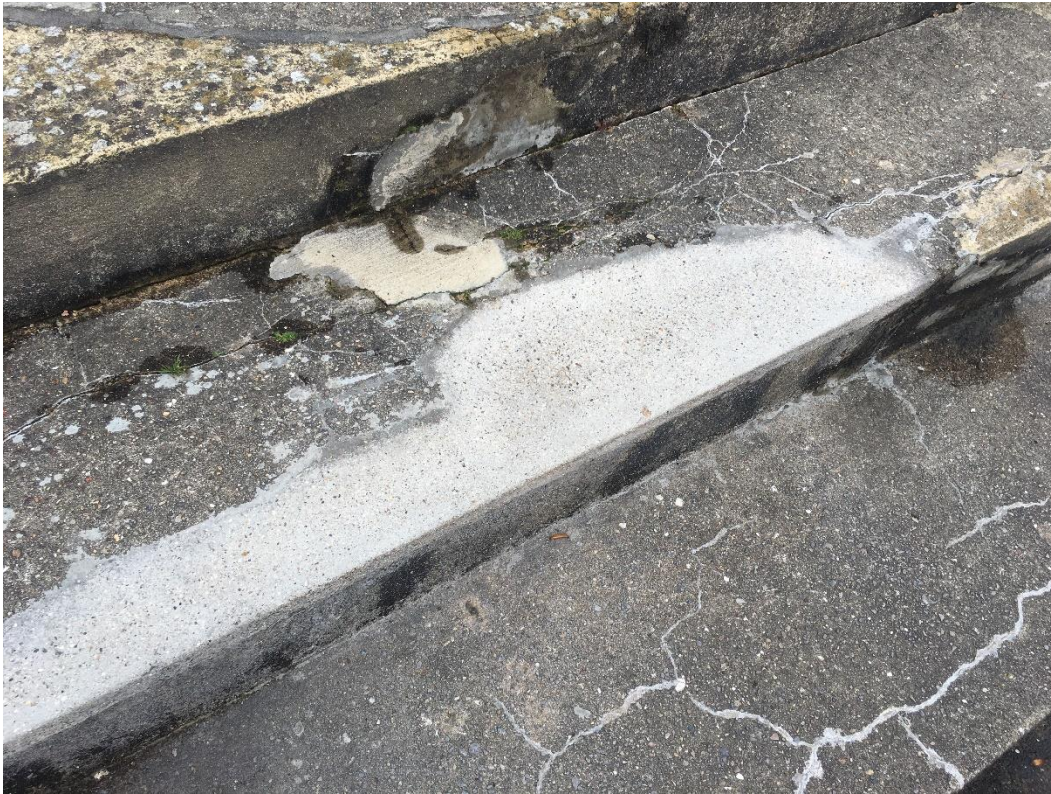
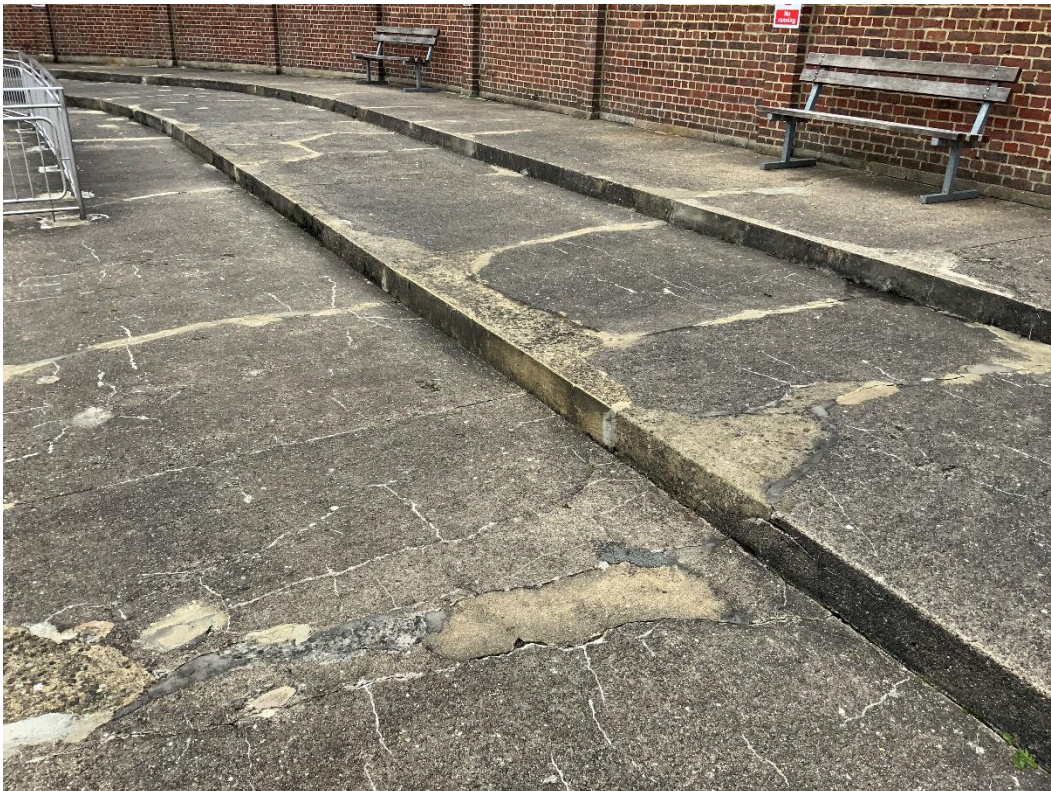
Patch repairs on an ad-hoc basis using unsympathetic repair materials that are a poor match to the original screed have resulted in a patchwork appearance. This is detrimental to the overall presentation of the site and presents a health and safety risk through delamination and spalling of surfaces, creating sharp edges in an area where a high proportion of users have bare feet.

*Poor previous repairs to steps and terraces resulting in a patchwork appearance. This is detrimental to the overall presentation of the site and presents a health and safety risk through delamination and spalling of surfaces, creating sharp edges in an area where a high proportion of users have bare feet.*

The bespoke mix is to be determined through carrying out of a number of sample panels of 600 mm<sup>2</sup>, each employing a 1:3 cement:sand ratio but with different variation of sands and aggregates to obtain the best possible match to the original. Cement type will also be varied in the samples between Ordinary Portland Cement (OPC) and white cement to determine the most appropriate type in terms of appearance and robustness.

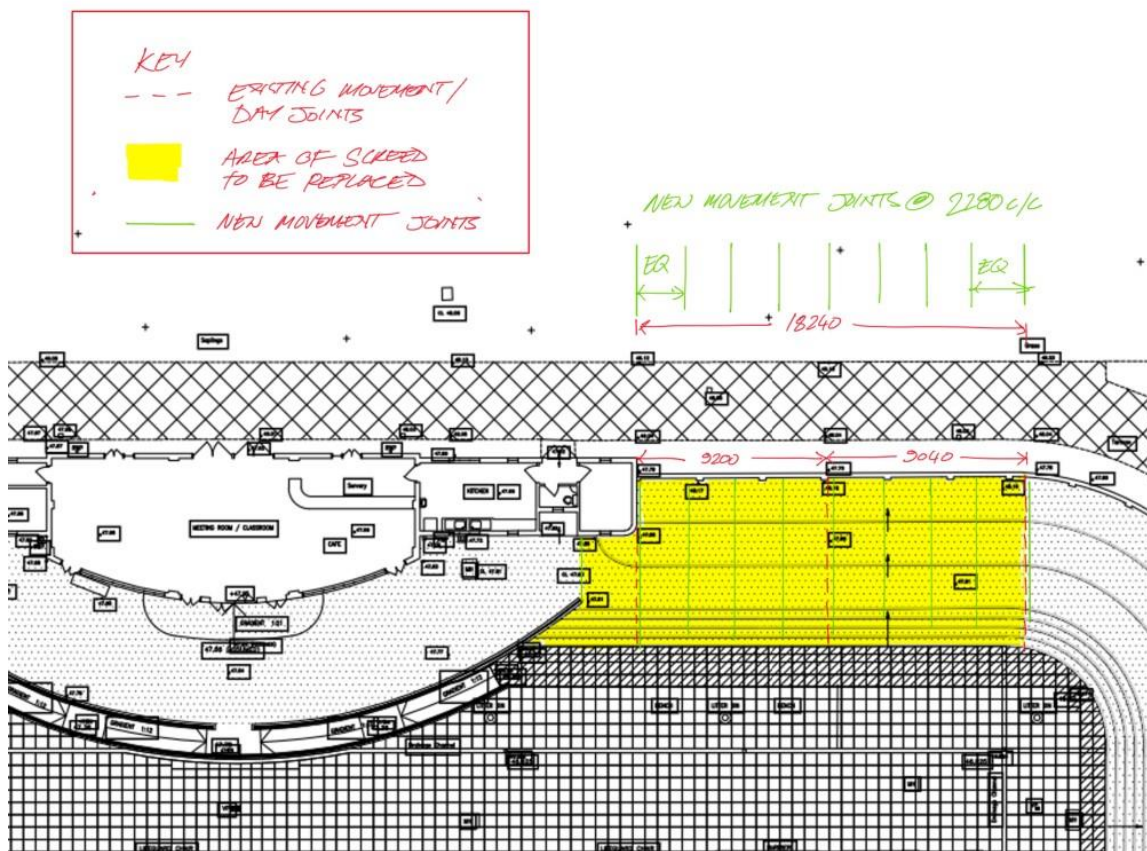
Plan of north-east terrace showing location of existing movement joints and proposed joints @ 2 m c/c approx. (final location and frequency of joints to be determined following removal of screed to expose slab)
