5 Elm Row, Hampstead Level 3Plus Condition Report

Level 3Plus Condition Report

5 Elm Row
Hampstead
London
NW3 1AA

19th May 2021

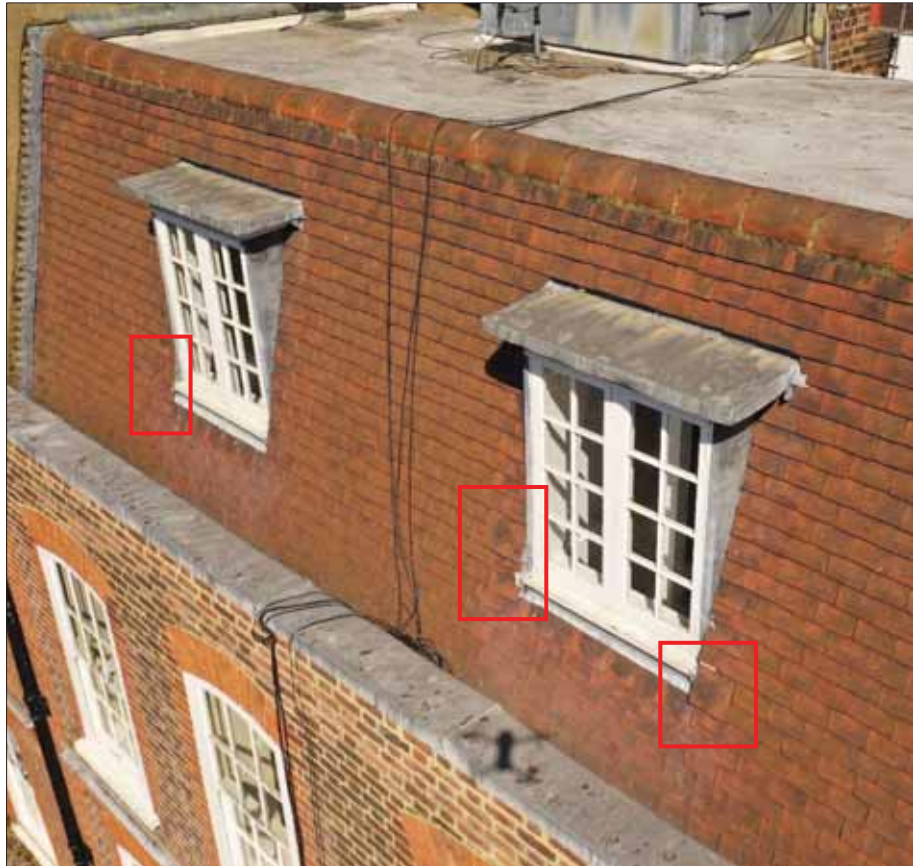
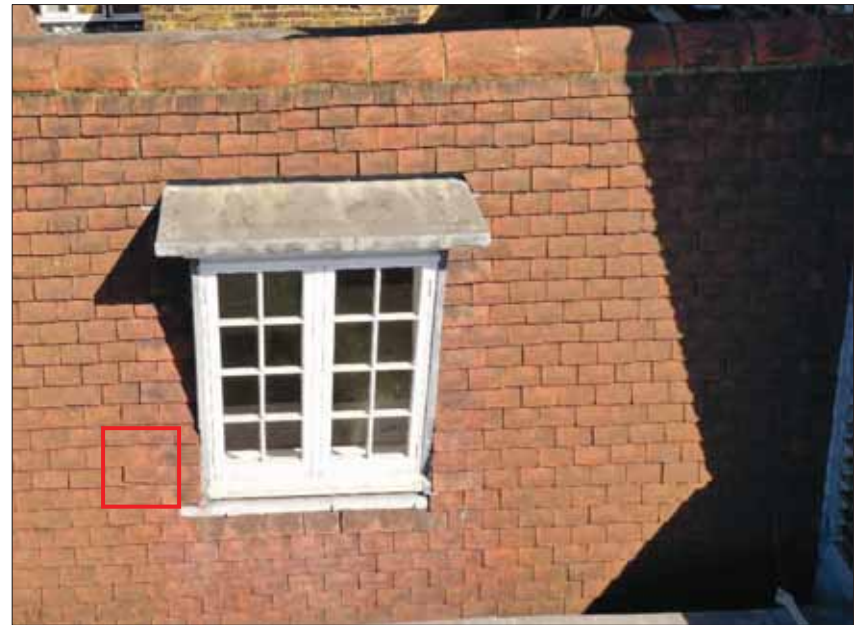
Element: Roof Coverings – Roof 1 – Machine-made Plain Clay Tiles	Category: B
Defect or Significant Observations: <p>7.1 Roof 1 comprises the front and back pitches of the mansard roof and is covered with machine-made plain clay tiles. Generally speaking, it is in a good condition and is performing its basic task of shedding rainwater.</p> <p>7.2 The roof structure and underside of the roof covering, which often holds clues as to the age of a roof, was inaccessible, however, the tiles are exhibiting no evidence of spalling or broken tiles indicating that they are unlikely to be of great age.</p> <p>7.3 Though several slipped tiles exist, this is within expected tolerances, especially on a roof with a near vertical pitch, happily though, as you would expect from a (likely) relatively recently laid covering, there is no evidence of widespread slipping or missing tiles which would indicate nail fatigue - which is where the metal fixings holding the tiles to the battens corrode and fail – and is essentially terminal.</p> <p>7.4 Clay ridge tiles to the front of the building are well affixed to the roof and are also in good condition.</p>

Images 2 & 3: Roof 1 - Front Pitch Showing Handful of Slipped Tiles.

Recommendations: <p>7.5 Undertake maintenance where tiles have slipped to the front pitch.</p> <p>7.6 See also Weather Flashings & Abutments.</p>

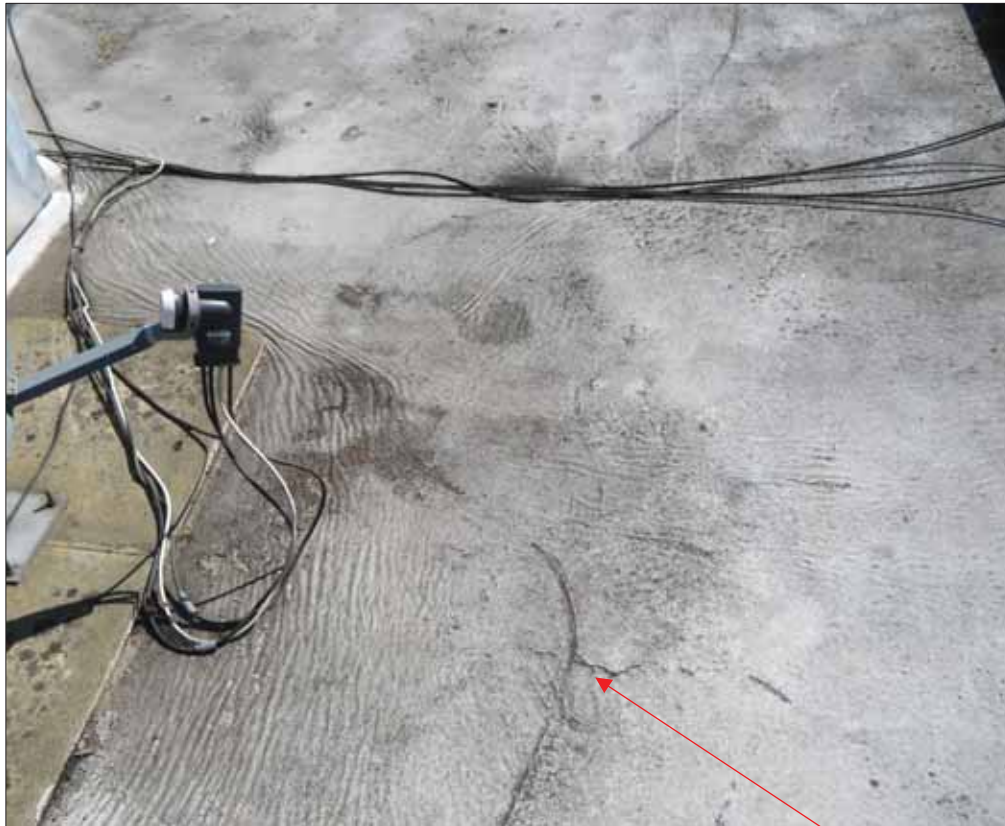
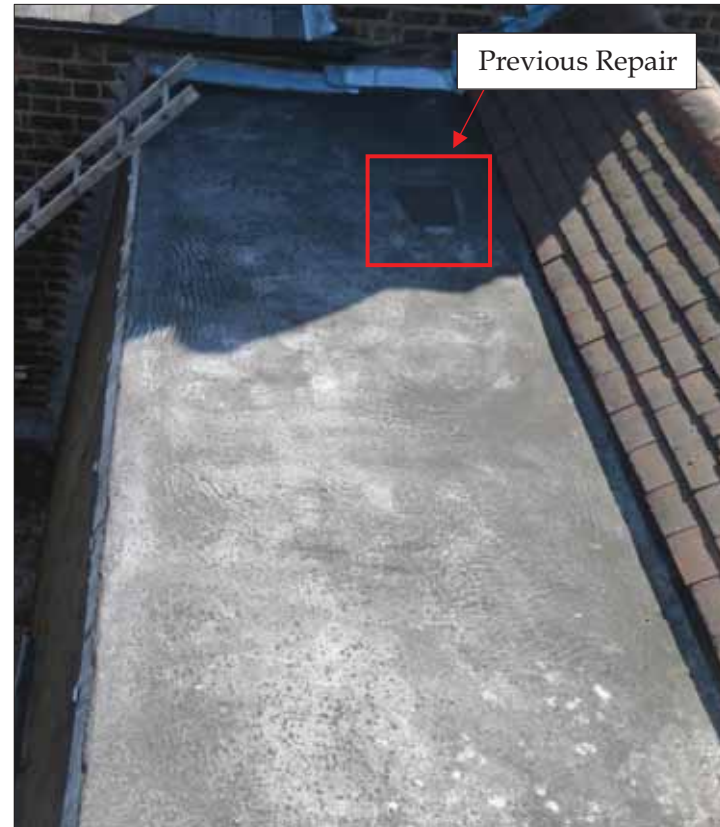
Element: Roof Coverings – Roofs 2 & 3 – Poured Mastic Asphalt	Category: B/D
Defect or Significant Observations: <p>7.7 Roofs 2 & 3 are flat roofs atop the mansard roof structure. Generally speaking, they appear to be performing their principal task of shedding water and there is no evidence that they are allowing water ingress. They are very slightly angled so as to drain towards the rear of the property.</p> <p>7.8 However, from a condition perspective, evidence of previous repairs and of blistering, rippling and cracking (often called aligatoring) – both of which are common indicators of old age – suggest that the coverings are likely to far closer to the end of their serviceable lives than the beginning.</p> <p>7.9 The surface of Roof 2 also appears to have been punctured by something, leaving a number of square shaped holes in the surface.</p> <p>7.10 Solar reflective paint coverings look tired and are unlikely to have been renewed/maintained within the past 5 years, as is recommended. The paint is intended to slow decay of the roof surface caused by direct sunlight and the absorption of ultraviolet light.</p>

Images 6 & 7: Rippling/Cracking to Roofs 2 & 3, Respectively.

Recommendations: <p>7.11 In the short term – and to provide confidence -the roof would benefit from a scheme of repair/maintenance by a roofer which may also include patching the square shaped holes, and closer inspection of the cracking and crazing, which can be relatively easily achieved using a range proprietary products.</p> <p>7.12 The roof should also be decorated using a solar reflective paint.</p> <p>7.13 Whilst repair is possible, you should be aware that this element of the roof is showing signs of advanced age and regardless of repair is likely to require full replacement in the next 7 – 10 years. Investing in the repair – along with the scaffolding required for access – may therefore represent a false economy depending on your perspective and intentions for the property.</p>

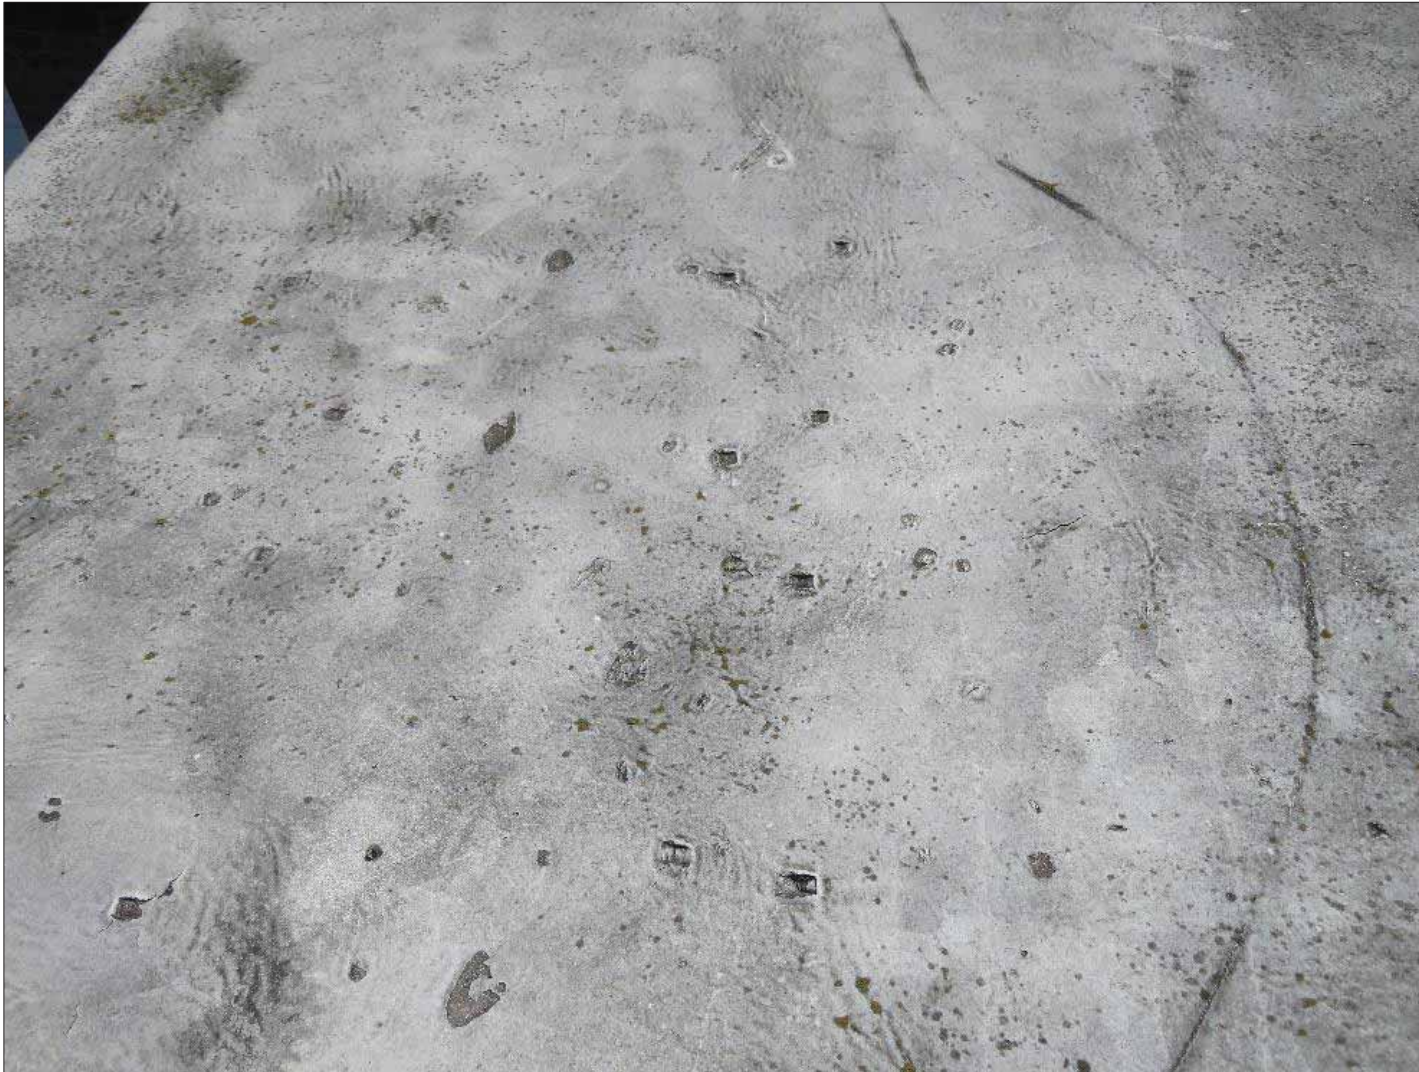
Image 8: Series of Square Puncture Holes to Roof 2.

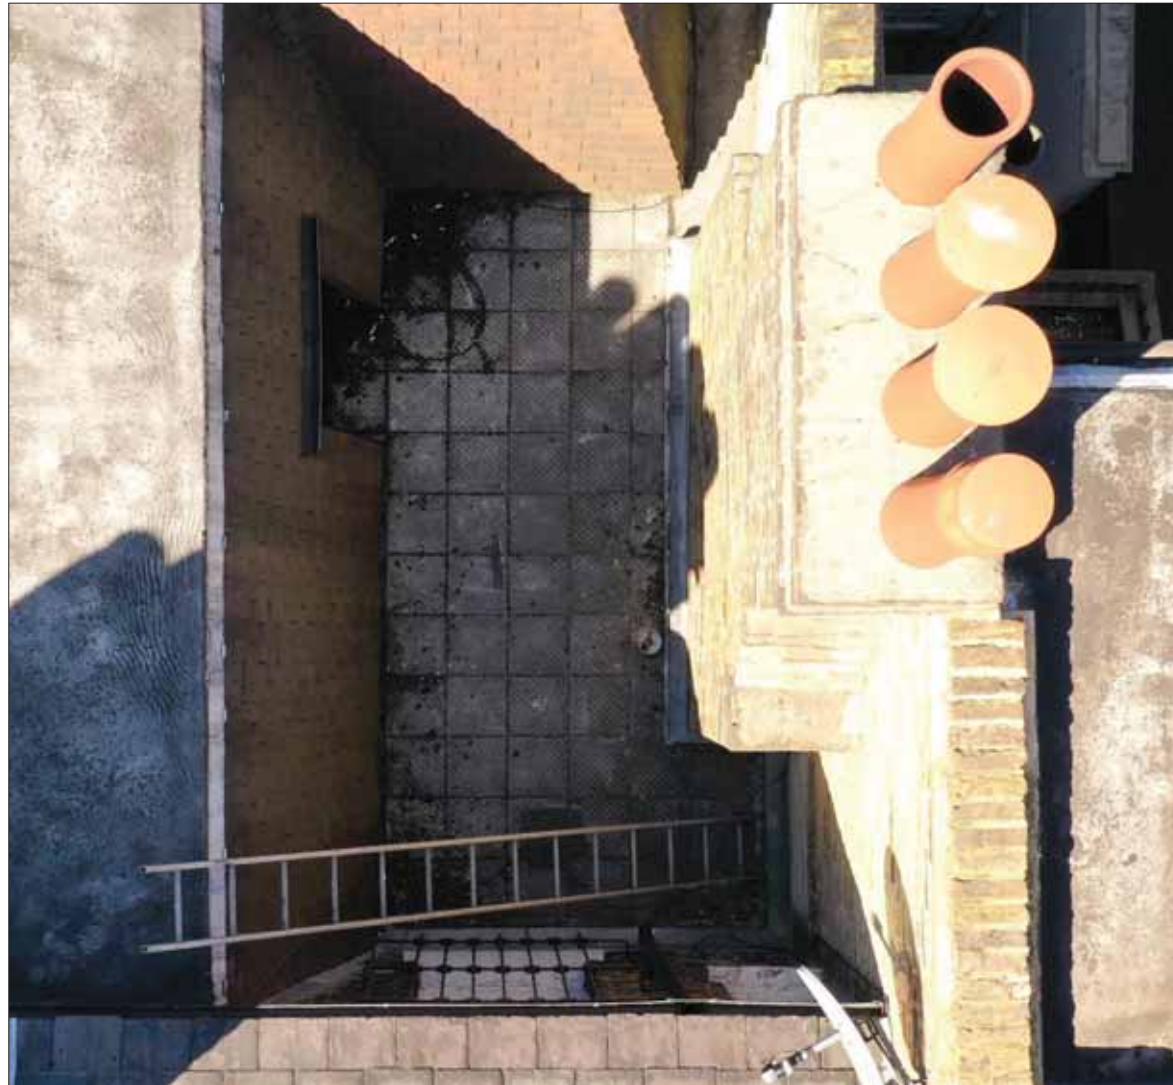
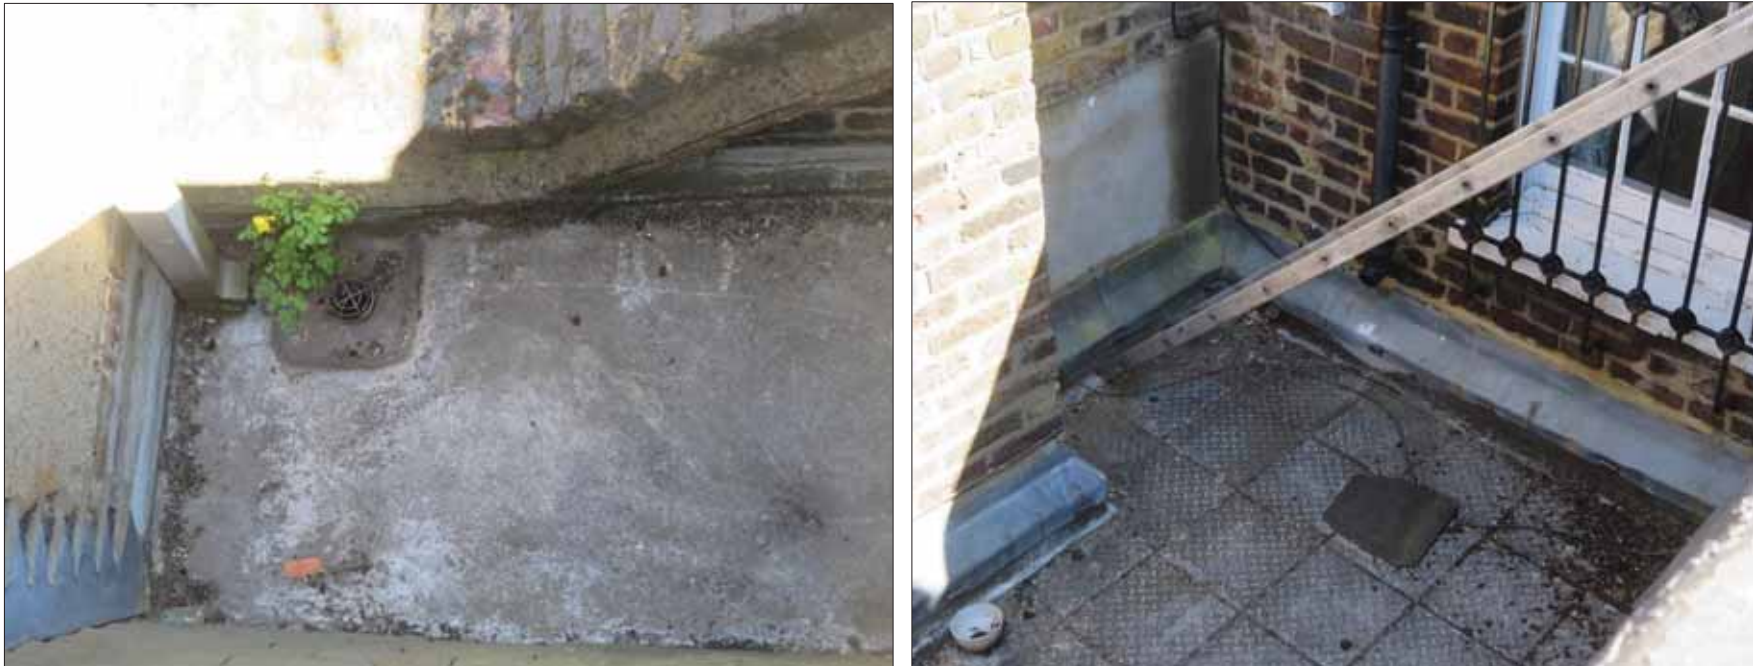
Element: Roof Coverings – Roof 4 – Poured Mastic Asphalt	Category: C
Defect or Significant Observations: <p>7.14 Roof 4 is a section of flat roof at the rear of the property. It too, seems to be covered with poured mastic asphalt, though this is largely obscured by the presence of non-slip tiles as Roof 4 also serves as an access route to the rest of the high-level roofs.</p> <p>7.15 A downpipe serving a large catchment area discharges directly onto Roof 4, meaning it also essentially forms a large parapet gutter. This may prove to be a point of weakness going forward but there is no evidence currently of water ingress and areas not covered with tiles seem to be in generally good condition. See also Rainwater Goods.</p> <p>7.16 A corresponding section of Roof 4/parapet gutter exists to the west side of Stack 1 but was inaccessible.</p>	
Recommendations: <p>7.17 Further, more invasive investigations would be required to accurately ascertain the remaining lifespan of the asphalt beneath the tiles of Roof 4.</p> <p>7.18 However, as the other asphalt flat roofs will soon require replacement, and with the economies of scale, it may be prudent to be proactive and recover Roof 4 at the same time.</p>

Image 9: Roof 4 Covered with Non-slip Tiles.

Images 10 & 11: Flat Roof 4 to the West & East, Respectively.

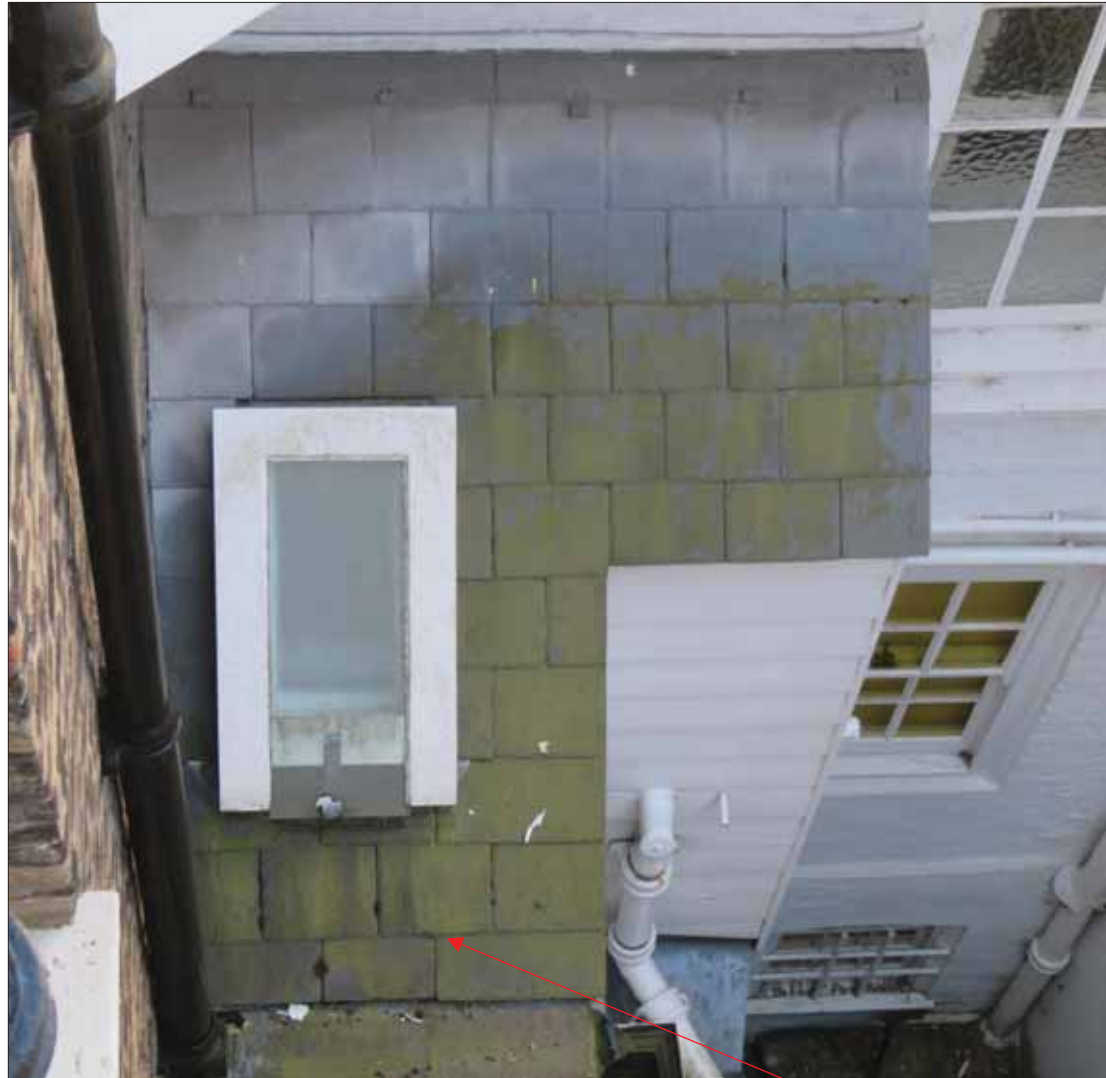
Element: Roof Coverings - Roofs 5 & 6 - Natural Slate	Category: D
Defect or Significant Observations: 7.19 Roofs 5 & 6 are covered with natural slate. Both are in generally good condition with no evidence of broken slates and only a single slipped slate, which has been previously repaired with a lead tingle, to Roof 6. 7.20 Roof timbers were not accessible, but happily the roof structure of Roof 5 is presumably well ventilated as it has been fitted with proprietary vent slates and there was no visual evidence of structural defect to either Roof 5 or 6.	
Recommendations: 7.21 No specific works currently required.

Image 14: Slate Covering of Roof 6 with Single Previous Lead Tingle Repair.

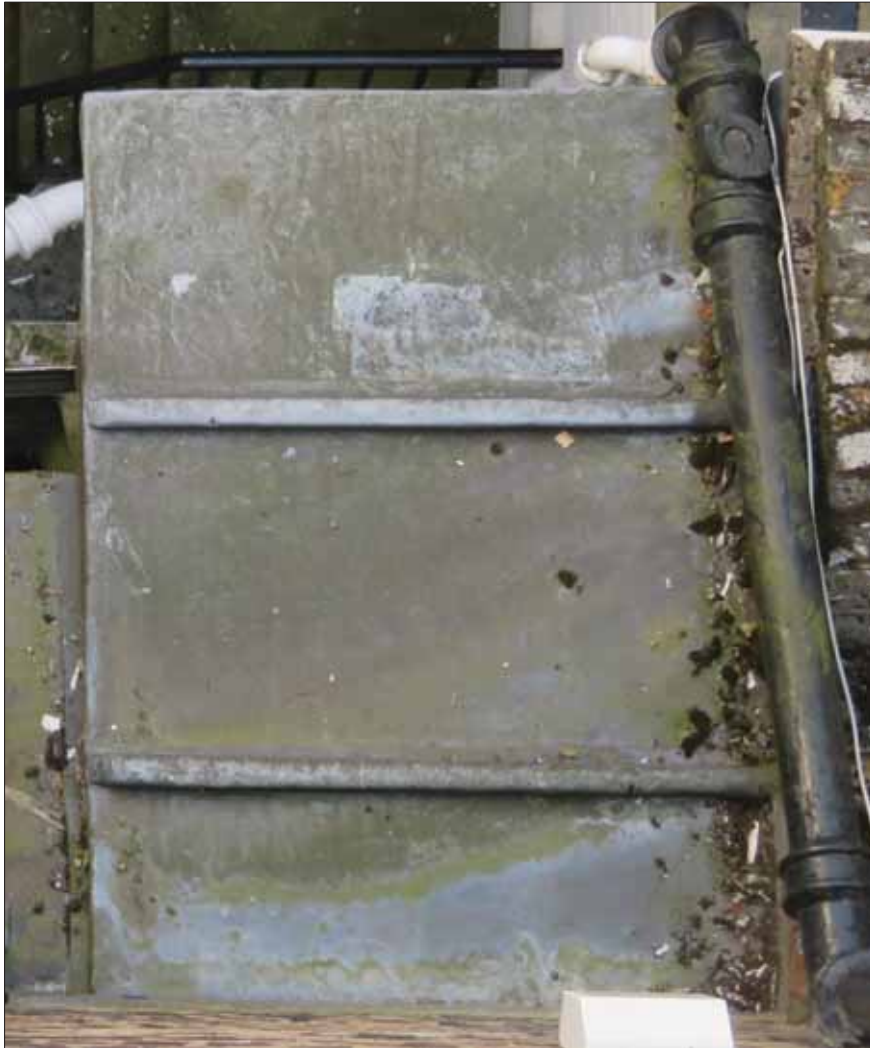
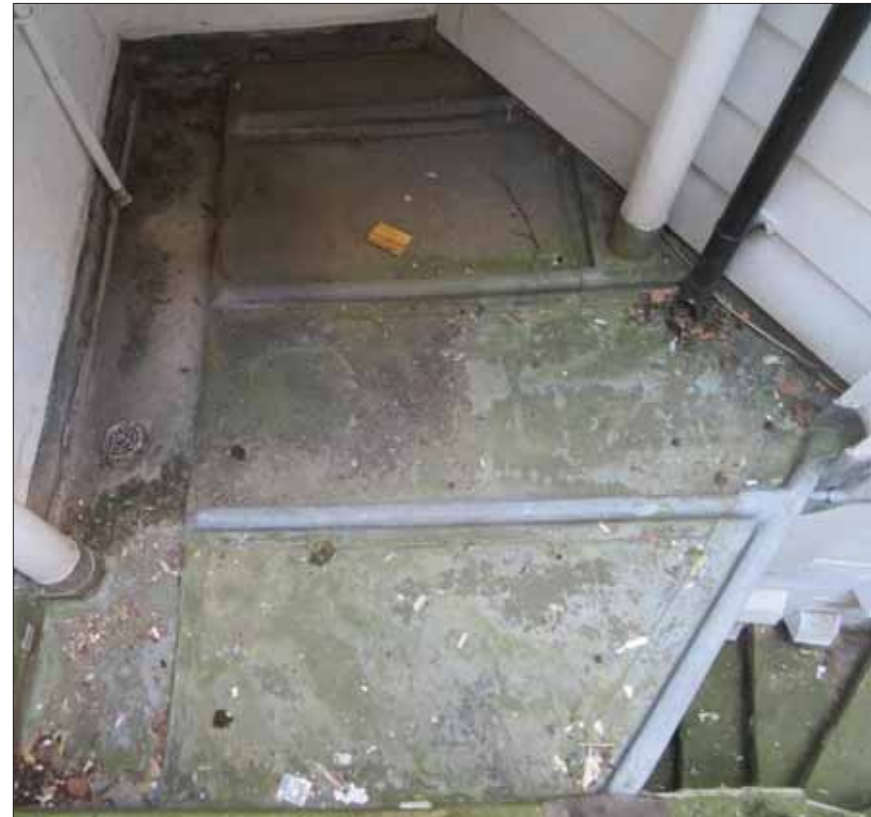
Element: Roof Coverings – Roofs 7 & 8 – Lead	Category: D
Defect or Significant Observations: 7.22 Roofs 7 & 8 are covered with sheet lead. The surface of both is largely obscured by dirt and algal growth, however where the patina is visible, it suggests that these coverings are of some age. This is corroborated by evidence of a previous repair to Roof 7. 7.23 Despite this, there is no evidence of associated water ingress internally.	
Recommendations: 7.24 No works currently required; however, you should be aware that these coverings are likely to require some repair/maintenance within the next 10 – 15 years. 7.25 Any new leadwork should be executed in accordance with the codes and details as set out by the Lead Sheet Training Academy. https://leadsheet.co.uk/service/rolled-lead-sheet-the-complete-manual/

Images 15 & 16: Lead Roofs 7 & 8, Respectively.

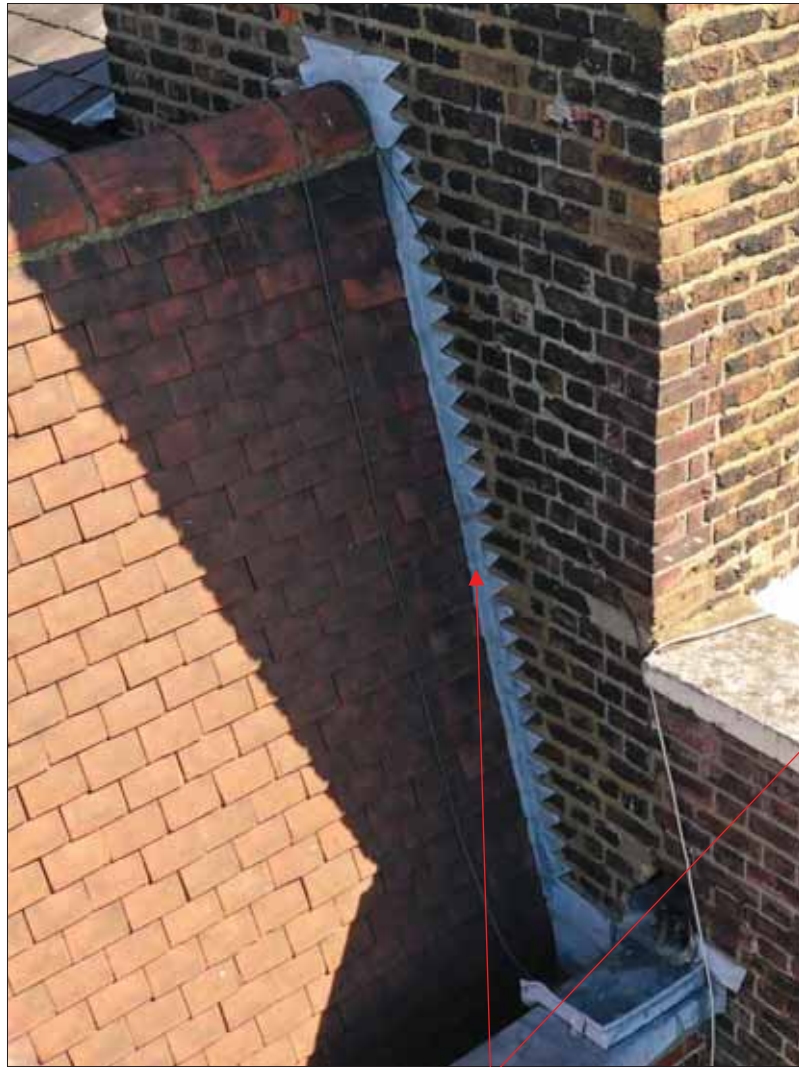
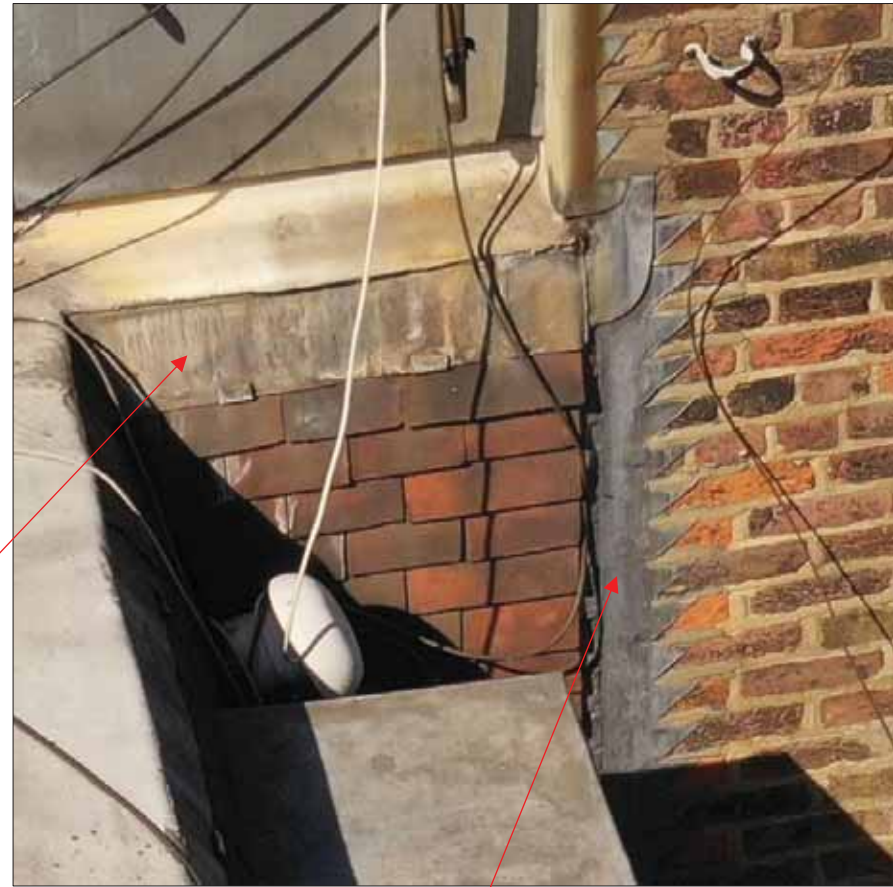
Element: Weather Flashings – Lead Flashings & Abutments	Category: C
Defect or Significant Observations:	
<p>8.1 Based on condition and observed level of patina, leadwork appears to differ in age which is indicative of a piecemeal approach to maintenance which is quite common and is generally an economically led decision. However, there was no evidence internally of water ingress attributable to failed flashings and abutments.</p> <p>8.2 Lead flashings associated with the flat top of the mansard roof as well as the party wall to the east appear to be of significant age, whereas other areas of leadwork is in a better overall condition.</p> <p>8.3 For example, the surface patina to leadwork associated with the west party wall, Roof 5, and Roof 6 suggests that the lead is no more than around 30 years old. For reference, the life expectancy of lead roofing material in the UK is around 80 – 100 years.</p> <p>8.4 However, the detailing is often fairly clumsy and is beginning to show its age in places. A number of clips have also become loose.</p>

Images 17 & 18: Example Areas of Older Leadwork to the East Party Wall & Top of the Mansard, Note the Newer Leadwork to Stack 1 Adjacent.

Recommendations:	
<p>8.5 The leadwork would benefit at this juncture from some routine maintenance from a lead worker. Clips should be returned to their former positions and any loose detailing re-bossed.</p> <p>8.6 It would be prudent to replace the older leadwork to the top of the mansard at the same time as its recovering. See Roof Coverings.</p> <p>8.7 For information, all new leadwork should follow the codes and details as set out by the Lead Sheet Training Academy.</p> <p>8.8 See also Lead Roofs above.</p>

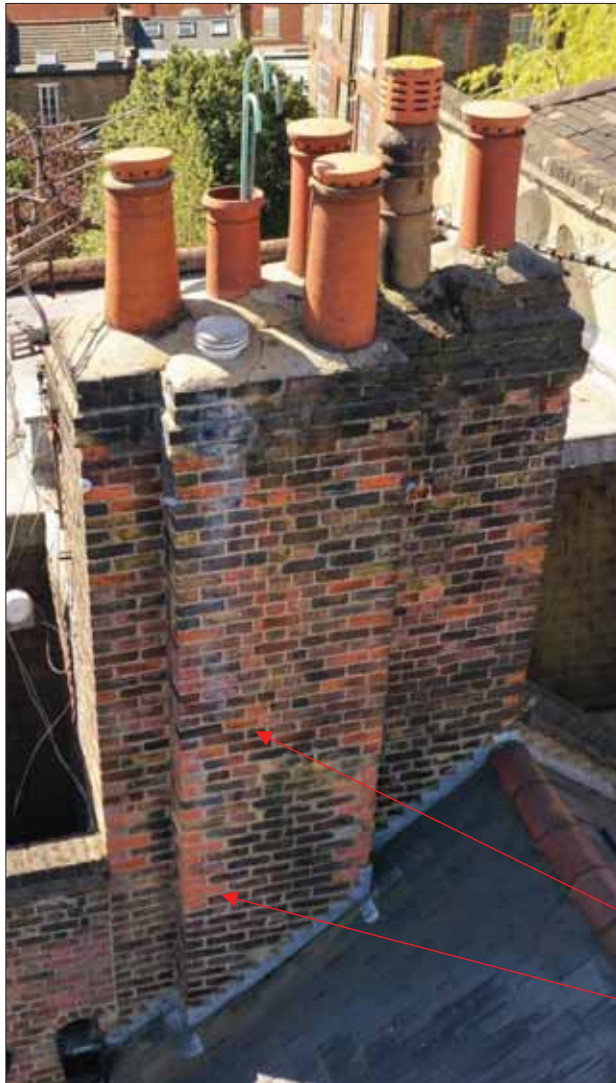
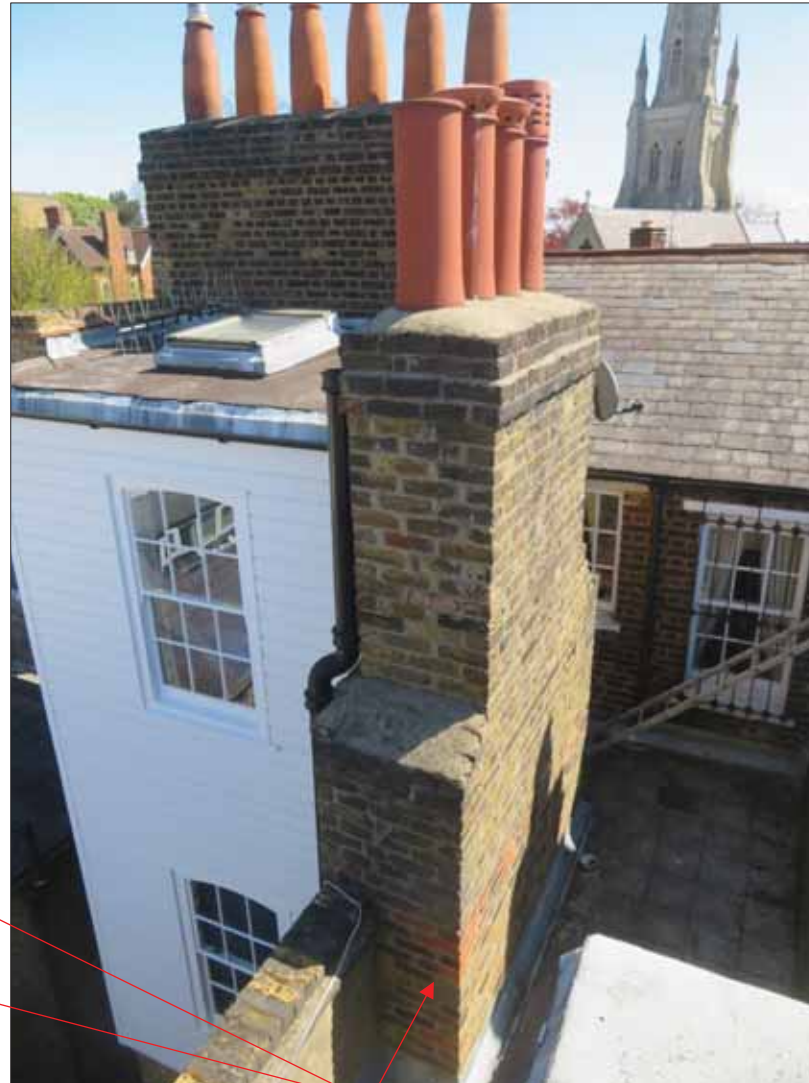
Element: Stacks 1 & 2 - Brick	Category: D
Defect or Significant Observation: <p>10.1 Stacks 1 & 2 are both in a good overall condition with no evidence of significant lean or structural deficiency. They have, however, been repointed to a greater or lesser extent in a cementitious mortar (see Masonry & Mortar), which has resulted in spalling of the brickwork in some instances, though this is not yet severe.</p> <p>10.2 The flaunching to both stacks - which performs an important role of holding the pots in place - is cracked, particularly to Stack 1.</p> <p>10.3 The pots themselves are in good condition. The vast majority are fitted with cowls (to prevent water ingress), although one pot to each of the stacks has been left open to the elements.</p>	
Recommendations: <p>10.4 Both stacks would greatly benefit from a full rake out and repoint in an appropriately specified lime mortar, as part of an overarching scheme of masonry works. Any badly spalled bricks should be replaced with new (not salvaged) bricks, to match the technical and aesthetic characteristics of the originals as closely as possible.</p> <p>10.5 Although the flaunching is far worse to Stack 1 than to Stack 2, it would be prudent to have the flaunching of both renewed to ensure confidence in the stability of all pots.</p> <p>10.6 Consideration should also be given to installing clay cowls to the two pots where they are currently absent.</p>

Images 22 & 23: Stacks 1 & 2, Respectively. Note the Spalling Brickwork.

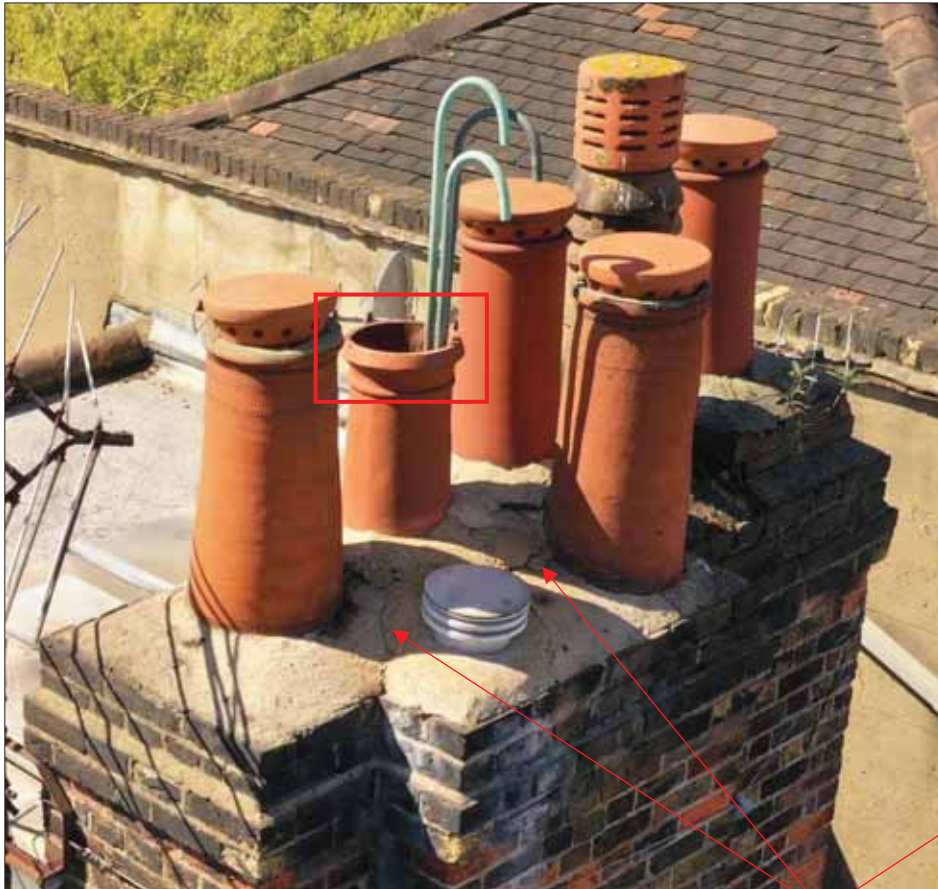
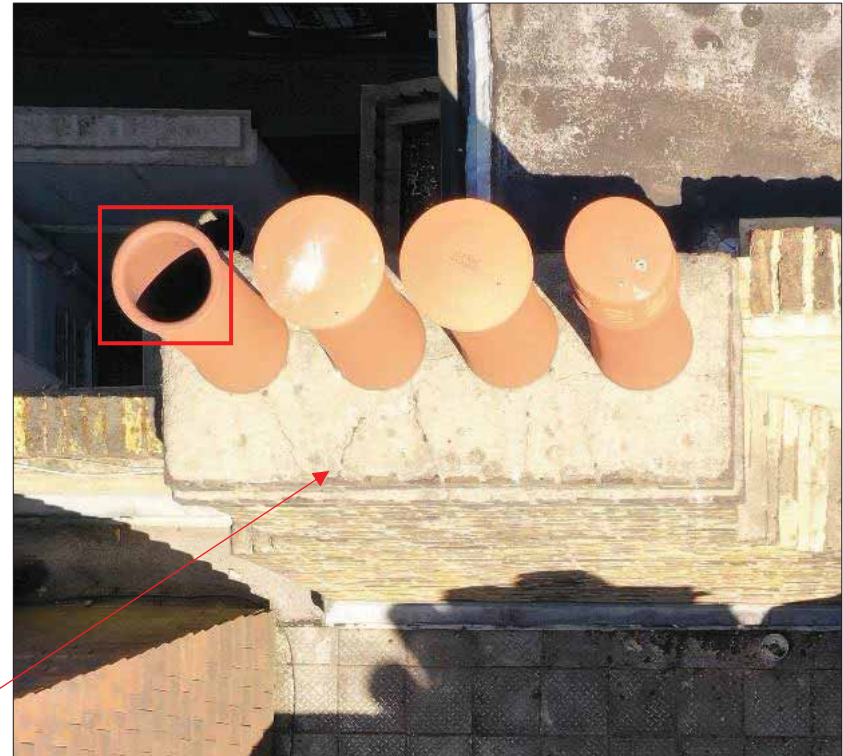
Images 24 & 25: Showing Cracking to Flaunching & Two Pots Without Cowls.

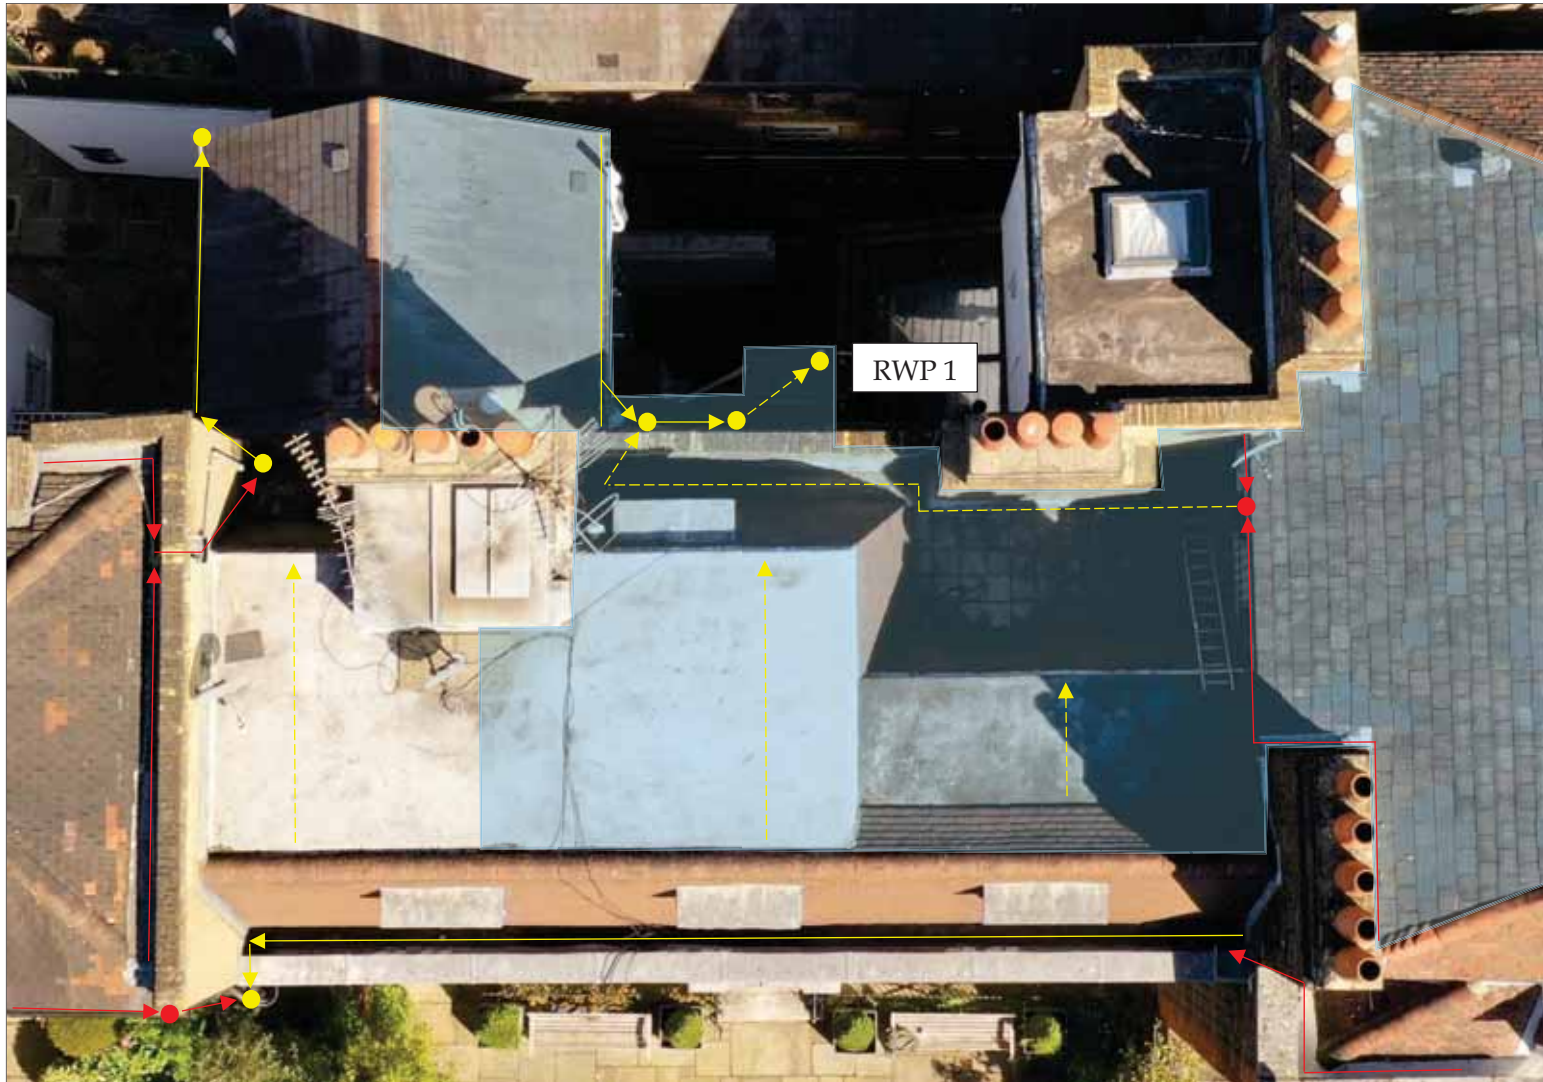
Image 26: Rainwater Goods (RWG) System. Note Very Large Catchment Area (Blue) Served by RWP 1. Parts of the System in Red Show Where Systems of the Neighbouring Properties Flow into the System of 5 Elm Row.

Element: Rainwater Goods – Cast Iron, PVCu & Lead	Category: B/C
Defect or Significant Observation: <p>11.1 The above ground rainwater system is a combination of materials and is fairly chaotic due to the growth of the building over the years. You should be aware that the rainwater system of 5 Elm Row seems also to be responsible for a large amount of rainwater from each of its neighbours – see above. The majority of the rainwater system drains to the rear of the building and is principally PVCu, although some cast iron elements also exist.</p> <p>11.2 You should be aware that the use of PVCu rainwater goods generally isn't permitted on listed buildings and it is unlikely to have gained listed building consent. Though it is relatively low risk, you should be aware that the liability for any works undertaken without consent is passed on with the ownership of the property. See also Statutory Consents.</p> <p>11.3 The system as a whole is haphazard in its design with several instances of poorly conceived detailing, which could easily give rise to blockages and failure. Evidence internally of water ingress, indicates that the single lead rainwater pipe to the front of the building has been damaged or blocked approximately half way down its length, however, this area is now dry. It is also clearly blocked at parapet gutter level, which if not addressed, makes the chances of future ingress practically a certainty.</p> <p>11.4 There are also concerns that some of the downpipes may be undersized. Rainwater pipe (RWP) 1 in particular, is serving a very large catchment area highlighted in blue above.</p>

Recommendations: <p>11.5 Ascertain ownership and responsibility of the rainwater goods.</p> <p>11.6 To provide absolute long-term confidence, the system would require full rationalization, and consideration should be given to increasing the diameter of the downpipe at the rear of the building to cater for predicted future weather events.</p> <p>11.7 Should the above not be feasible, we highly recommend that all gutters, downpipes, and grates are cleaned out (jetted) on entering the property – the importance of this cannot be overstated.</p> <p>11.8 Rub down, mend and redecorate where necessary the cast iron and lead elements of the rainwater system.</p>

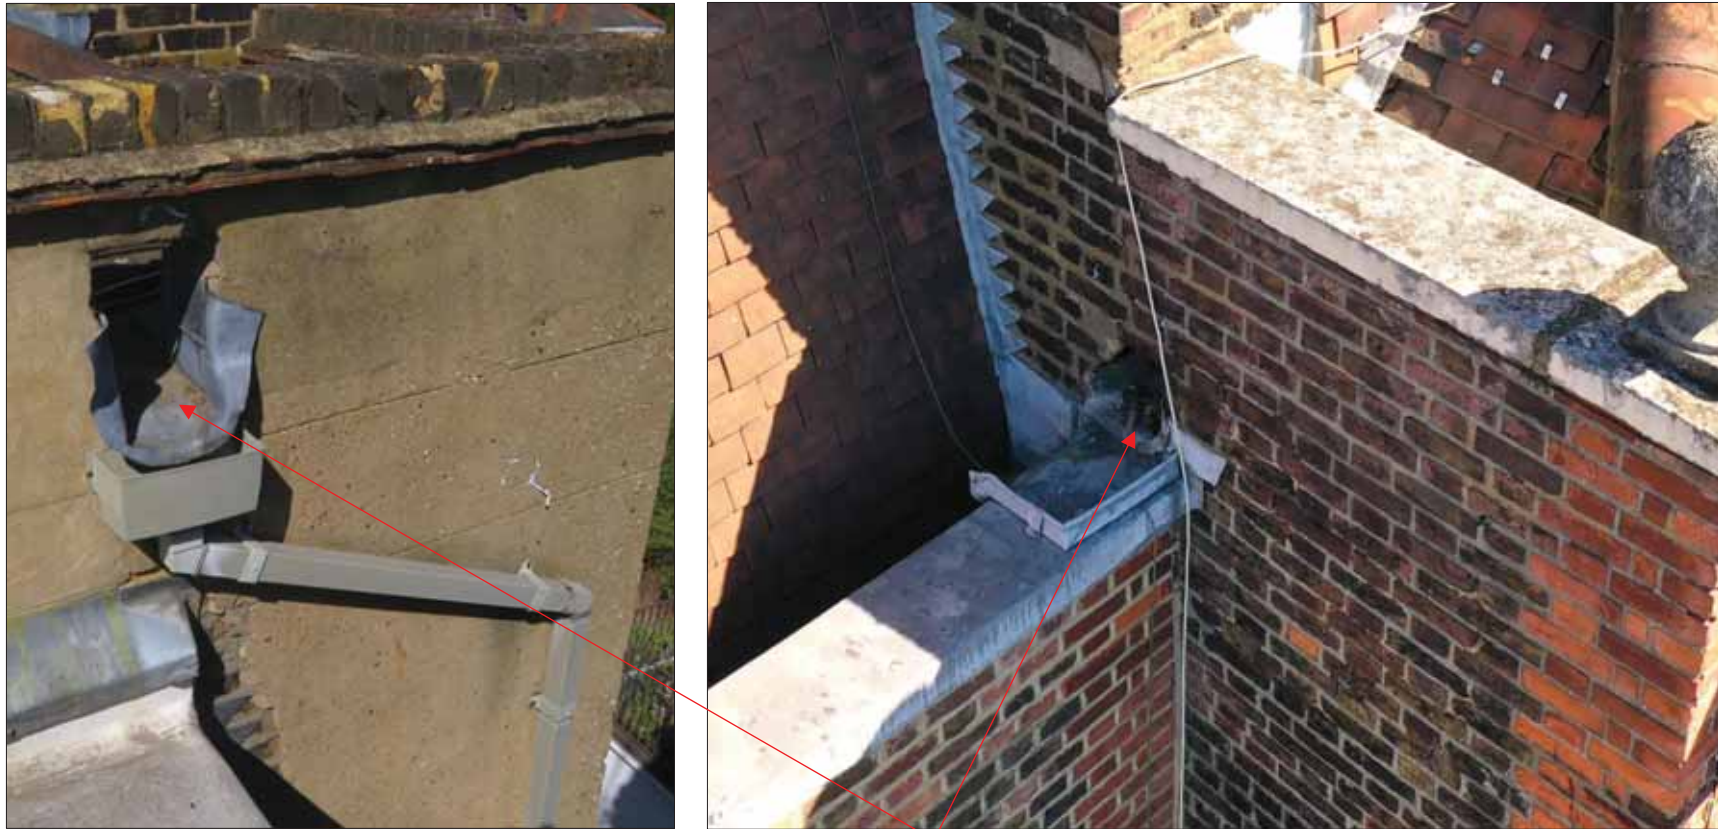
Images 27 & 28: Example Areas Where Rainwater from Neighbouring Properties Flows into the System of 5 Elm Row.

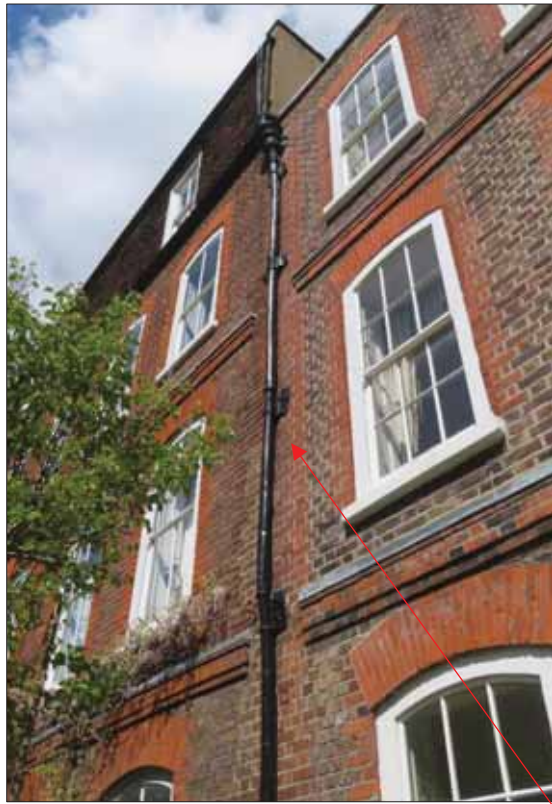
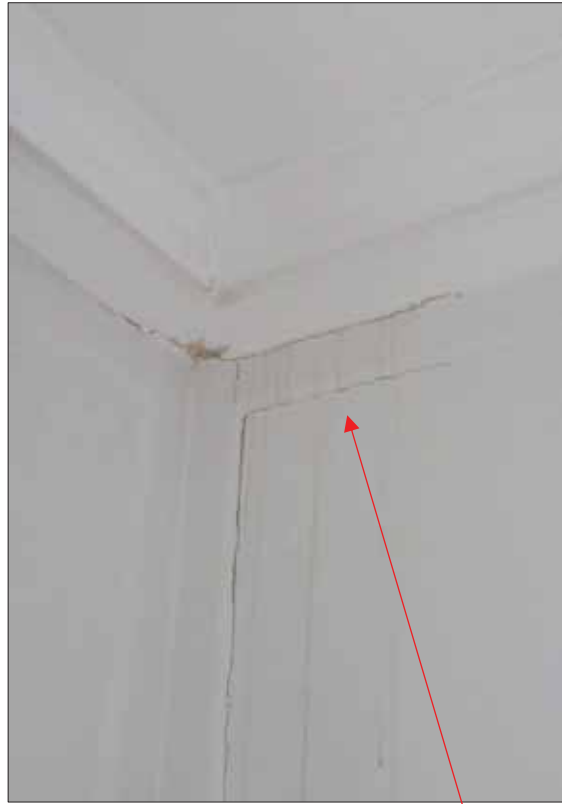
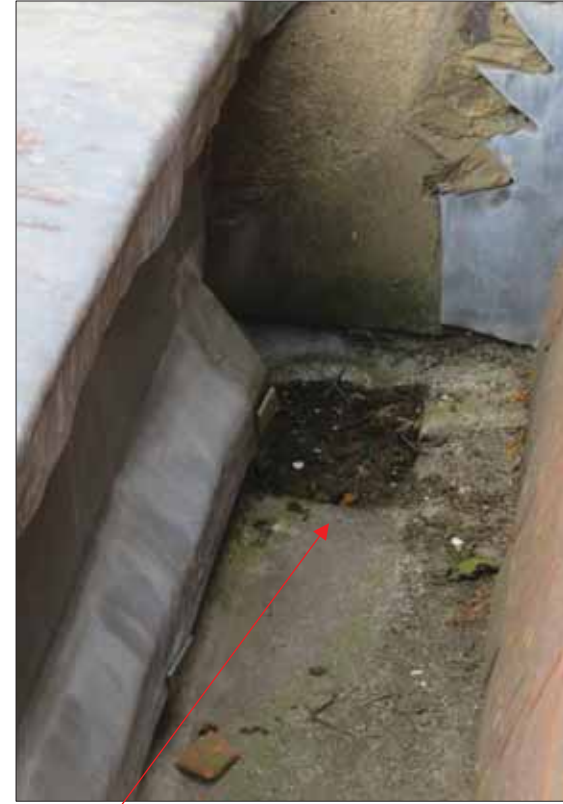
Images 29 – 31: Lead Downpipe to Front Elevation, Corresponding Water Damage Internally & Blockage at its Head.
