5 Elm Row, Hampstead Level 3Plus Condition Report

Level 3Plus Condition Report

5 Elm Row
Hampstead
London
NW3 1AA

19th May 2021

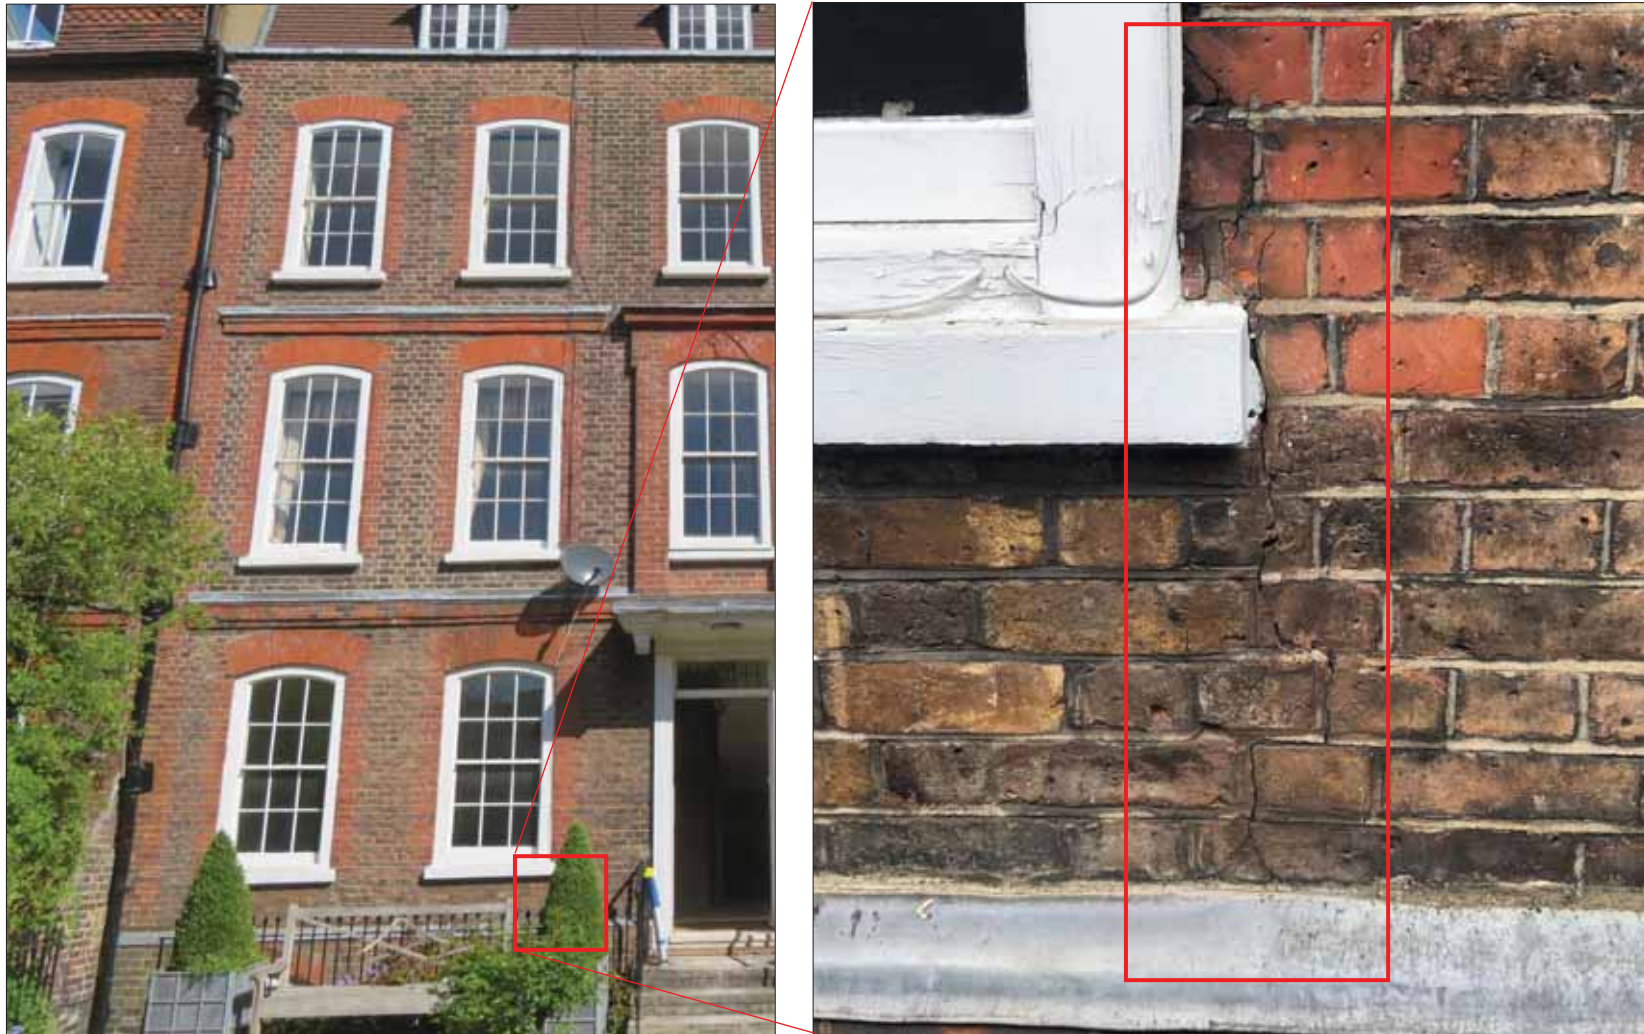
Element: External Walls – Structural Stability, Masonry & Mortar.	Category: C
Defect or Significant Observation: <p>12.1 Generally speaking, the property is in relatively good structural repair, with no evidence of significant deficiency or imminent collapse.</p> <p>12.2 Cracking was seen around one of the windows to the front of the property. This is a relatively common defect likely to be caused by a lack of compressive strength in these areas and is not a major cause for concern.</p> <p>12.3 It was however apparent that the brickwork has been repointed, probably relatively recently, in a cementitious mortar, which is generally regarded as being inappropriate for use on historic solid walled structures and can lead to the degradation of the masonry through ‘spalling’- though happily the brickwork itself is still in generally good condition and the number of spalled/damaged bricks is still very small. Most examples can be found to the Chimneys.</p> <p>12.4 You should be aware that buildings such as this, which are solid and therefore do not have a cavity, act like a sponge, and absorb water during periods of precipitation and rely on their wide cross-sectional thickness to prevent the water from coming through the internal face. When the rain stops, they go through a drying process aided by the sun and wind, where the retained moisture is evaporated back into the environment (See Appendix B & Appendix C).</p> <p>12.5 Traditionally this drying out process occurs mainly through the mortar joints, and mortars were specified to be more absorbent and porous with higher capillarity than the surrounding masonry. The mortar therefore is constantly working to protect the masonry and essentially sucks the water out of the bricks, which then evaporates in the atmosphere. This is the basic concept of the breathing building which you may have heard about.</p> <p>12.6 In modern times, however, builders have adopted the use of cement or until very recently Naturally Hydraulic Lime (NHL), both of which – in many situations – can be considered inappropriate for the use of historic buildings. Cement is a one size fits all material which can be used by anyone in any circumstance and should be avoided. However, you should also be aware that there is a spectrum of lime mortars with different characteristics. The skill of the specifier – which would have been second nature to the masons of the past but has now generally been lost – is to choose the correct mortar for the building in question. This takes account of substrate type, aspect, environment/exposure etc.</p>

Images 32 & 33: Cracking to One of the Window Openings of the Front Elevation.

- 12.9** Though the level of spalling is by no means severe, due to the other concerns surrounding wet masonry the building would benefit from the removal/repair of any spalled bricks and the careful raking out of cement mortar and replacement with an appropriately specified lime mortar. The lime mortar should be ‘sacrificial’, being softer and more permeable than the masonry around it meaning that it should fail before the masonry fails, extending the life of the brickwork.
- 12.10** Where localized structural movement exists, it is recommended in the first instance that the cracks are filled with in a lime mortar and monitored to ascertain if the movement is current – which seems unlikely. Should current movement exist the cracks can be stabilized with the introduction of stepped stainless steel bed joints reinforcement.

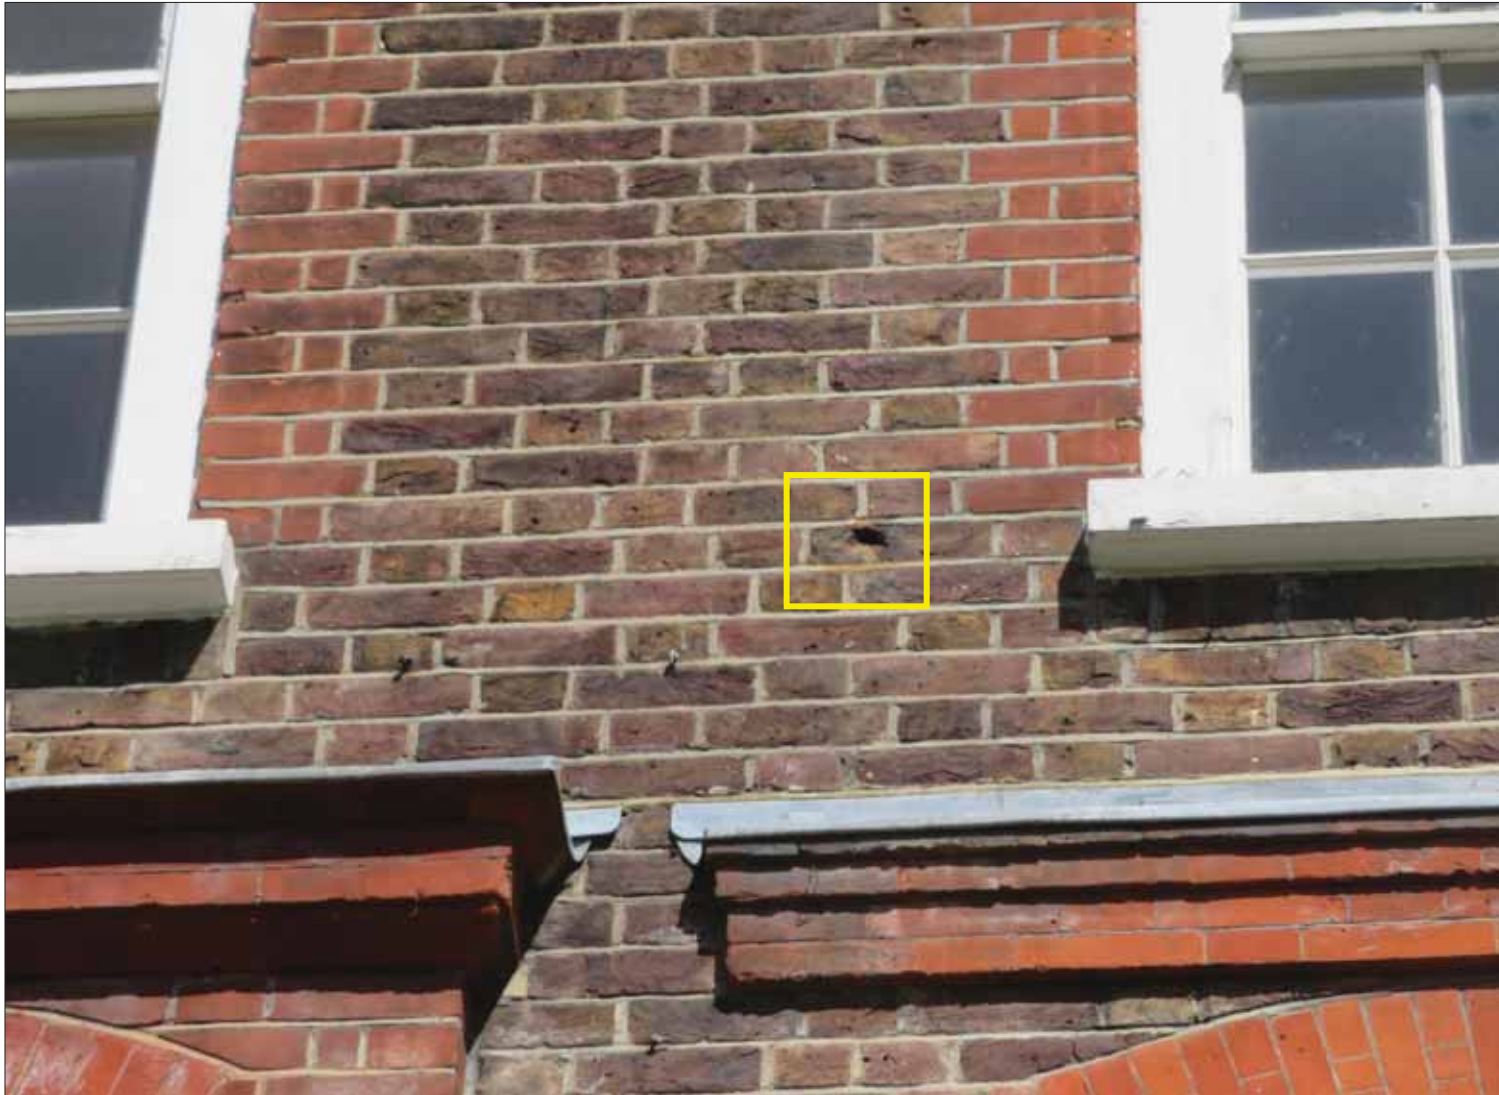
- 12.7** When the incorrect mortar is specified – one that is denser and less porous and absorbent than the surrounding masonry - it effectively blocks up the joints, which act like the pores of a building, and prevents moisture from escaping through them. For trapped moisture, the path of least resistance is then through the face of the masonry itself. In certain conditions, this leads to ‘spalling’.
- 12.8** As the masonry under these conditions is also permanently damp, the high moisture content can precipitate rot and wood boring insect infestation within timber in contact with the walls, such as joist ends and lintels, along with internal damp and decreases the building’s thermal mass making it more difficult to heat. Indeed, research shows that wet walls are up to 40% less thermally efficient than dry walls.

Image 34: Brickwork of the Front Elevation, Relatively Recently Repointed in Cementitious Mortar.

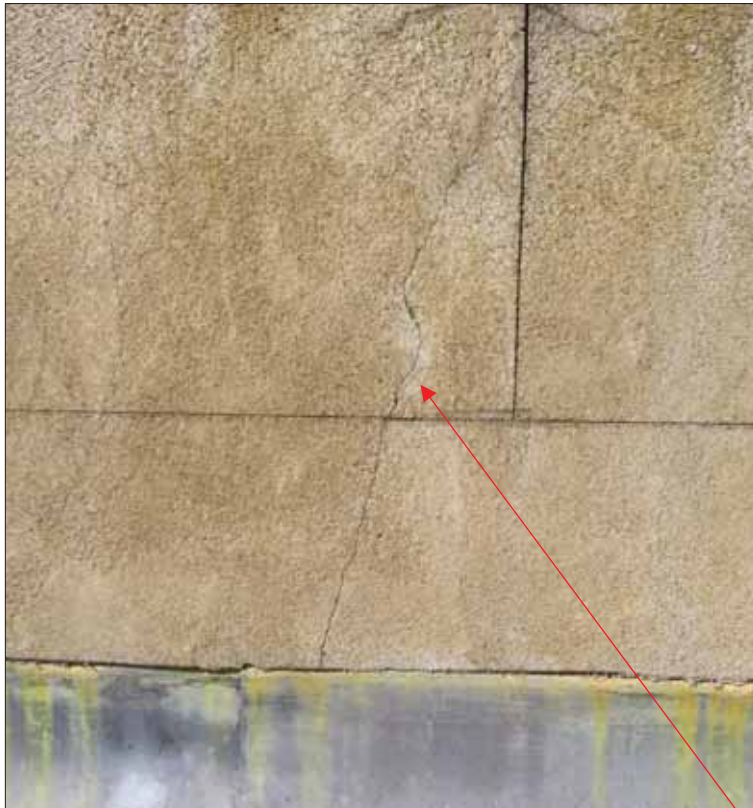
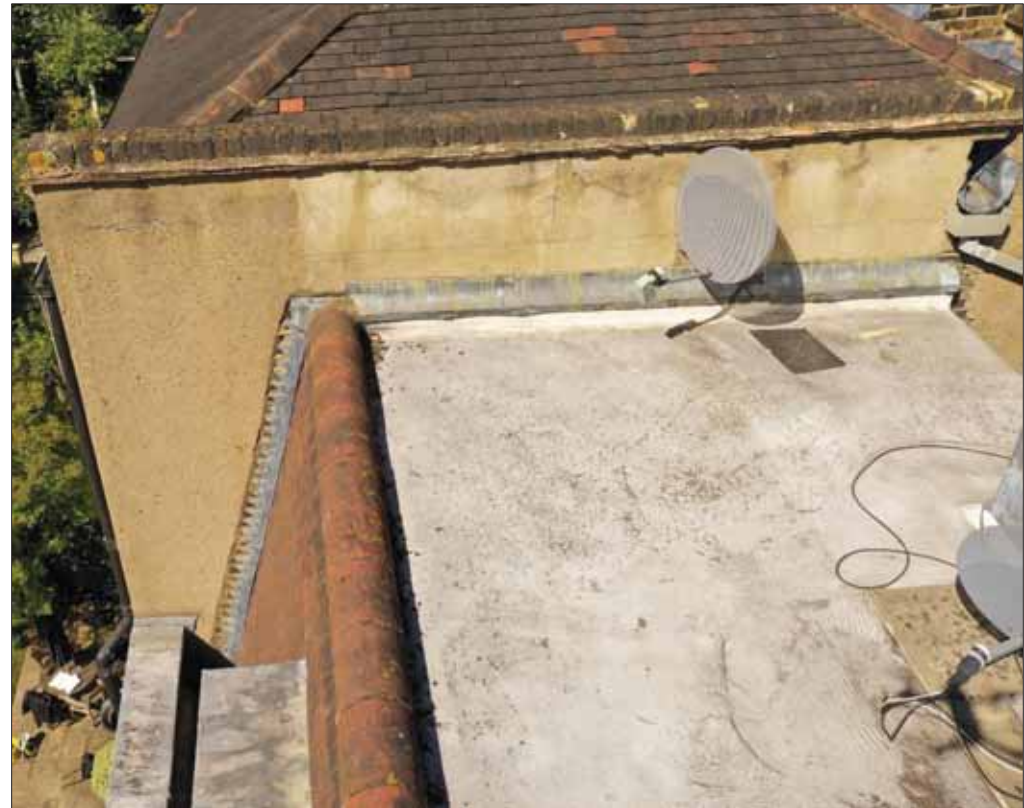
Element: External Walls - Render	Category: C
Defect or Significant Observation: <p>12.11 The western party wall at high level and the internal faces of the parapet walls have been coated in, what is likely to be, a cementitious render.</p> <p>12.12 Cement based materials, or incorrectly specified limes, have a low modulus elasticity and therefore cannot flex and bend to accommodate the natural movement of old structures. This in turn inevitably leads them to crack, which presents a direct path for rainwater to penetrate behind the render layer, which, due to the low permeability coefficient of the material traps it in the substrate, leading to permanently damp conditions.</p> <p>12.13 In the worst cases, these permanently damp conditions can precipitate rot and wood boring insect infestation in any timber elements in contact with the walls, such as the joust ends associated with the mansard roof. Although these timbers could not be visibly inspected, there was no indication that they are decayed at this juncture.</p>

Images 35 & 36: Cracking Render to Western Party Wall at High Level.

Recommendations: <p>12.14 The cementitious render poses a risk to the fabric due to its ability to trap moisture, therefore, building would therefore benefit from its removal as part of an overarching scheme of masonry works.</p> <p>12.15 You should be aware that the decision to render in the first place may have been because the brickwork was in poor condition. However, due to the strength of bond between cement and masonry, removing the render may cause damage to the brick faces, leaving no option but to re-render in an appropriately specified lime.</p> <p>12.16 The reapplication of a render should therefore form part of your project budgeting.</p>

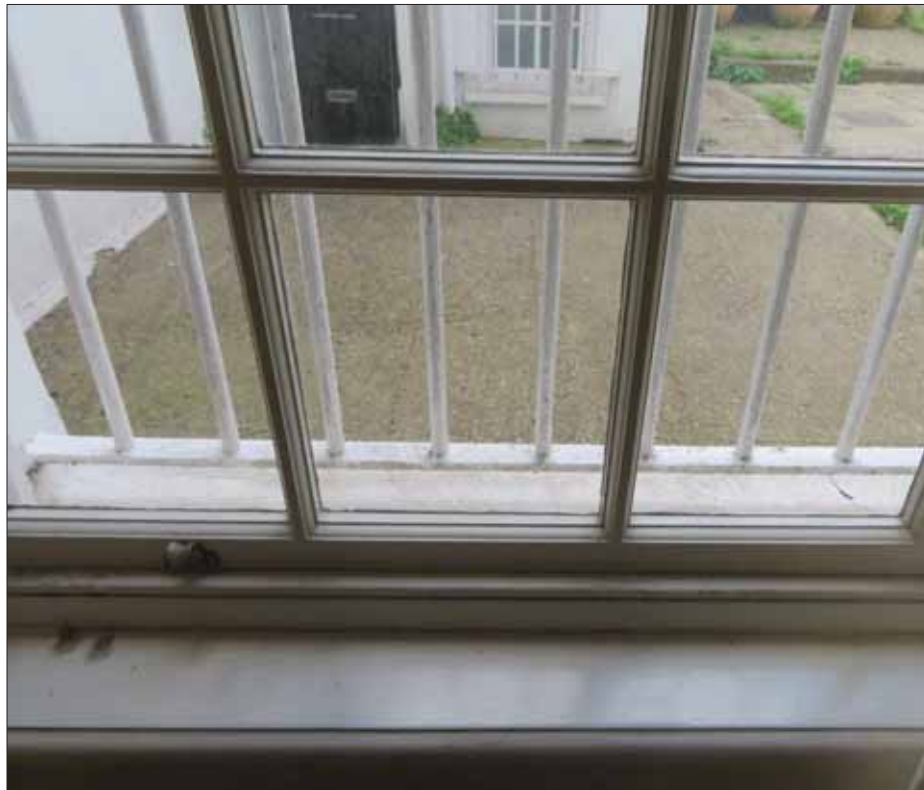
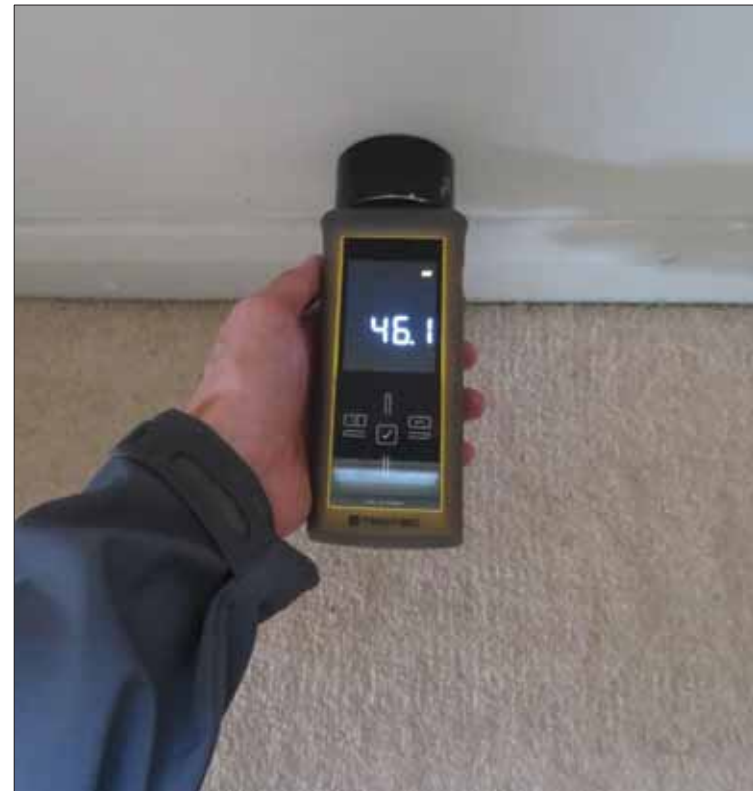
Element: External Ground Levels & Damp	Category: C
Defect or Significant Observation:	
<p>13.1 When considering ground levels and damp, to the lower ground floor, it should be remembered that it was never designed to be a habitable space in the same terms as it is now, being purely the domain of staff or storage etc.</p> <p>13.2 That said, where tested with the masonry moisture meter, the moisture content of the masonry at lower ground floor level was acceptable - generally between 34 and 41. For reference, around 40 on a scale of 200 is considered normal and anything below this is good.</p> <p>13.3 Along the front elevation, a series of holes in the masonry indicate that Doulton Tubes have been installed. These ceramic tubes were installed most commonly between the 1930s and 1970s to draw moisture away from the surrounding masonry. However, as in this case, they are usually surrounded by cement, which renders them useless.</p> <p>13.4 To the north west corner of the floor above (ground floor), the external ground levels, forming part of the neighbours back yard, are very high. This has resulted in only slightly elevated moisture contents and no damage to internal finishes, but it should be born in mind that this is a potential area of weakness going forward.</p>

Images 41 & 42: High External Ground Levels to North West Corner of the House & Corresponding Elevated Masonry Moisture Reading.

Recommendations:	
<p>13.5 No works currently required, but the area beneath the north west ground floor window should be monitored for damp.</p>

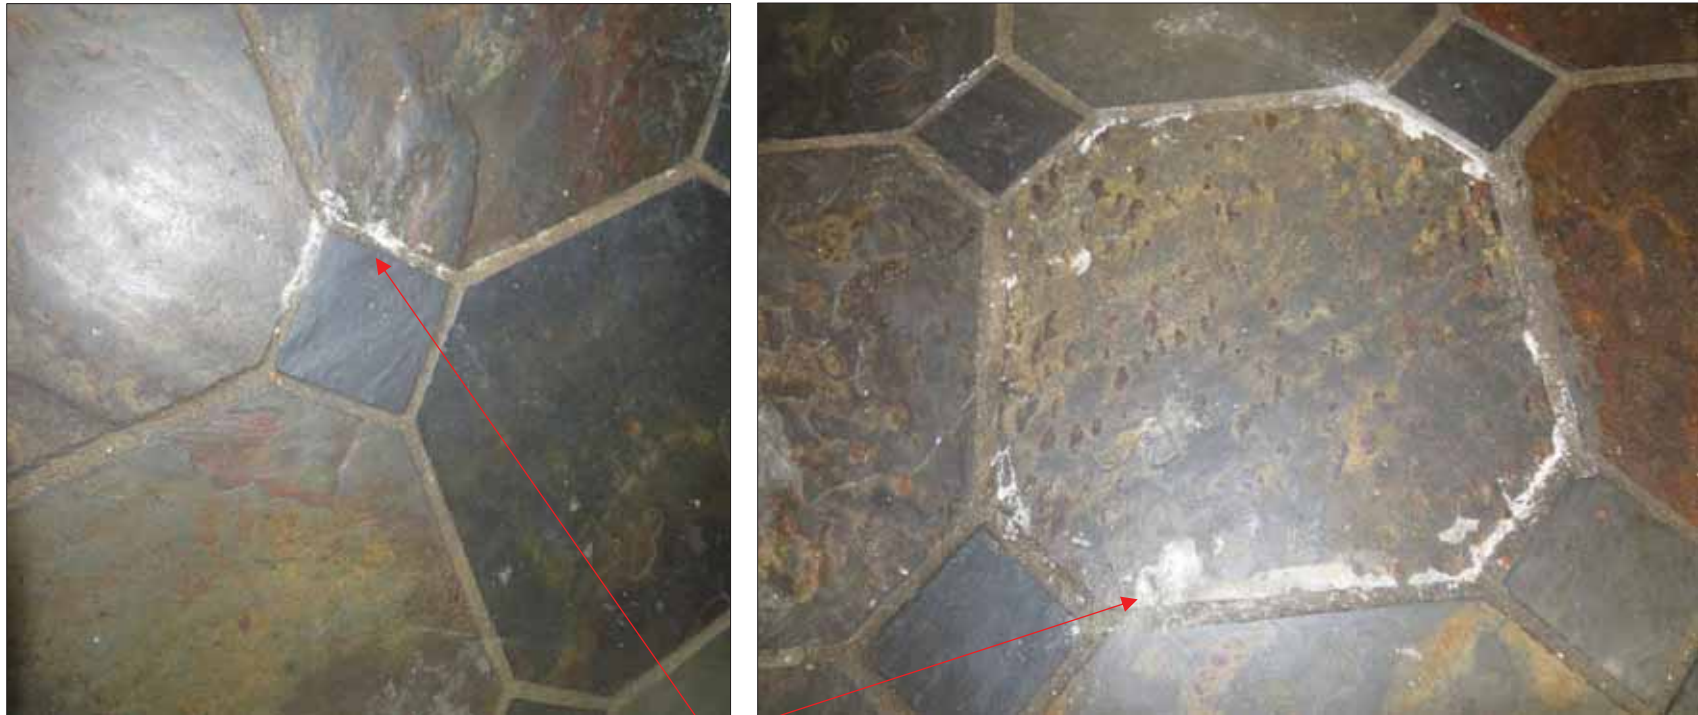
Element: Internal Floors - Ground Floor - Solid Floor	Category: C
Defect or Significant Observation: <p>14.1 The lower ground floor is solid throughout and is covered largely in a modern floor tile. It is difficult to say for certain without undertaking further, more intrusive investigation what the makeup of the floor is - it could, for instance, be that the floor consists of a relatively modern concrete slab, alternatively the tiles may be laid over the original flag stones.</p> <p>14.2 Certain types of solid floor can cause damp issues in historic buildings, as ground water and vapour is unable to migrate through the floor surface and so is forced up the walls due to hydrostatic pressure - there seems to be only one small area of this beside the fridge. There is also evidence that moisture trapped beneath the floor is resulting in elevated moisture contents to the timbers at the base of the staircase, putting them at risk from decay mechanisms.</p> <p>14.3 Interestingly, there is also evidence of efflorescence - the movement of naturally occurring salts) around a number of the floor tiles which indicates a high moisture content.</p>

Images 43 & 44: Evidence of Efflorescence (Salts), Around Floor Tiles at Lower Ground Floor Level.

Recommendations: <p>14.4 Further investigation would be required to definitively ascertain the makeup of the solid floor.</p> <p>14.5 Consideration should be given to its removal of impermeable materials and the installation of an insulated vapour permeable flooring system which can also incorporate underfloor heating.</p>

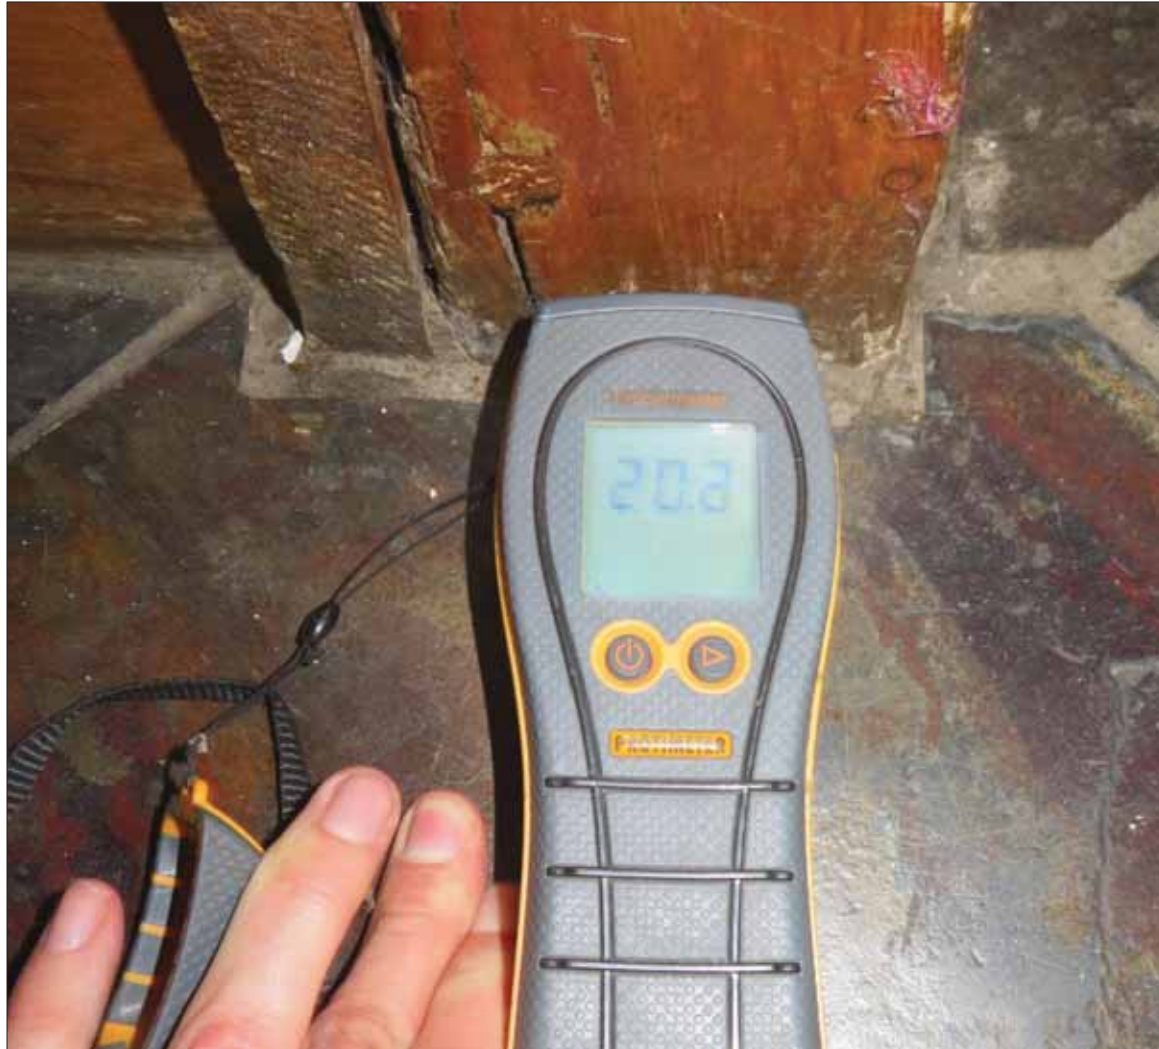
Image 45: Elevated Moisture Contents to the Timbers at the Base of the Staircase.

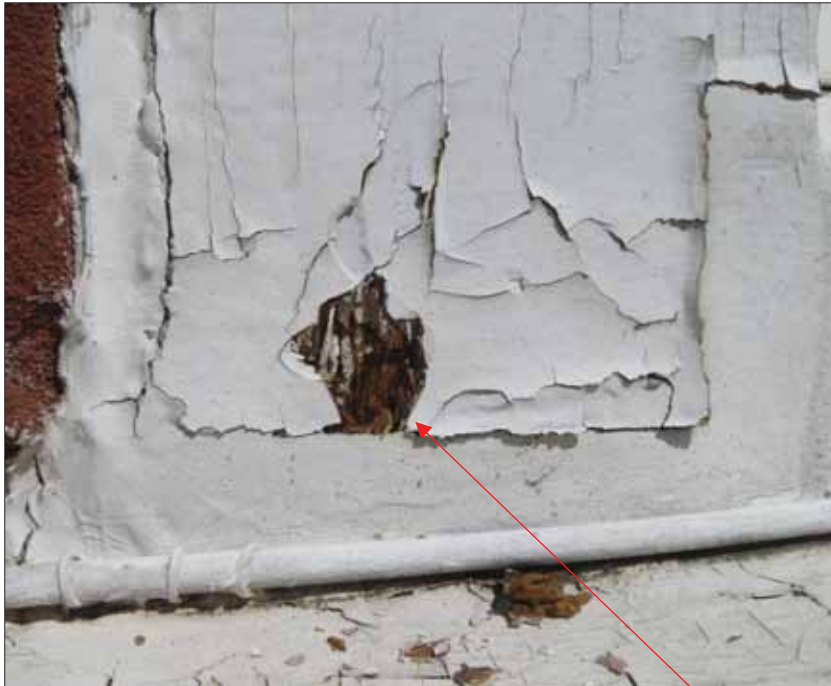
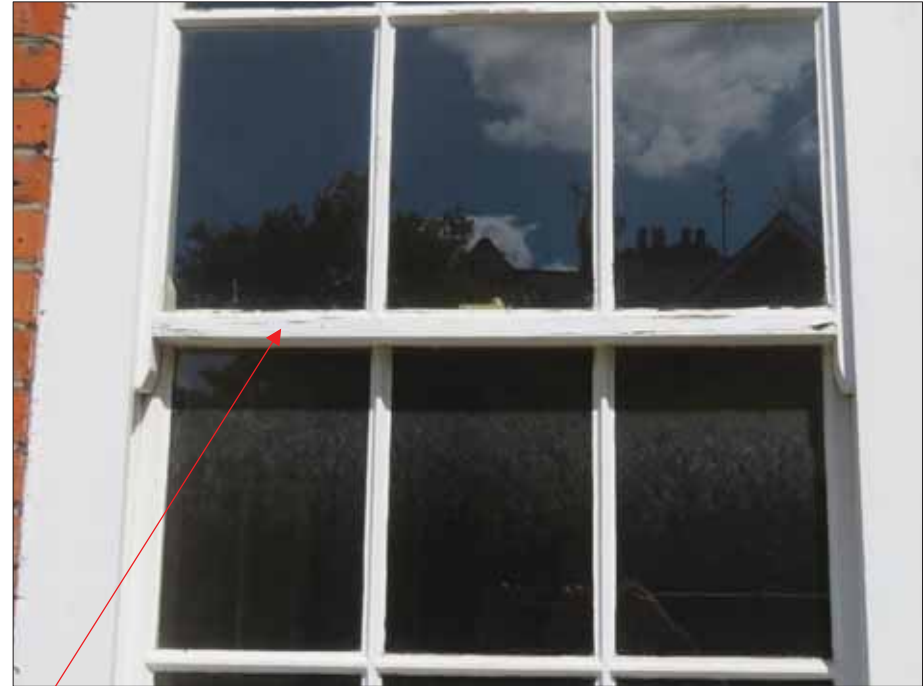
Element: Windows & Doors	Category: B
Defect or Significant Observation:	
<p>15.1 Windows are a mixture of timber sashes and timber casements. They are generally in a fair condition, although where tested not all were operational, as in some instances they have been painted shut, and in one instance the sash cords have been cut.</p> <p>15.2 There are areas of decay in several of the windows, but it is not yet endemic.</p> <p>15.3 Doors are all timber and where inspected were free from decay.</p> <p>15.4 Both windows and doors are at the end of their decorative cycle.</p>	
Recommendations:	
<p>15.5 A full window survey and schedule would be required to fully understand the extent of decay/repair. Based on the inspection and the obvious neglect the building has experienced generally, whilst some repair is obviously required, more should be anticipated, and the impact/cost of this element alone should not be overlooked.</p> <p>15.6 Subsequently, all windows require a full rub down and redecoration.</p> <p>15.7 The installation of secondary glazing to the windows and draughtproofing to both windows and doors would have a significant positive impact on the building's thermal efficiency.</p>

Images 47 & 48: Examples of Decay & Failed Decoration of Sash Windows of the Front Elevation.

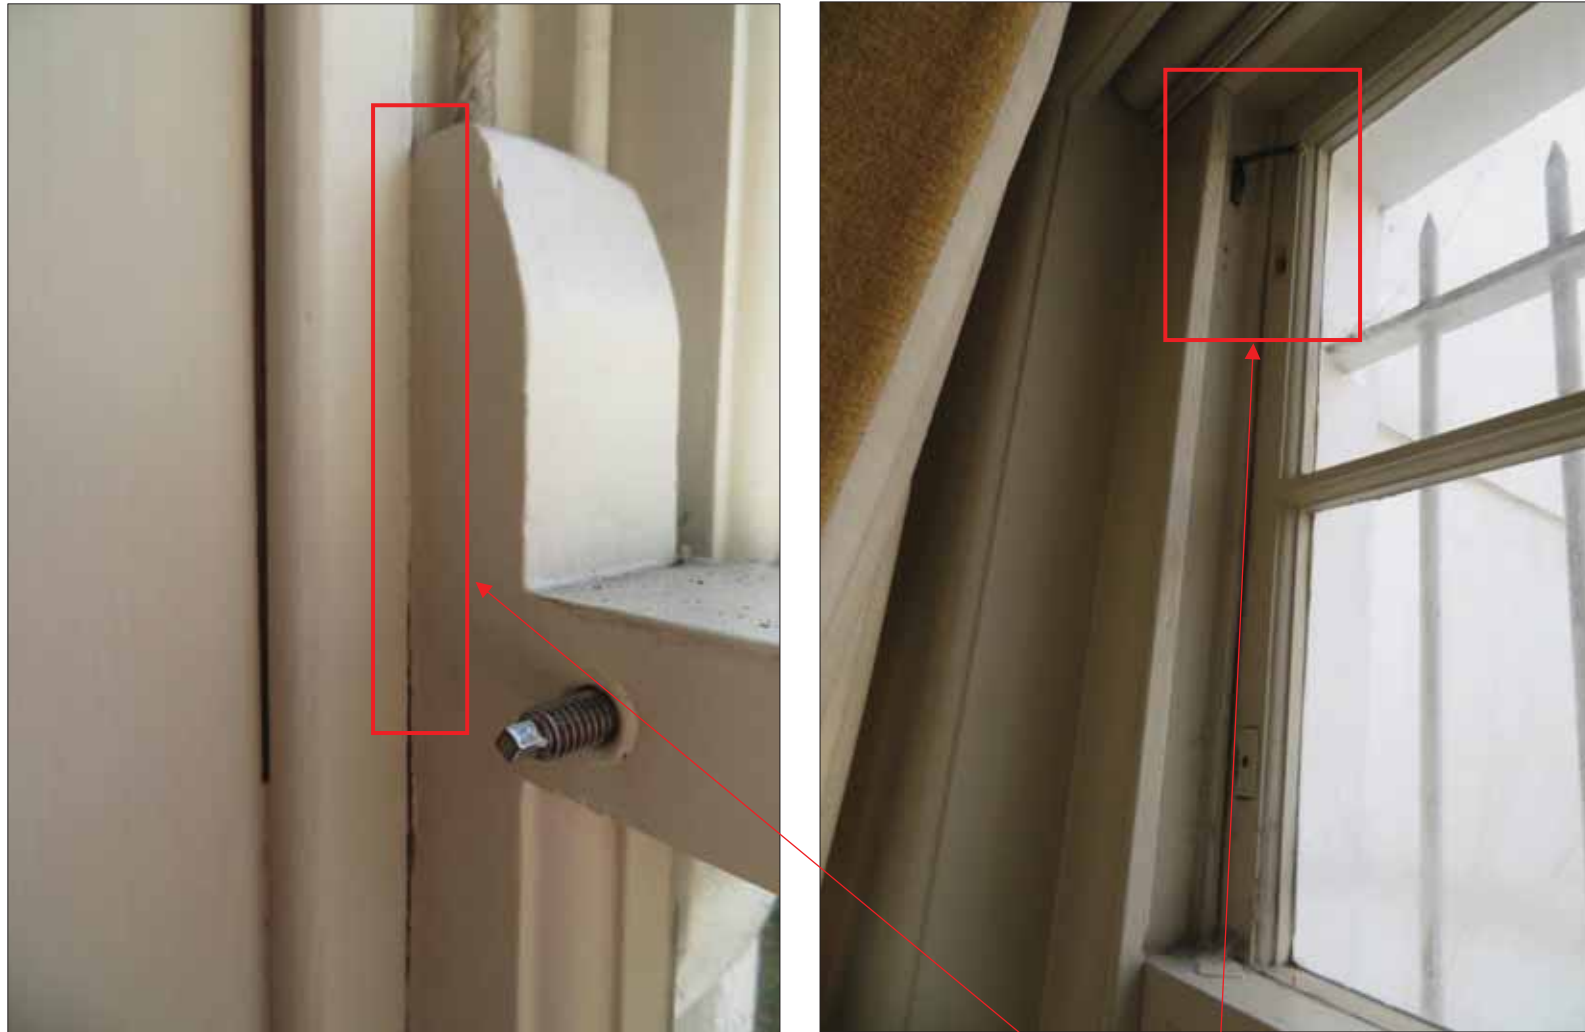
Images 49 & 50: Examples of Inoperable Windows that have been Painted Shut & Cords Cut, Respectively.

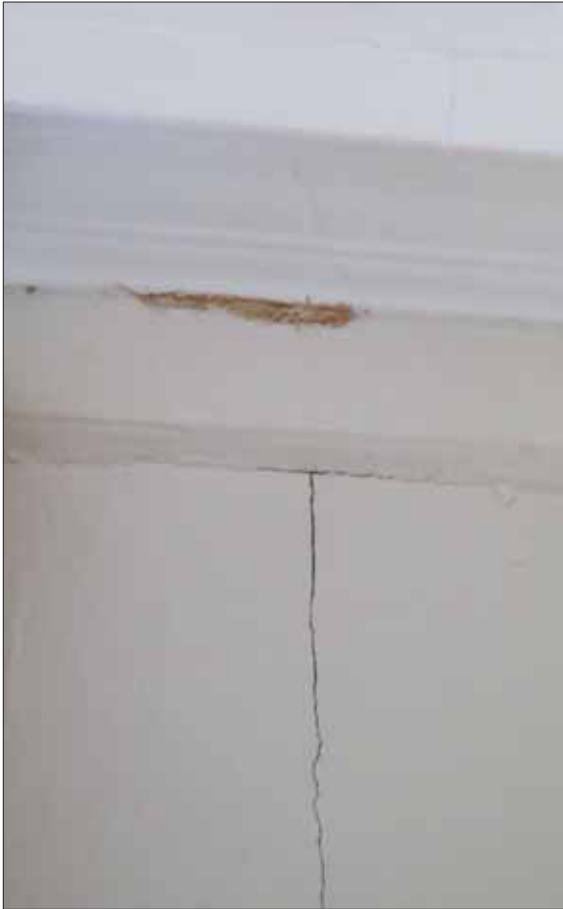
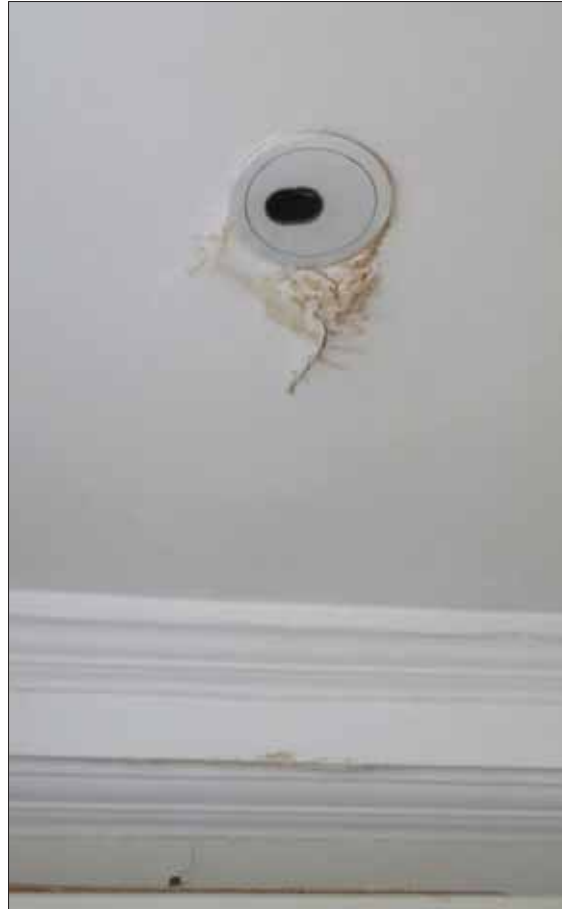
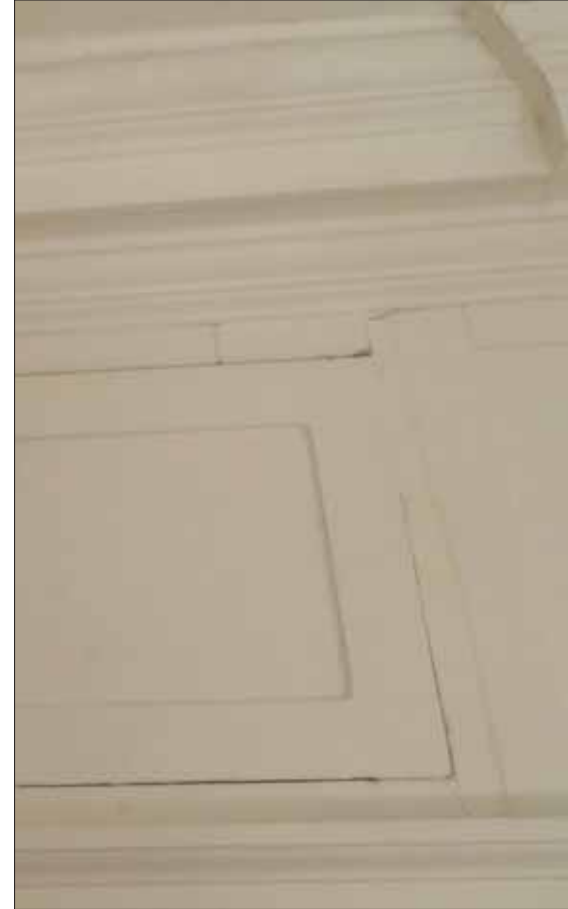
Element: Internal	Category: -
Defect or Significant Observation:	
16.2 Whilst we don't comment on cosmetic elements, internally, finishes are often below the standard one might expect from a building of this calibre and to a certain extent, detract from the building's aesthetic significance as a heritage asset.	
16.3 There is evidence to suggest there have been a number of plumbing leaks which have resulted in staining to plasterwork/panelling, however, where tested, no elevated moisture contents were recorded.	
Recommendations:	
16.4 See Services Report – further inspection of the plumbing is likely to be required and associated works should be anticipated.

Images 51 – 53: Example Evidence of Plumbing Leaks.
