5 Elm Row  
London  
NW3 1AA

## DRAINAGE INSTALLATION

## MECHANICAL & ELECTRICAL APPRAISAL

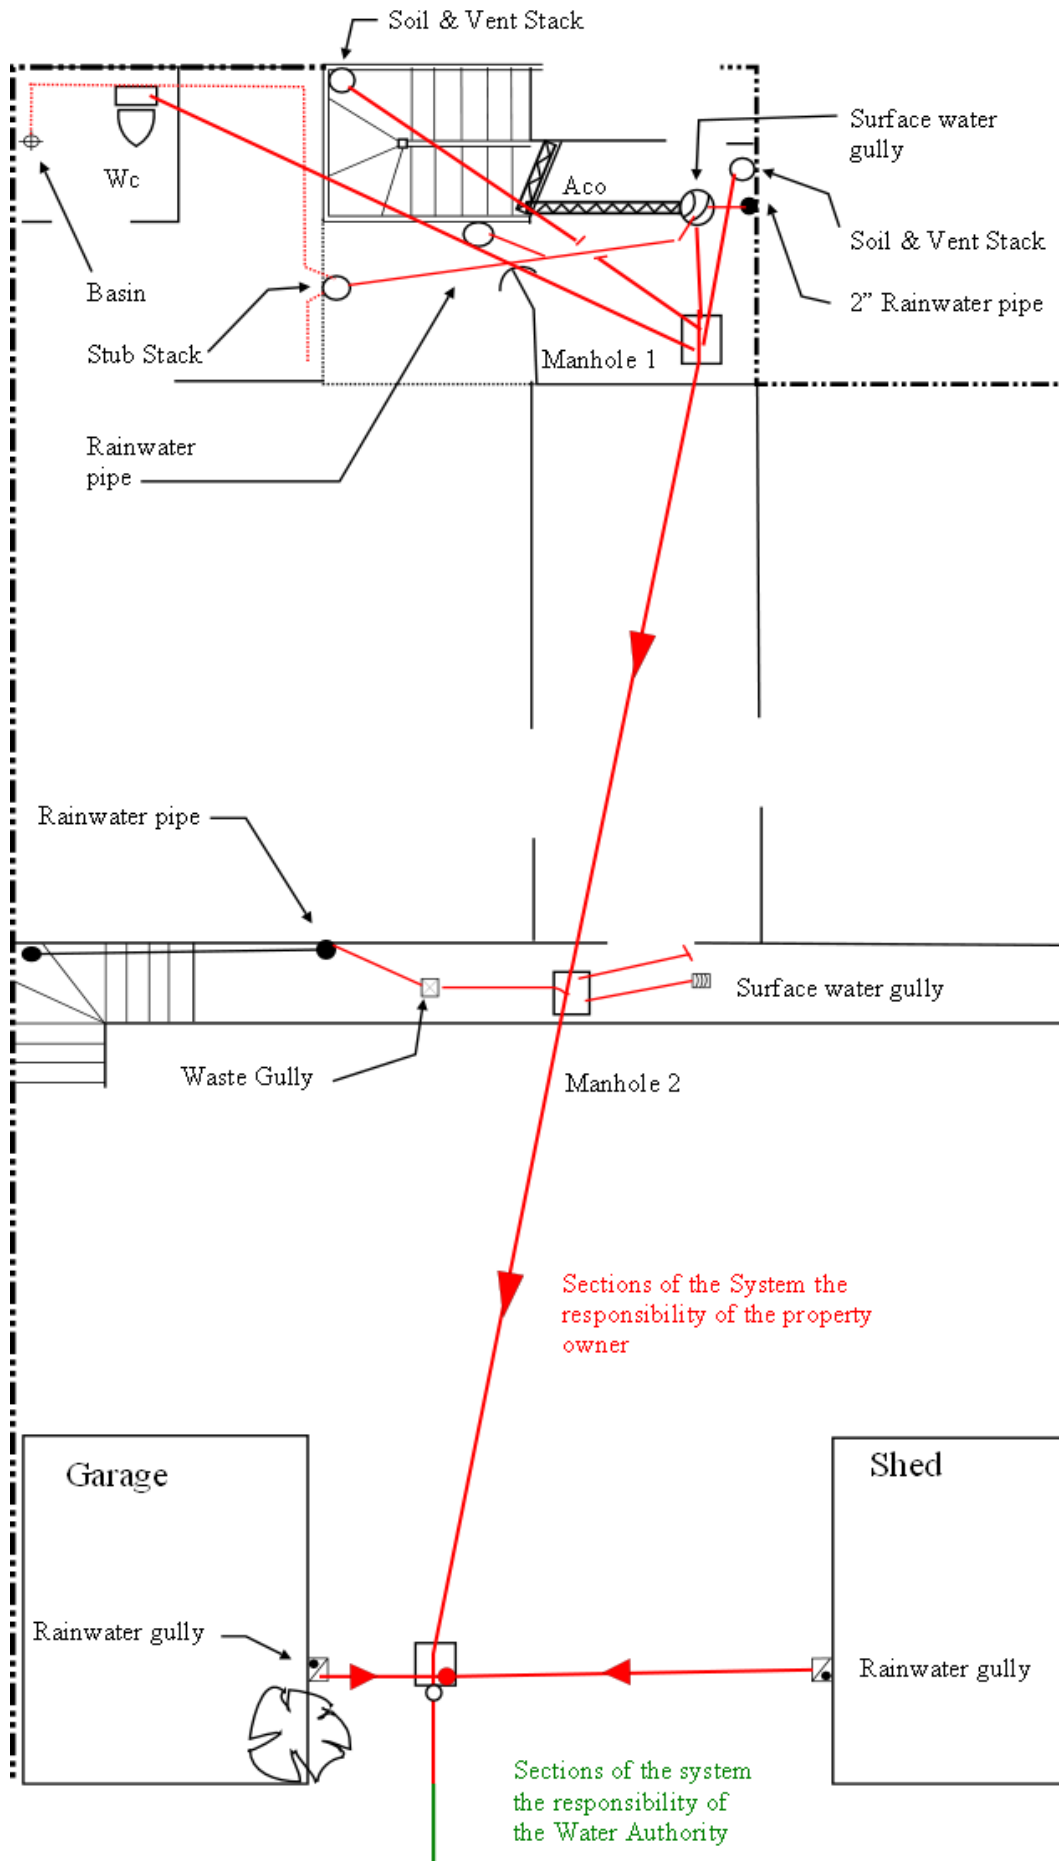
The primary drainage run serving the property has been identified on the enclosed sketch. This is for reference purposes only and should not be scaled. All dimensions should be checked on site. Invert level taken from outgoing pipework to cover level.

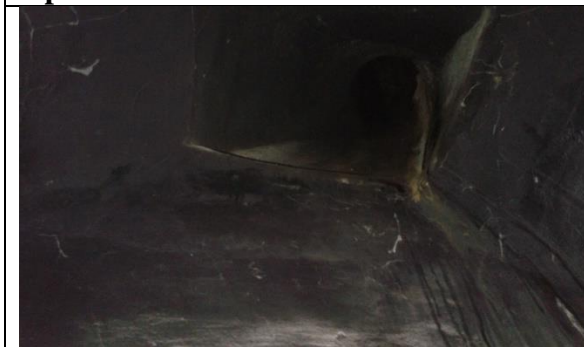
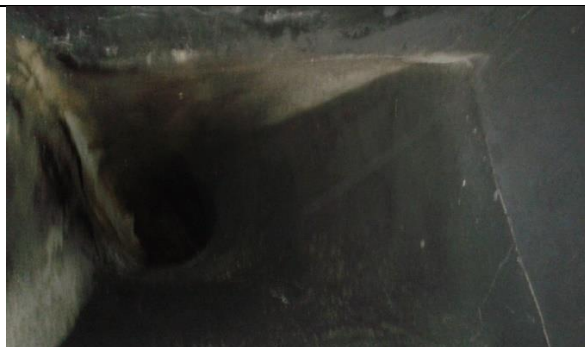
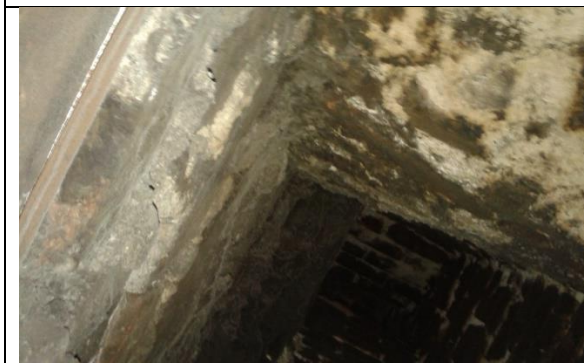
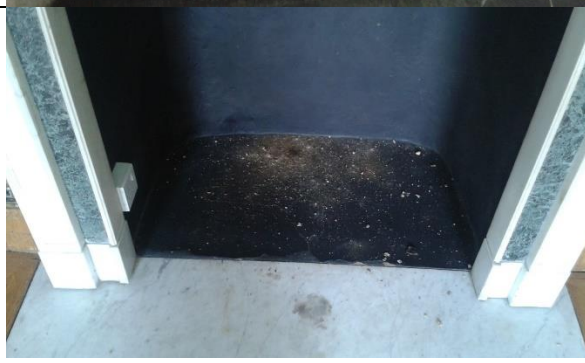
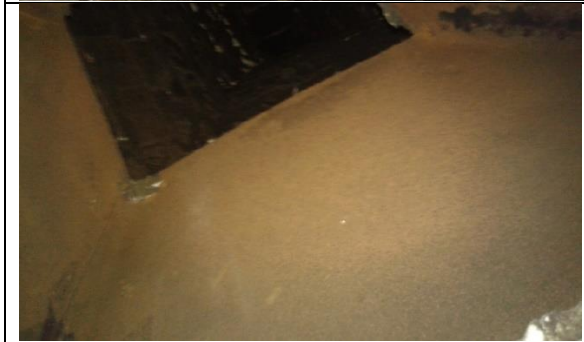
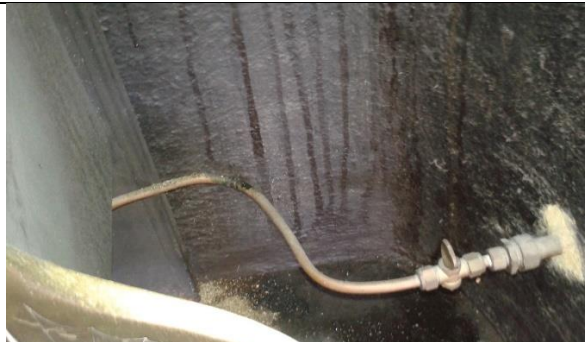
**Open Fire Flues**

Open flues to both the second-floor bedrooms were similar to the Drawing room flue construction describe above, the Parging has failed and the flues will require lining if to be re-used.

The open fireplaces predominantly appear to be brick constructed originally parged internally. The exception being the dining room which had a clay liner to the upper sections. Part J requirements require all chimneys to be tested. It is our opinion where parging is deteriorated, which was noted in all cases, it will be necessary to line the chimneys. The chimneys will require a full CCTV survey, sweeping and extensive investigations prior to such lining or type of lining being considered.
