SITE INVESTIGATION FACTUAL REPORT

Report No: [REDACTED]
Client: Crawford Claims Management
Site: 16 Nassington Road, Hampstead
Client Ref: [REDACTED]
Date of Visit: 30/04/2021

Investigation Layout Plan

Site: 16 Nassington Road

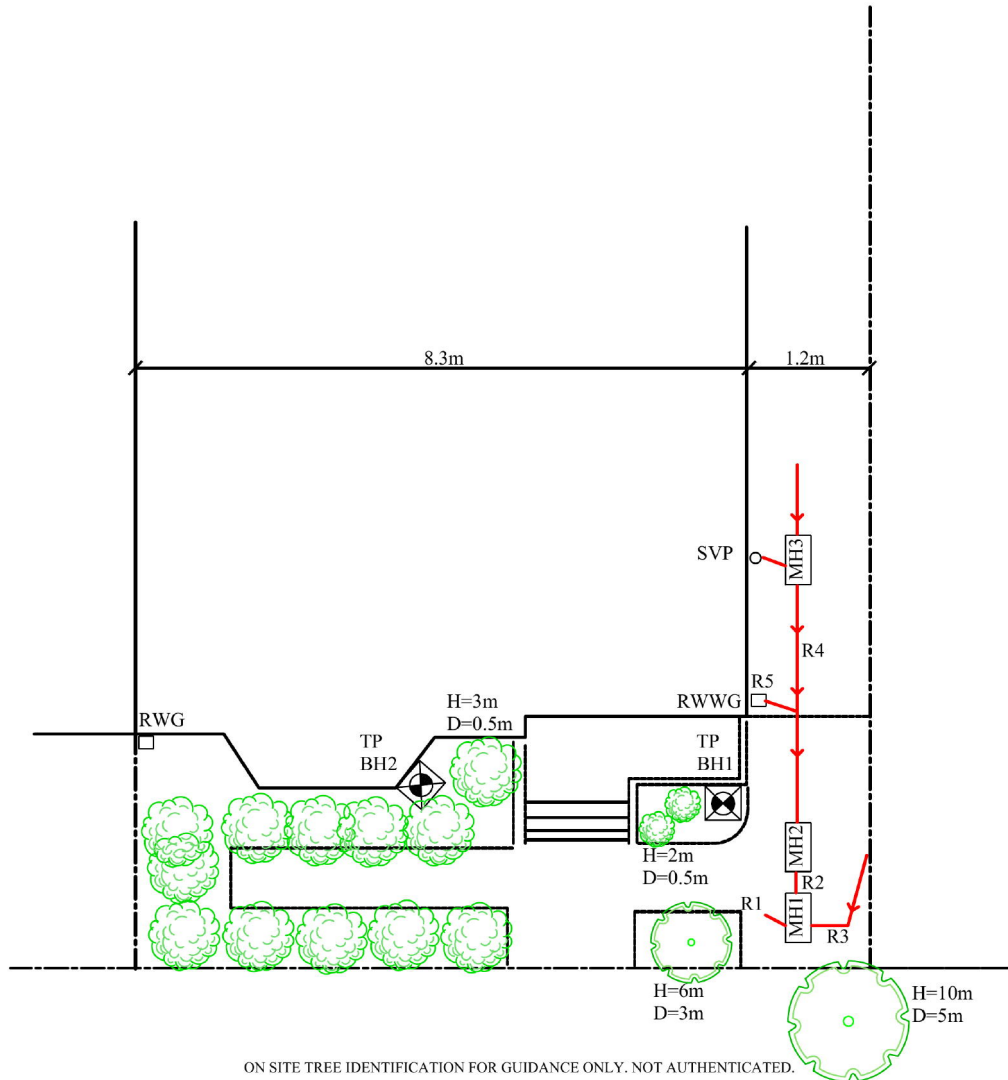
Remarks:
UNABLE TO LIFT MH2

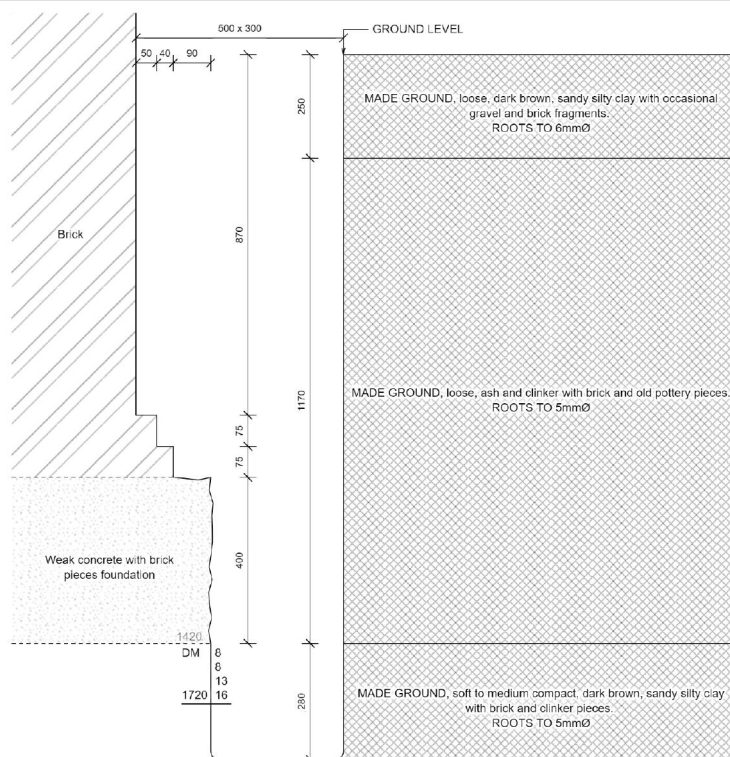
TRIAL PIT REF: TP1

For Strata below 1700mm see Bore Hole log

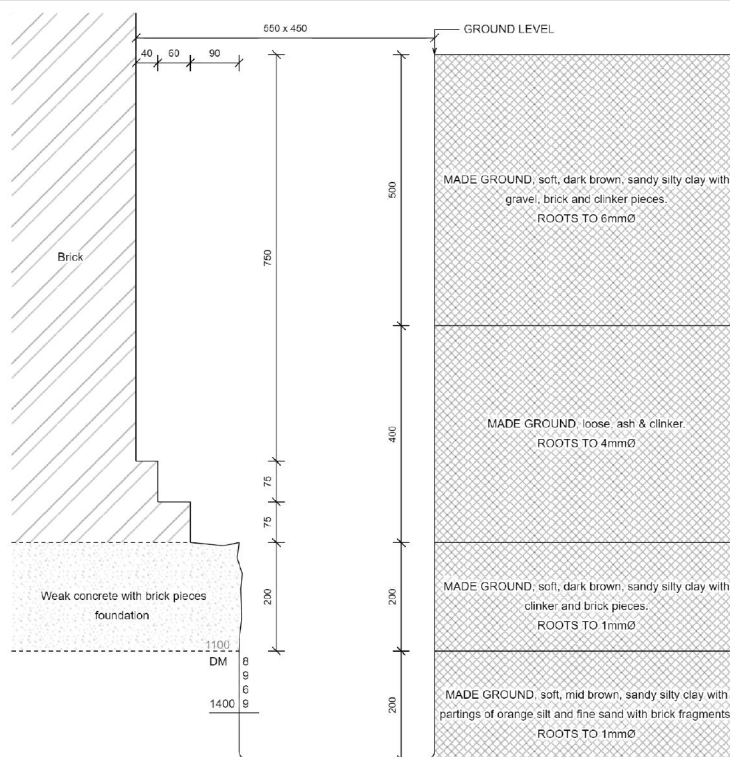
TRIAL PIT REF: TP2

For Strata below 1300mm see Bore Hole log
