TECHNICAL REPORT ON A SUBSIDENCE CLAIM

16 Nassington Road
Hampstead
London
NW3 2UD

SUBSIDENCE CLAIM

14th April 2021

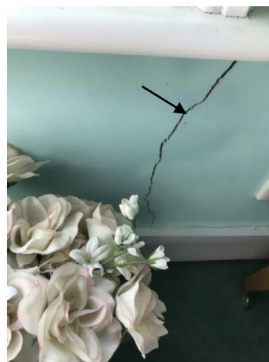
Cracking in bathroom

- Top corner of front elevation window - 2mm.
- Bottom right corner of front elevation window as viewed internally - 3mm.
- High level crack top corner of flank wall window.

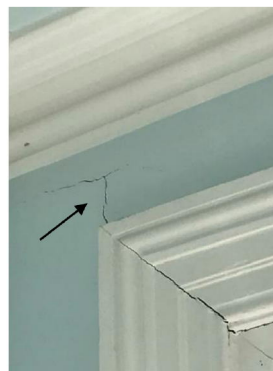
Cracking in bathroom
