Arboricultural Appraisal Report

Subsidence Damage Investigation at:

16 Nassington Road
Hampstead
London
NW3 2UD

CLIENT:	Crawford & Company
CLIENT REF:	[REDACTED]
MWA REF:	[REDACTED]
MWA CONSULTANT:	Giles Mercer (BSc Hons)
REPORT DATE:	06/08/2021

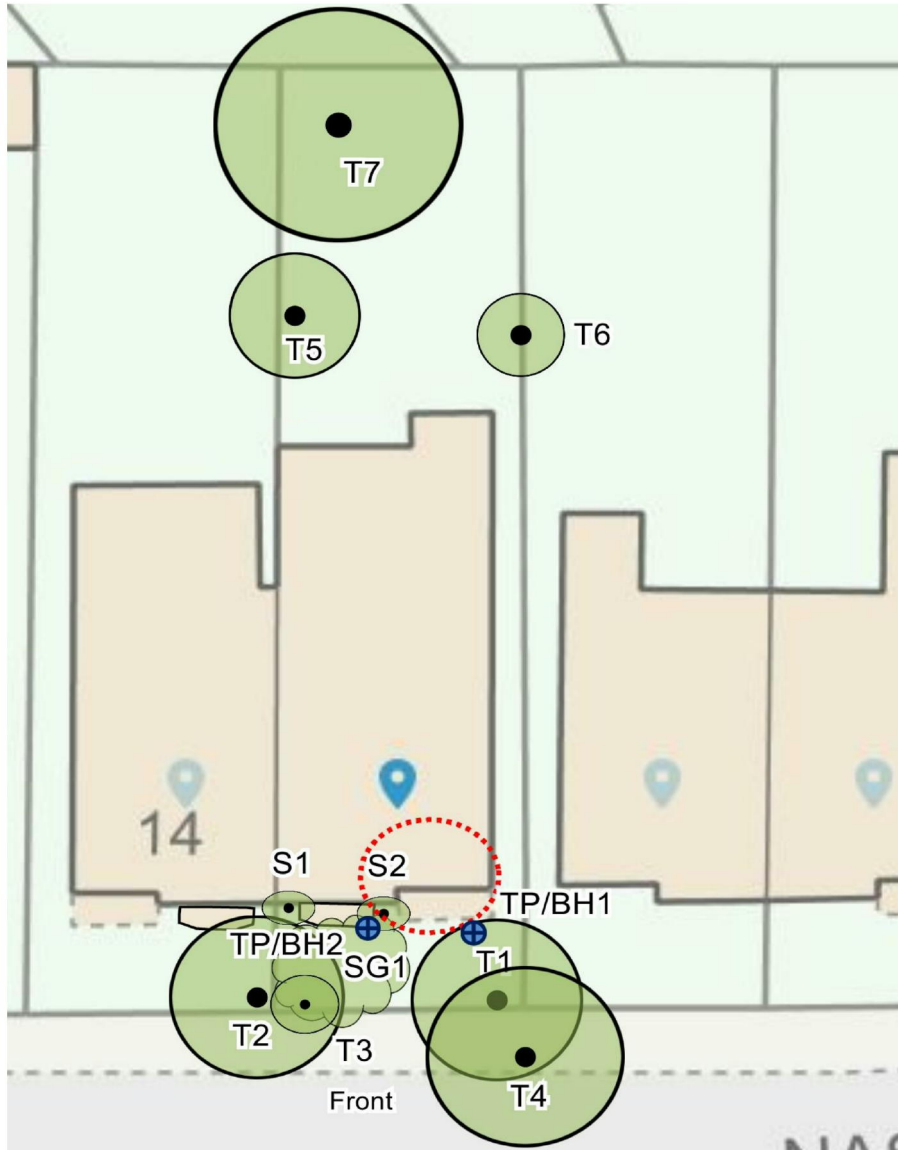
Site Plan

Approximate areas of damage

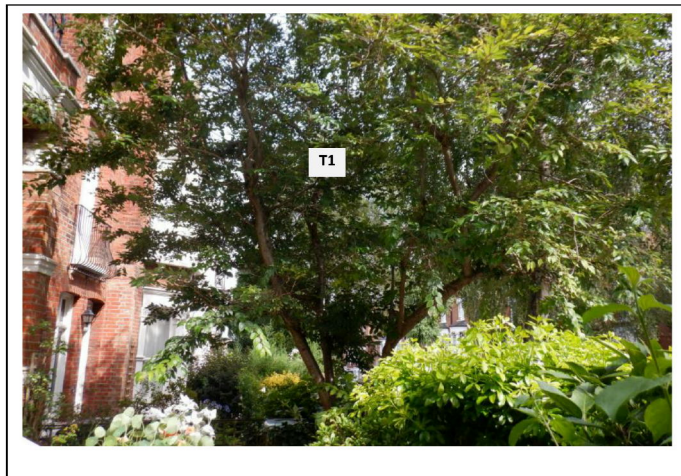
View of T1

Roots were observed to a depth of 2.7m bgl in TP/BH1 and to a depth of 1.9m in TP/BH2 and recovered samples have been positively identified (using anatomical analysis) as *Prunus* spp., *Betula* spp. and a member of the Pomoideae group, the origins of which will be the Cherry (T1), the Birch (T4), the Flowering Crab (T2) and potentially the Rowan (T3) confirming their influence on the soils below the foundations.

Based on the technical reports currently available, engineering opinion and our own site assessment we conclude the damage is consistent with shrinkage of the clay subsoil related to moisture abstraction by vegetation. Having considered the information currently available, it is our opinion that the Cherry (T1), the Birch (T4), the Flowering Crab (T2) and the Rowan (T3) are the principal cause of or are materially contributing to the current subsidence damage.

If an arboricultural solution is to be implemented to mitigate the influence of the implicated trees/vegetation we recommend that the Cherry (T1), the Birch (T4), the Flowering Crab (T2) and the Rowan (T3) are removed. Other vegetation recorded presents a potential future risk to building stability and management is therefore recommended.
