## Arboricultural Appraisal Report

### Subsidence Damage Investigation at:

16 Nassington Road  
Hampstead  
London  
NW3 2UD

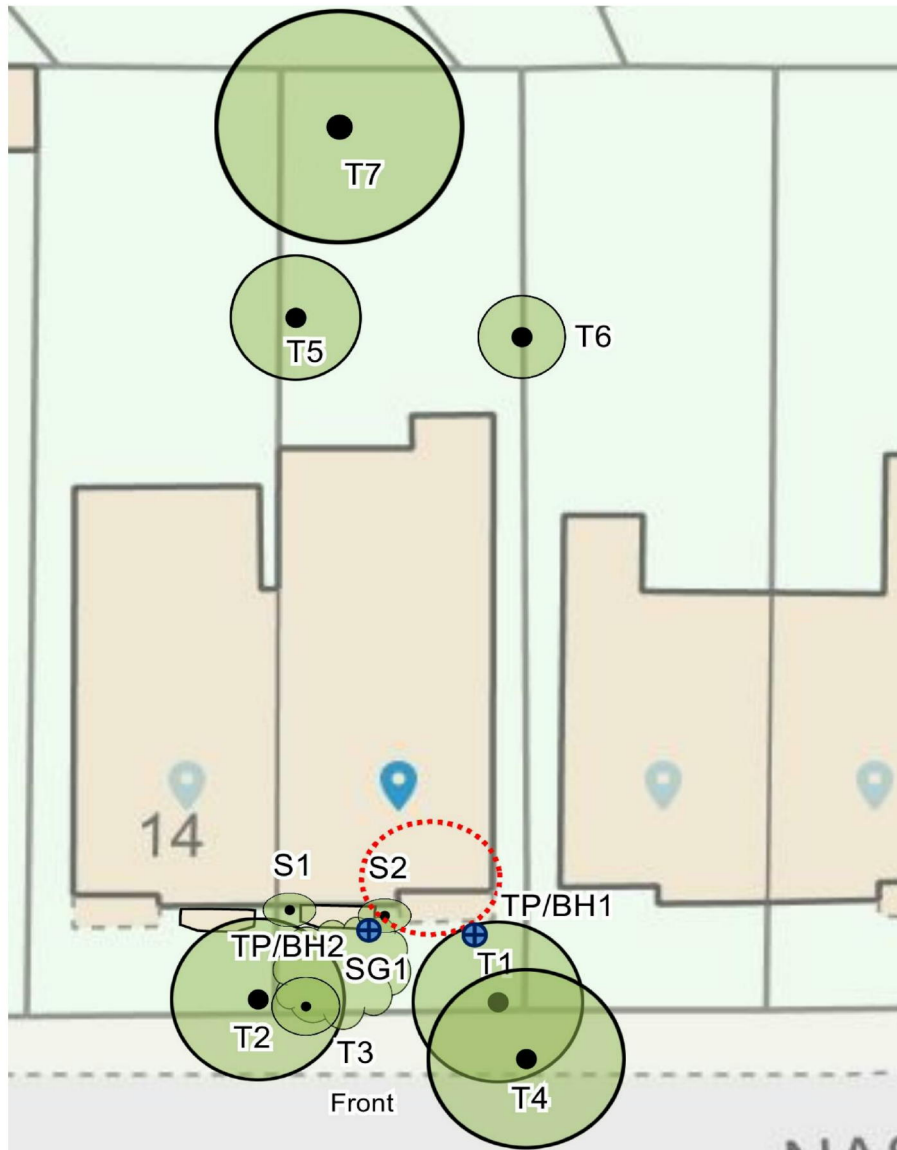
Site Plan

Approximate areas of damage

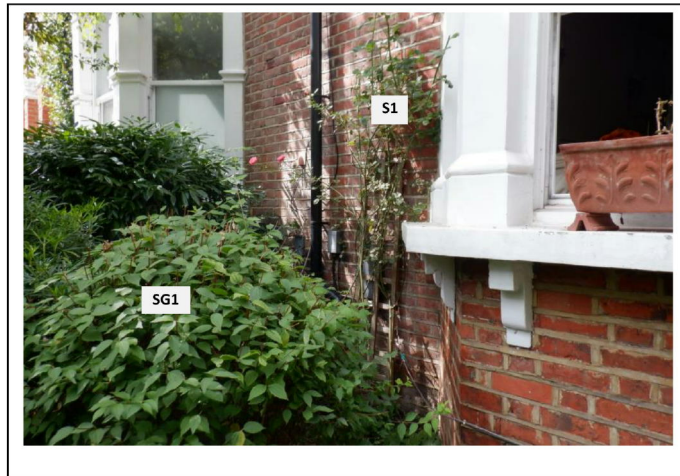
| Tree No. | Species | Ht (m) | Dia (mm) | Crown Spread (m) | Dist. to building (m) | Age Classification | Ownership |
|---|---|---|---|---|---|---|---|
| S1 | Rose | 3.5 | 15 Ms * | 2 | 0.3 | Younger than Property | Policy Holder |

View of S1 & SG1

| Tree No. | Species | Ht (m) | Dia (mm) | Crown Spread (m) | Dist. to building (m) | Age Classification | Ownership |
|---|---|---|---|---|---|---|---|
| Recommendation | | Maintain broadly at no more than current dimensions by periodic pruning. | | | | | |

| Tree No. | Species | Ht (m) | Dia (mm) | Crown Spread (m) | Dist. to building (m) | Age Classification | Ownership |
|---|---|---|---|---|---|---|---|
| Recommendation | | Maintain broadly at no more than current dimensions by periodic pruning. | | | | | |

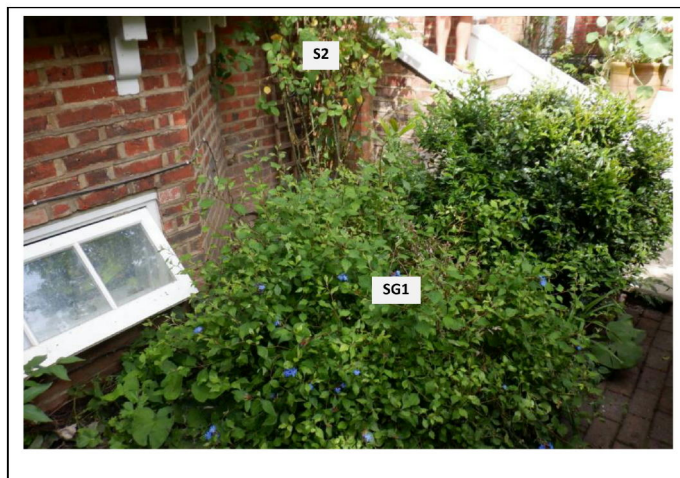
| Tree No. | Species | Ht (m) | Dia (mm) | Crown Spread (m) | Dist. to building (m) | Age Classification | Ownership |
|---|---|---|---|---|---|---|---|
| S2 | Rose | 3.5 | 15 Ms * | 2 | 0.3 | Younger than Property | Policy Holder |

View of S2 & SG1

| Tree No. | Species | Ht (m) | Dia (mm) | Crown Spread (m) | Dist. to building (m) | Age Classification | Ownership |
|---|---|---|---|---|---|---|---|
| Recommendation | | Maintain broadly at no more than current dimensions by periodic pruning. | | | | | |

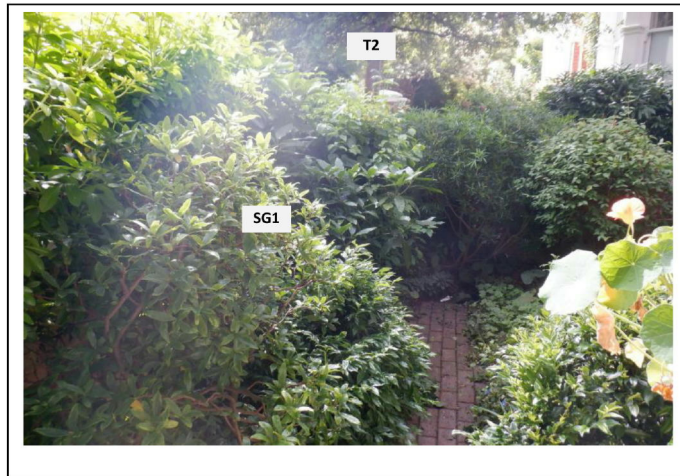
View of SG1 & T2

| Tree No. | Species | Ht (m) | Dia (mm) | Crown Spread (m) | Dist. to building (m) | Age Classification | Ownership |
|---|---|---|---|---|---|---|---|
| Recommendation | | Remove (fell) to near ground level and treat stump to inhibit regrowth. | | | | | |

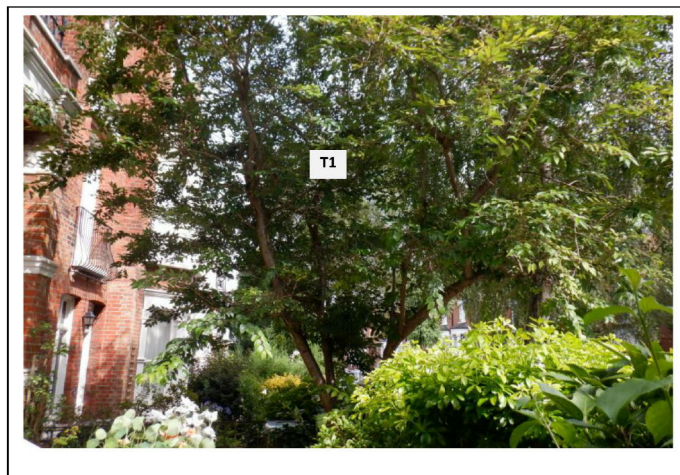
Roots were observed to a depth of 2.7m bgl in TP/BH1 and to a depth of 1.9m in TP/BH2 and recovered samples have been positively identified (using anatomical analysis) as *Prunus* spp., *Betula* spp. and a member of the *Pomoideae* group, the origins of which will be the Cherry (T1), the Birch (T4), the Flowering Crab (T2) and potentially the Rowan (T3) confirming their influence on the soils below the foundations.

| Tree No. | Species | Ht (m) | Dia (mm) | Crown Spread (m) | Dist. to building (m) | Age Classification | Ownership |
|---|---|---|---|---|---|---|---|
| T1 | Cherry | 7.2 | 160 Ms | 6.8 | 3.3 | Younger than Property | Policy Holder |
| Management history | | Subject to past management/pruning - previously crown reduced (regrowth appears 3 yrs age). | | | | | |

View of T1

If an arboricultural solution is to be implemented to mitigate the influence of the implicated trees/vegetation we recommend that the Cherry (T1), the Birch (T4), the Flowering Crab (T2) and the Rowan (T3) are removed. Other vegetation recorded presents a potential future risk to building stability and management is therefore recommended.

| Tree No. | Species | Ht (m) | Dia (mm) | Crown Spread (m) | Dist. to building (m) | Age Classification | Ownership |
|---|---|---|---|---|---|---|---|
| Recommendation | | Remove (fell) to near ground level and treat stump to inhibit regrowth. | | | | | |

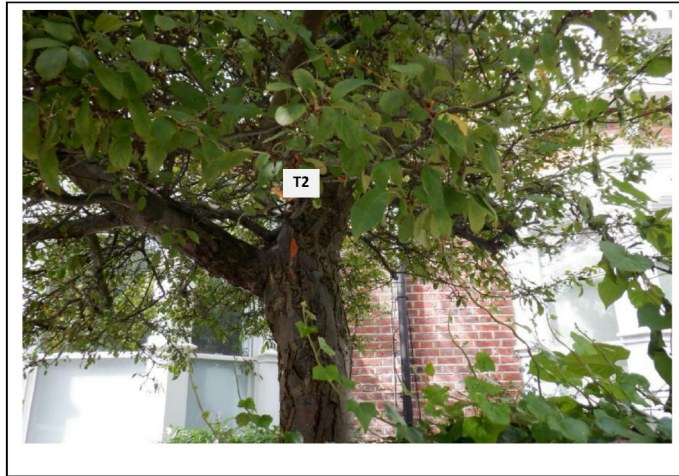
| Tree No. | Species | Ht (m) | Dia (mm) | Crown Spread (m) | Dist. to building (m) | Age Classification | Ownership |
|---|---|---|---|---|---|---|---|
| T2 | Malus sylvestris (flowering crab) | 6.7 | 200 * | 6 | 3.7 | Younger than Property | Third Party<br>14 Nassington Road<br>NW3 2UD |
| Management history | | No significant recent management noted. | | | | | |

View of T2

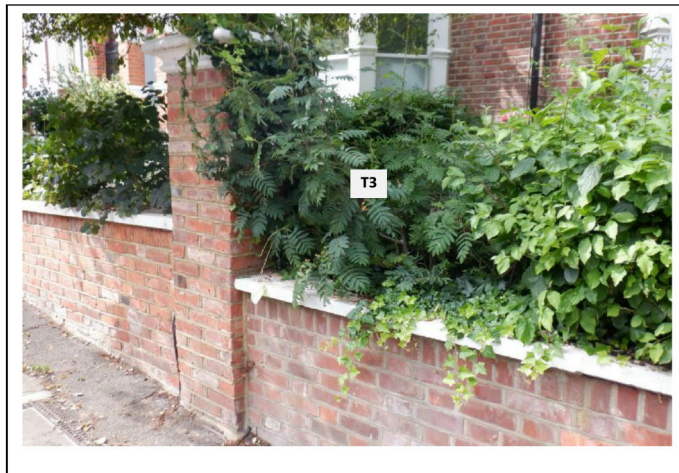
| Tree No. | Species | Ht (m) | Dia (mm) | Crown Spread (m) | Dist. to building (m) | Age Classification | Ownership |
|---|---|---|---|---|---|---|---|
| T3 | Rowan | 2 | 30 Ms * | 1.5 | 3 | Younger than Property | Policy Holder |
| Management history | | Regrowth from large Rowan tree removed at some point between 10/2009 and 06/2012. | | | | | |

View of T3

| Tree No. | Species | Ht (m) | Dia (mm) | Crown Spread (m) | Dist. to building (m) | Age Classification | Ownership |
|---|---|---|---|---|---|---|---|
| Recommendation | | Remove (fell) to near ground level and treat stump to inhibit regrowth. | | | | | |

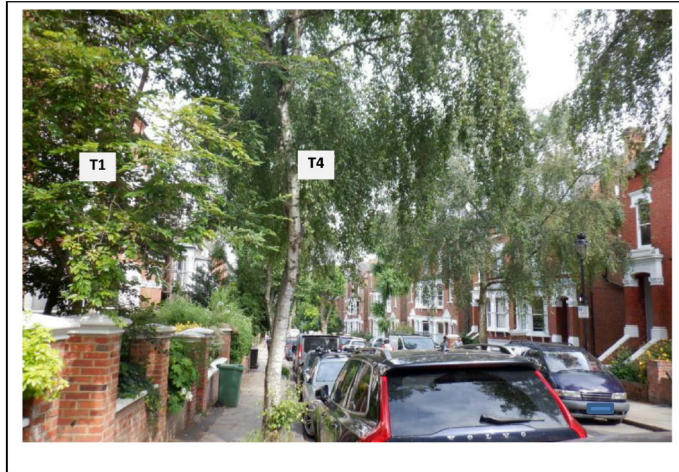
| Tree No. | Species | Ht (m) | Dia (mm) | Crown Spread (m) | Dist. to building (m) | Age Classification | Ownership |
|---|---|---|---|---|---|---|---|
| T4 | Birch | 13.3 | 265 | 7.5 | 5.95 | Younger than Property | Local Authority |
| Management history | | No significant recent management noted. | | | | | |

View of T4

| Tree No. | Species | Ht (m) | Dia (mm) | Crown Spread (m) | Dist. to building (m) | Age Classification | Ownership |
|---|---|---|---|---|---|---|---|
| Recommendation | | Remove (fell) to near ground level and treat stump to inhibit regrowth. | | | | | |

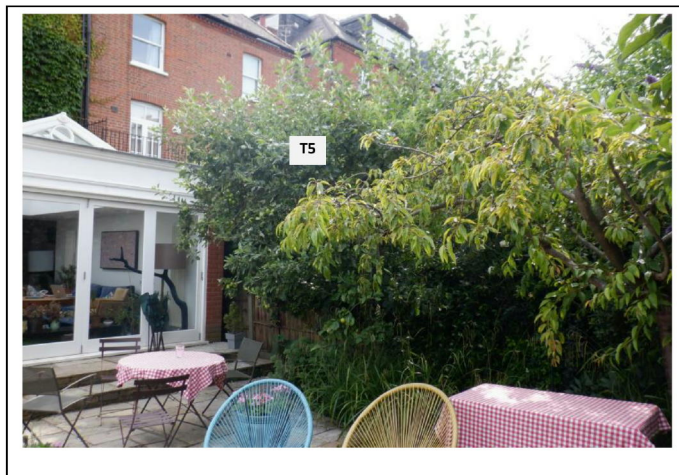
| Tree No. | Species | Ht (m) | Dia (mm) | Crown Spread (m) | Dist. to building (m) | Age Classification | Ownership |
|---|---|---|---|---|---|---|---|
| T5 | Apple | 4 | 225 * | 5 | 3.6 | Younger than Property | Policy Holder |
| Management history | | Subject to past management/pruning - appears regularly pruned. | | | | | |

View of T5

| Tree No. | Species | Ht (m) | Dia (mm) | Crown Spread (m) | Dist. to building (m) | Age Classification | Ownership |
|---|---|---|---|---|---|---|---|
| Recommendation | | Maintain broadly at no more than current dimensions by periodic pruning. | | | | | |

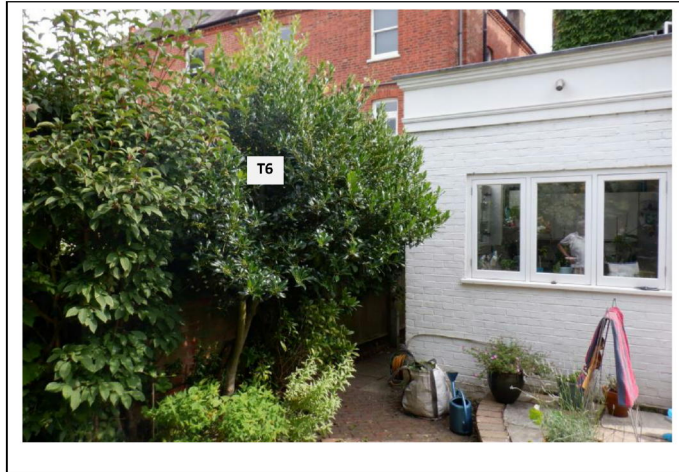
| Tree No. | Species | Ht (m) | Dia (mm) | Crown Spread (m) | Dist. to building (m) | Age Classification | Ownership |
|---|---|---|---|---|---|---|---|
| T6 | Holly | 3 | 80 Ms * | 3.25 | 2 | Younger than Property | Policy Holder |
| Management history | | Subject to past management/pruning - appears regularly pruned. | | | | | |

View of T6

| Tree No. | Species | Ht (m) | Dia (mm) | Crown Spread (m) | Dist. to building (m) | Age Classification | Ownership |
|---|---|---|---|---|---|---|---|
| Recommendation | | Maintain broadly at no more than current dimensions by periodic pruning. | | | | | |

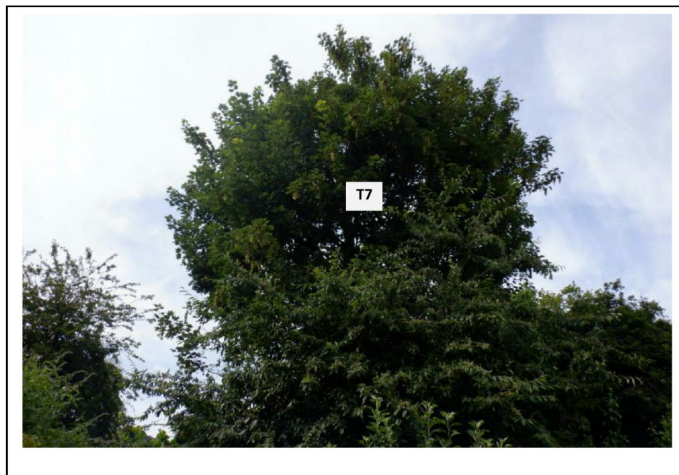
| Tree No. | Species | Ht (m) | Dia (mm) | Crown Spread (m) | Dist. to building (m) | Age Classification | Ownership |
|---|---|---|---|---|---|---|---|
| T7 | Sycamore | 15.5 | 550 Ms * | 12 | 14.5 | Younger than Property | Policy Holder |
| Management history | | Subject to past management/pruning - appears regularly pruned. | | | | | |

View of T7

| Tree No. | Species | Ht (m) | Dia (mm) | Crown Spread (m) | Dist. to building (m) | Age Classification | Ownership |
|---|---|---|---|---|---|---|---|
| Recommendation | | Do not allow to exceed current dimensions. | | | | | |
