TECHNICAL REPORT ON A SUBSIDENCE CLAIM

16 Nassington Road  
Hampstead  
London  
NW3 2UD

SUBSIDENCE CLAIM

14<sup>th</sup> April 2021

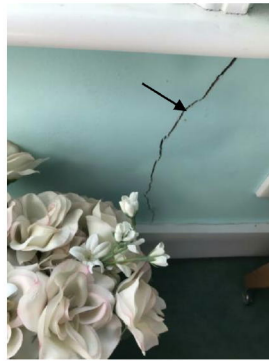
Cracking in bathroom

- Top corner of front elevation window - 2mm.
- Bottom right corner of front elevation window as viewed internally - 3mm.
- High level crack top corner of flank wall window.

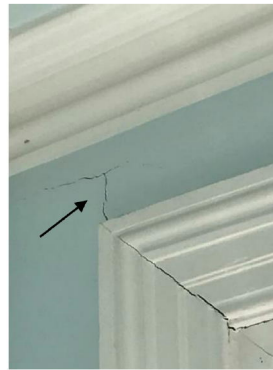
Cracking in bathroom

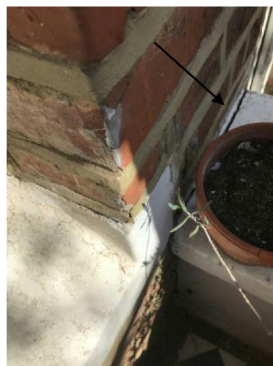
Movement to front steps

- Gap up to 5mm between top of steps and entrance column.
- Underside of balcony. Contractor has replaced some floor timbers and possibly introduced the concrete lintels.
- Window arch under the balcony. Cracking and movement looks old.
- Front door arch - top left corner movement.
- Left side cracking to stonework over first floor right side front elevation window - the room with the balcony.
- First floor bay cracking to high level stonework noted.

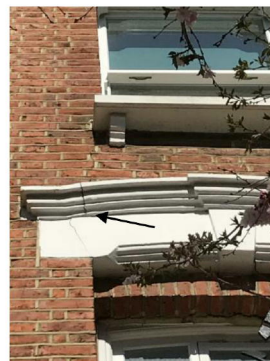
Cracking to front elevation

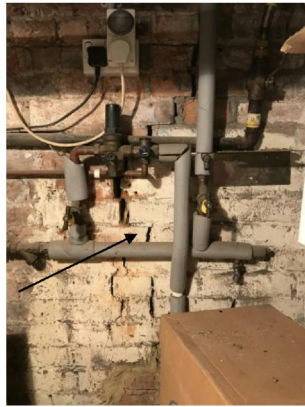
- Front of basement - vertical stepped cracks. This one is directly under front door.
- There is also a crack under window close to front corner.

Cracking in cellar

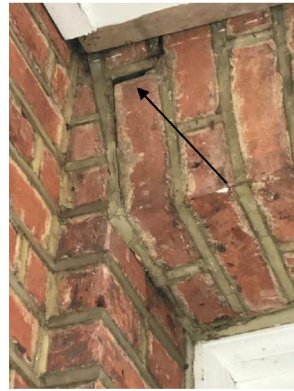
Cracking above front door arch

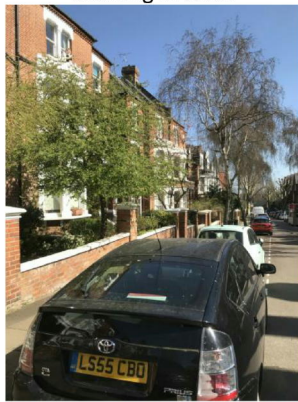
The timing of the event, the presence of shrinkable clay beneath the foundations and the proximity of vegetation where there is damage indicates the shrinkage to be root induced. This is a commonly encountered problem and probably accounts for around 70% of subsidence claims notified to insurers.

View of trees to front of property

Although the cause of the movement needs to be dealt with, in addition to the cherry tree within the front garden of the risk address, we note the potential involvement of a Local Authority tree in the pavement to the front of the property. Unfortunately, they will require certain investigations to be carried out to demonstrate the influence of their vegetation.
