Simon Pryce Arboriculture

Site: Newmount, Lyndhurst Terrace, London, NW3 5QA

Subject: Tree survey, recommendations for work

Inspection date: 30 August 2017

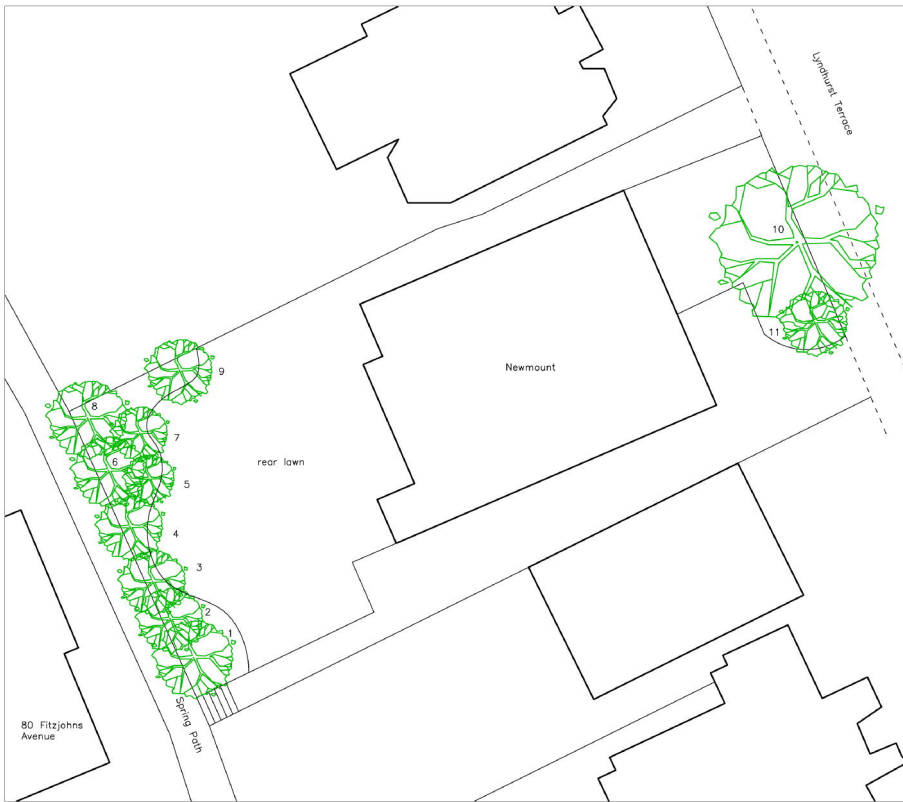
Tree no.	Species	Age / vigour	Ht. m	Dia. mm	Comments and recommendations
The tree locations are shown on the attached site plan					
rear					
1	Norway maple	MA/N	13	220 330 370	One sided due to growing at the end of the row but also one of the more vigorous trees due to receiving more light. There is a narrow fork between the trunks but regular reduction will keep its weight and wind resistance down. Like most of the others it has been reduced about 2 years ago and had side growth over the path shortened. <ul style="list-style-type: none"> Reduce back to former reduction points and trim lower growth to give 5m clearance over the path.
2	Ash	MA/N	13	330	Slightly one sided, but sound and healthy, has also been reduced recently. <ul style="list-style-type: none"> Reduce back to former reduction points and trim lower growth to give 5m clearance over the path.
3	Lime	MA/N	13	330	Similar to the previous trees, slightly drawn up due to growing close the others but not unduly suppressed. <ul style="list-style-type: none"> Reduce back to former reduction points and trim lower growth to give 5m clearance over the path.

4	Hornbeam	MA/N	13	320	Leans over the lawn, but not unduly suppressed and is sound and healthy. <ul style="list-style-type: none"> Reduce back to former reduction points.
5	Ash	MA/N	13	240	Drawn up due to growing among the others, so is becoming suppressed and does not contribute significantly to the group or to the screening effect. Will become increasingly suppressed if retained and removing it would give the other trees more space to develop and improve the group as a whole. <ul style="list-style-type: none"> Fell to thin out the group.
6	Variigated sycamore	MA/N	14	400	Slightly one sided but is a healthy specimen and one of the more dominant trees in the group. <ul style="list-style-type: none"> Reduce back to former reduction points and trim lower growth to give 5m clearance over the path.
7	Hornbeam	MA/N	11	190 160	One sided due to growing among the other trees and leans over the lawn, but is far more shade tolerant than the ash and is not unduly suppressed. <ul style="list-style-type: none"> Reduce back to former reduction points.

8	Ash	MA/N	14	400	Growing at the end of the row, so receives more light than the others, so is one of the larger and more dominant individuals. <ul style="list-style-type: none"> Reduce back to former reduction points and trim lower growth to give 5m clearance over the path.
9	Holly	MA/N	8	130 140	Well established specimen, probably older than the other trees, growing in a raised bed at the side of the garden. Healthy but naturally slow growing. <ul style="list-style-type: none"> No work needed at present.
front					
10	Horse chestnut	M/N	18	750	Large mature tree that probably pre dates the building. The base is heavily covered in ivy but probing that did not reveal any decay or other defects. It has been pollarded at about 5m when younger and possibly recut regularly, but was then left to grow on and develop a natural looking crown. In 2016 it was reduced lightly and side growth growing towards the block was cut back. Regrowth since then has not been very rapid. It is infested with horse chestnut leaf miner, but there are no signs of die back or trunk bleeding which is potentially more serious. <ul style="list-style-type: none"> No work needed at present but is likely to need moderate recutting in future.

Tree no.	Species	Age / vigour	Ht. m	Dia. mm	Comments and recommendations
11	Crab apple	Y/N	6	150	One sided due to growing under the chestnut but is not unduly suppressed. <ul style="list-style-type: none"> No work needed at present
