## Arboricultural Appraisal Report

### Subsidence Damage Investigation at:

134 Abbey Road  
London  
NW6 4SN

| REPORT DATE: | 09/06/2021 |

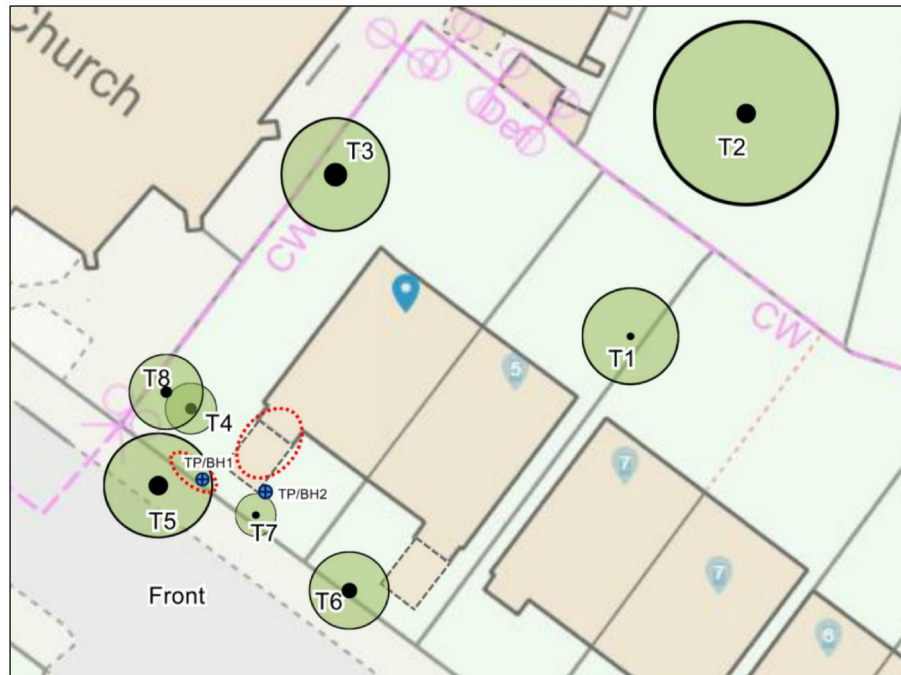
Site Plan

Approximate areas of damage

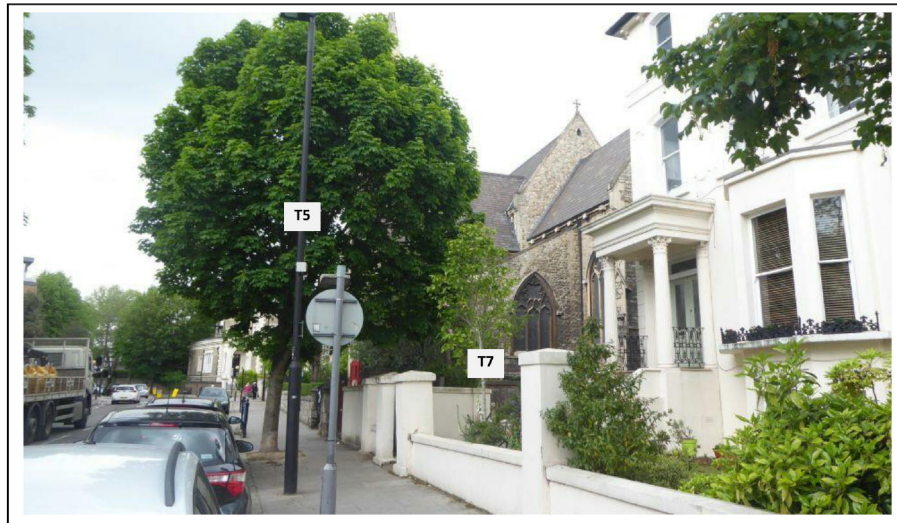
| Tree No. | Species | Ht (m) | Dia (mm) | Crown Spread (m) | Dist. to building (m) | Age Classification | Ownership |
|---|---|---|---|---|---|---|---|
| T5 | Maple | 12.0 | 340 | 9.0 | 5.0 | Younger than Property | Local Authority |

| Tree No. | Species | Ht (m) | Dia (mm) | Crown Spread (m) | Dist. to building (m) | Age Classification | Ownership |
|---|---|---|---|---|---|---|---|
| T7 | Magnolia | 4.5 | 50 | 1.0 | 1.9 | Younger than Property | Policy Holder |

View of T5 Maple and T7 Magnolia

| Tree No. | Species | Ht (m) | Dia (mm) | Crown Spread (m) | Dist. to building (m) | Age Classification | Ownership |
|---|---|---|---|---|---|---|---|
| Recommendation | | Remove (fell) to near ground level and treat stump to inhibit regrowth. | | | | | |

| Tree No. | Species | Ht (m) | Dia (mm) | Crown Spread (m) | Dist. to building (m) | Age Classification | Ownership |
|---|---|---|---|---|---|---|---|
| Recommendation | | Maintain broadly at no more than current dimensions by periodic pruning. | | | | | |

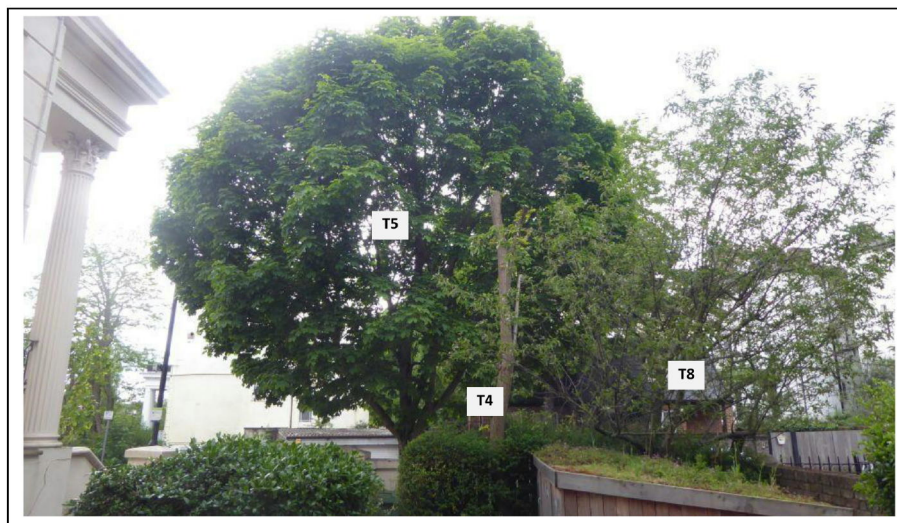
Based on the technical reports currently available, engineering opinion and our own site assessment we conclude the damage is consistent with shrinkage of the clay subsoil related to moisture abstraction by vegetation. Having considered the information currently available, it is our opinion that the combined soil drying effects of T4 False Acacia, T5 Maple and T8 Apple are the cause of the current subsidence damage.

View of T4 False Acacia and T8 Apple, with T5 Maple visible beyond – small understorey shrubs are not considered relevant

If an arboricultural solution is to be implemented to mitigate the influence of the implicated trees/vegetation we recommend that T4 False Acacia and T5 Maple are removed and T8 Apple reduced. Other vegetation recorded presents a potential future risk to building stability and management is therefore recommended. Recommended tree works may be subject to change upon receipt of additional information.

| Tree No. | Species | Ht (m) | Dia (mm) | Crown Spread (m) | Dist. to building (m) | Age Classification | Ownership |
|---|---|---|---|---|---|---|---|
| Recommendation | | Remove (fell) to near ground level and treat stump to inhibit regrowth. | | | | | |
| Recommendation | | Reduce by ~1.5-2.0m leaving balanced crown and prune on biennial cycle to maintain broadly at reduced dimensions. | | | | | |

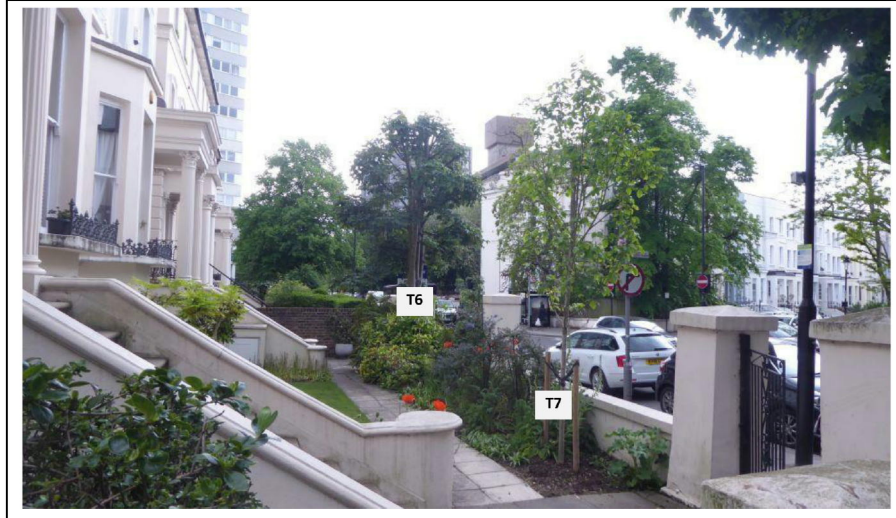
| Tree No. | Species | Ht (m) | Dia (mm) | Crown Spread (m) | Dist. to building (m) | Age Classification | Ownership |
|---|---|---|---|---|---|---|---|
| T6 | Sycamore | 5.5 | 280 | 2.5 | 1.8 [to eastern steps] | Younger than Property | Policy Holder |
| Management history | | Recently reduced/pruned.<br>Future risk to eastern steps. | | | | | |

View of T7 Magnolia with T6 Sycamore visible beyond

| Tree No. | Species | Ht (m) | Dia (mm) | Crown Spread (m) | Dist. to building (m) | Age Classification | Ownership |
|---|---|---|---|---|---|---|---|
| Recommendation | | Remove (fell) to near ground level and treat stump to inhibit regrowth. | | | | | |
