## Site Investigation Report

Job Information	
Client	Crawford & Co - Axa (Subsidence)
Client ref	
Visit date	17/03/2021
Report date	23/03/2021

Auger were commissioned by Crawford & Co - Axa (Subsidence) to undertake a site investigation and CCTV inspection of the underground drainage within the area of concern at the property.

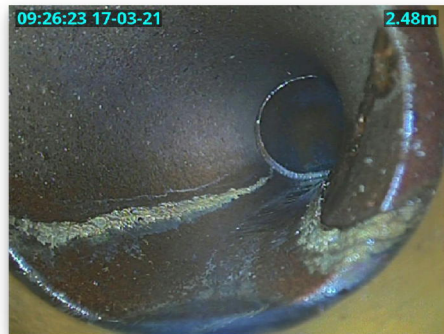
Our CCTV survey revealed Cracking and joint displacements 1.0m upstream from MH1 and directly downstream from WG1, this will be resulting in an escape of water

The above mentioned defects to the below ground drainage system have been caused by ground movement.

Fig 1.1: Line 2, joint displacement

LINE 2			
Direction	Upstream	From	MH1
Pipe Size (mm)	100MM	Depth (m)	2M
Pipe Material	VC	To	WG1
0.0m	Start of Survey Length		
0.1m	Crack - Circumferential		
0.3m	Joint Displacement - Medium		
0.5m	Joint Displacement - Medium

2.5m                      Joint Displacement - Medium  
2.8m                      Finish of Survey Length (WGI)

**Line 2** - Auger recommend to install 1.5m of 100mm liner from MH1 upstream and then to excavate and replace WG1 and 1.0m of 100mm pipework at a depth no greater than 1.0m through decking over concrete. A specialist will be required to reinstate decking

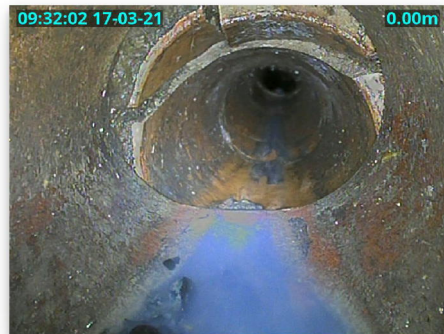
Our CCTV survey revealed Cracking and joint displacements throughout the line downstream to the property boundary, this will be resulting in an escape of water

Fig 1.2: Line 4, displaced interceptor trap

**Line 4** - Auger recommend to excavate and replace 1.0m of 150mm pipework directly downstream from MH1 through the manhole wall then install 5.0m of 150mm flexi liner downstream to the boundary

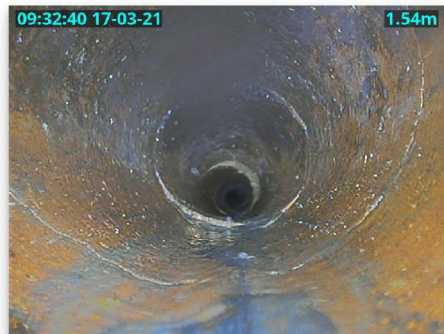
Fig 1.3: Line 4, cracking

0.0m                      Start of Survey Length  
0.1m                      Fracture - Multiple  
0.8m                      Crack - Circumferential  
1.5m                      Crack - Circumferential  
2.3m                      Open Joint - Medium  
3.3m                      Fracture - Circumferential  
10.5m                      Finish of Survey Length (LWA)

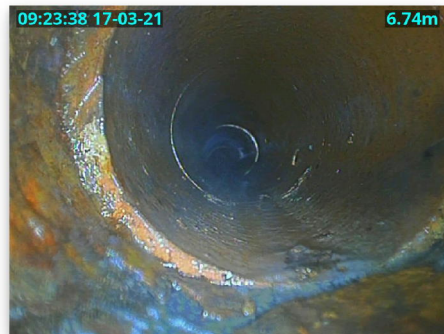
Our CCTV survey revealed Cracking and joint displacements 6.7m and 8.1m upstream, this will be resulting in an escape of water

Fig 1.4: Line 1, cracking

LINE 1			
Direction	Upstream	From	MH1
Pipe Size (mm)	150MM	Depth (m)	2M
Pipe Material	CI	To	MH2
0.0m	Start of Survey Length		
6.7m	Material Change (VC )		
6.7m	Dimension of Sewer Changes		
6.7m	Dimension of Sewer Changes		
8.2m	Crack - Circumferential		
8.6m	Finish of Survey Length (MH2)

**Line 1** - Auger recommend to install 100mm patches 6.7m and 8.1m upstream from MH2
