Site Investigation Report

Client	Crawford & Co - Axa (Subsidence)
Client ref	
Visit date	21/12/2020
Report date	13/01/2021

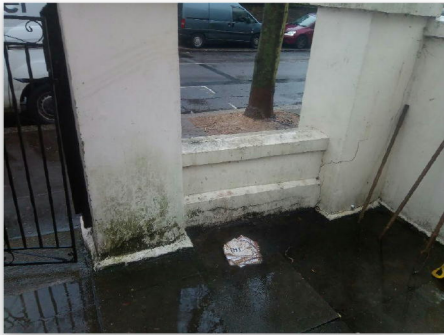
Trial Hole 1 & 2	
Fig 1.1: Trial Hole 1 Location	Fig 1.2: Trial Hole 1 Footing

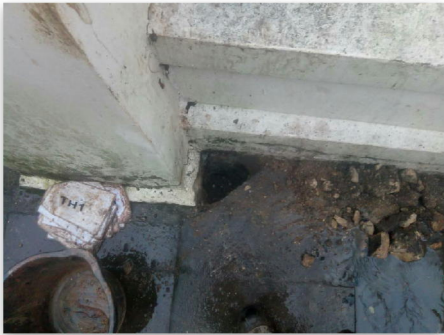
Trial Hole Log No.1

Moist stiff Brown silty sandy fine to medium gravelly CLAY	66kpa		Soil @ 0.5m	Root @ 0.5m
1.0

Moist stiff Brown fine gravelly sandy silty CLAY	74kpa		Soil @ 1m	Root @ 1m
1.5

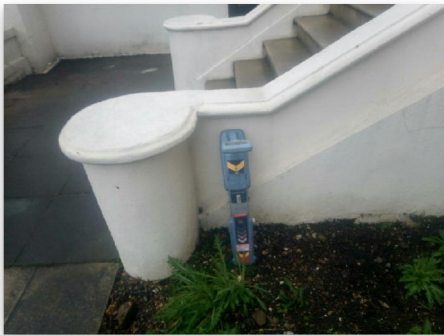
Fig 1.3: Trial Hole 2 Location	Fig 1.4: Trial Hole 2 Footing

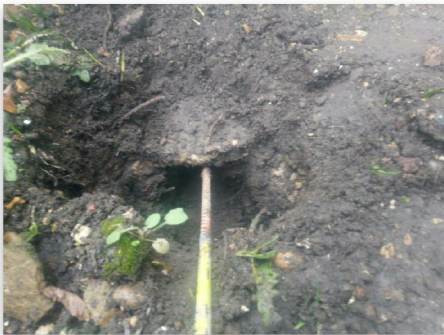
Trial Hole Log No.2

Depth (m)	Symbolic Log	Strata Description	Insitu Tests		Soil Sample	Root Sample
			SV(19)			
0.0		Ground Level Brickwork Soil (Border) Concrete				
0.5		Moist light Brown fine to medium gravelly silty CLAY	20kpa		Soil @ 0.4m	Root @ 0.4m
1.0			60kpa		Soil @ 0.9m	Root @ 0.7m
1.5			60kpa		Soil @ 1.4m	
2.0		Dry stiff Brown sandy fine to medium gravelly silty CLAY	100kpa		Soil @ 1.9m	Root @ 1.9m
2.5			110kpa		Soil @ 2.4m	
3.0		TRIAL HOLE TERMINATED	110kpa 110kpa		Soil @ 2.9m	
3.5

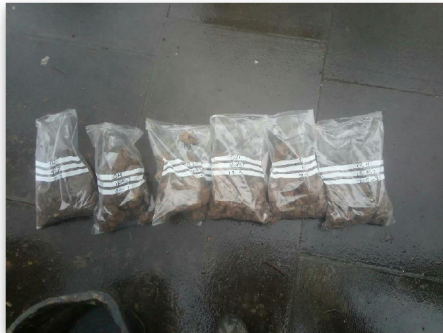
Fig 2.3: Soil samples collected

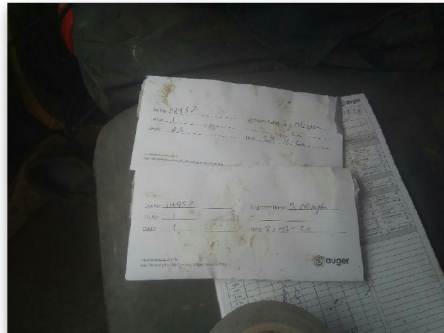
Fig 2.4: Root samples collected

TH1, 0.4m		
1 no.	Examined root: ACER (Maples, Sycamores).	Alive, recently*.
TH1, 0.7m		
3 no.	Examined root: could well be an herbaceous (non-woody) plant.	Alive, recently*.
TH1, 1.9m		
2 no.	Examined root: very THIN. We cannot rule out ACER (Maples, Sycamores).	Dead* (note this 'dead' result can be unreliable with such thin samples).
3 no.	Unfortunately all with insufficient cells for identification.

TH1, 0.5m		
7 no.	Examined root: ACER (Maples, Sycamores).	Alive, recently* .
TH1, 1.0m		
2 no.	Examined root: ACER (Maples, Sycamores).	Alive, recently* .
2 no.	Examined root: the family LEGUMINOSAE (a group of closely related trees: Robinia (False Acacia), Laburnum, Sophora (Pagoda tree), Gleditsia (Honey Locust), Cercis (Judas tree/Redbud), Albizia (Silk tree), Acacia (Mimosa), as well as such shrubs as Wisteria, Lupins, Gorse and Brooms).	Alive, recently* .
