20105/JO

19 October 2020
[REDACTED]

REF: 2 FELLOWS ROAD. FRONT GARDEN WALL. NORTH.

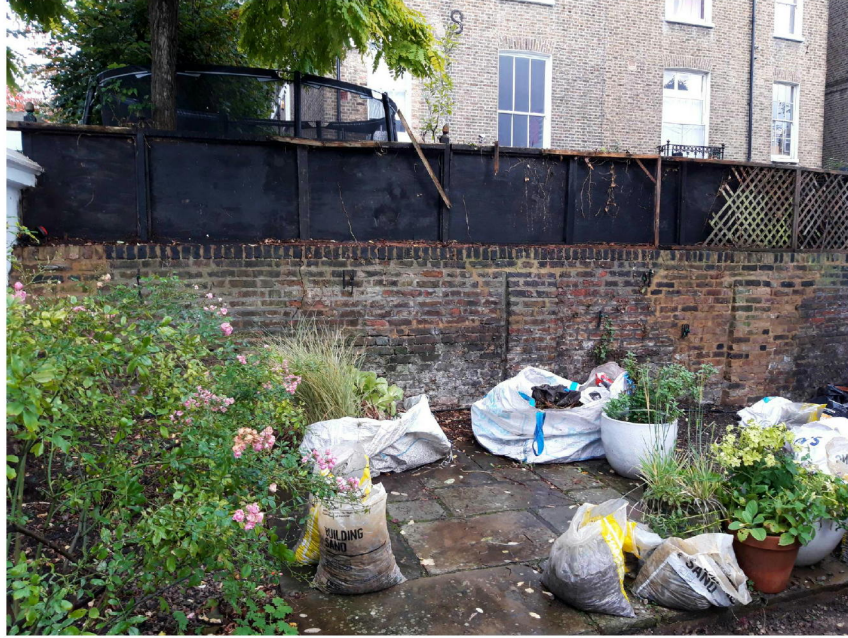
General distortion in the wall is long-standing and not new. I estimate it is out of plumb by as much as 100mm. The general impression is of the base of the wall leaning slightly and the top half both bulging out and undulating in plan.

General view facing wall

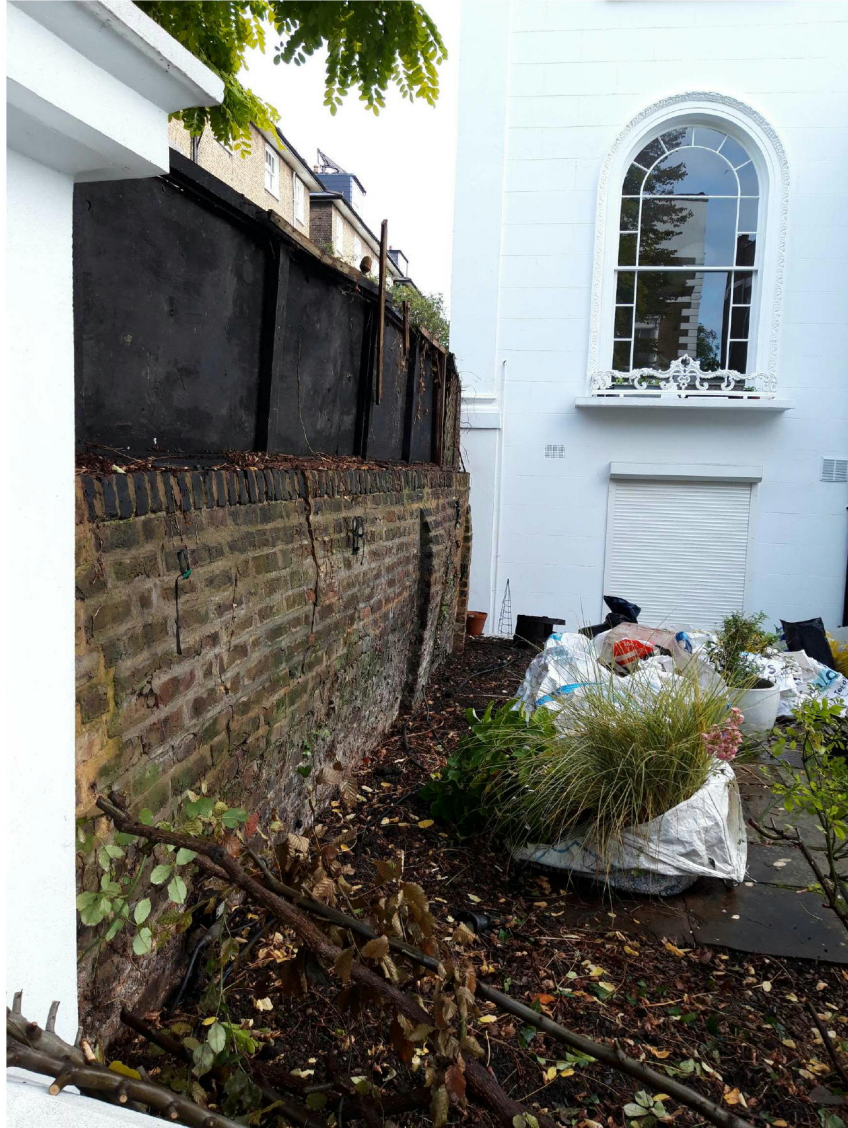
General view along wall

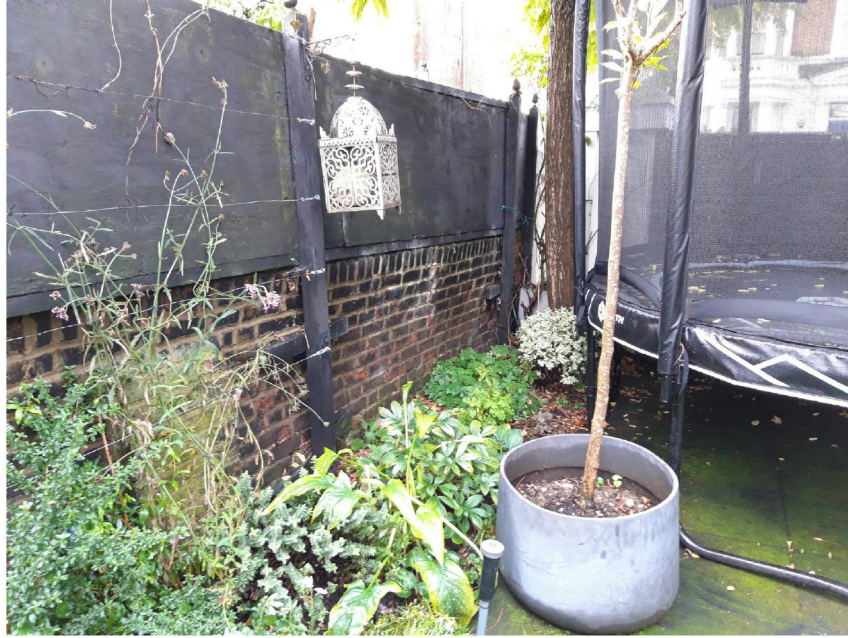
Near the Ash tree there are recent cracks indicating that movement here is related to the presence of the tree. Cracks are diagonal and vertical. The wall leans away from your site in the immediate vicinity of the tree.

The Ash tree is very close to the wall and the roots are certain to pass under the wall foundation. Water will be taken from the soil by the tree as it grows, and this will differ in volume during the wet and dry seasons. There will be a consequential expansion and shrinkage in the soil and we believe these seasonal changes are causing damage to the wall near the tree. We do not see this changing if the tree remains in place.

View of rear of wall behind Ash tree.

Where the wall is cracked near the tree , the brickwork will need to be rebuilt. If cracks remain ties can be added to strengthen the wall locally.
