Refurbishment Survey for
JG Construction London Ltd
at
Flat 1
27 Maresfield Gardens
London
NW3 5SD

Project Number: J017620

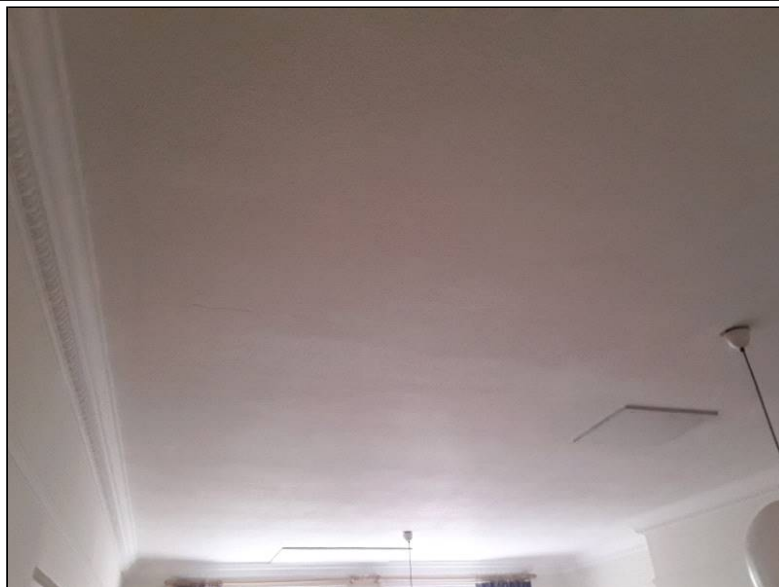
Non Asbestos Textured Coating to ceiling

No further action required

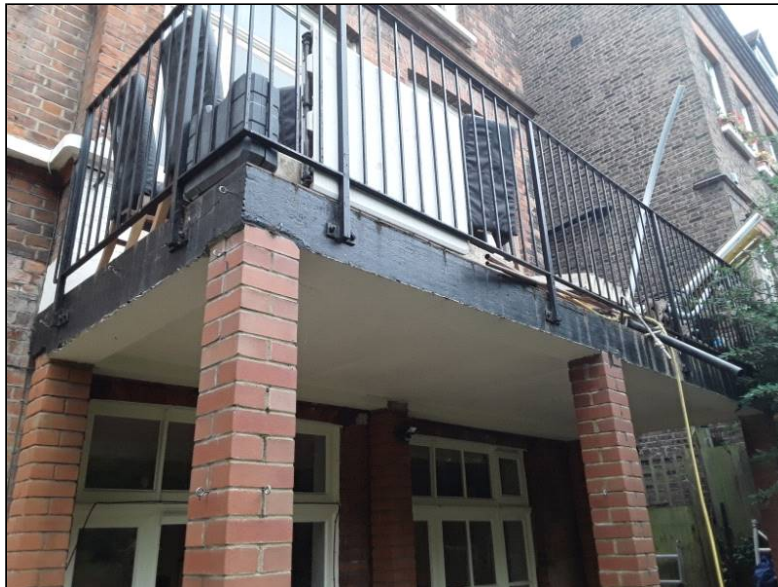
Non Asbestos Bitumen coating to upstand around canopy

No further action required

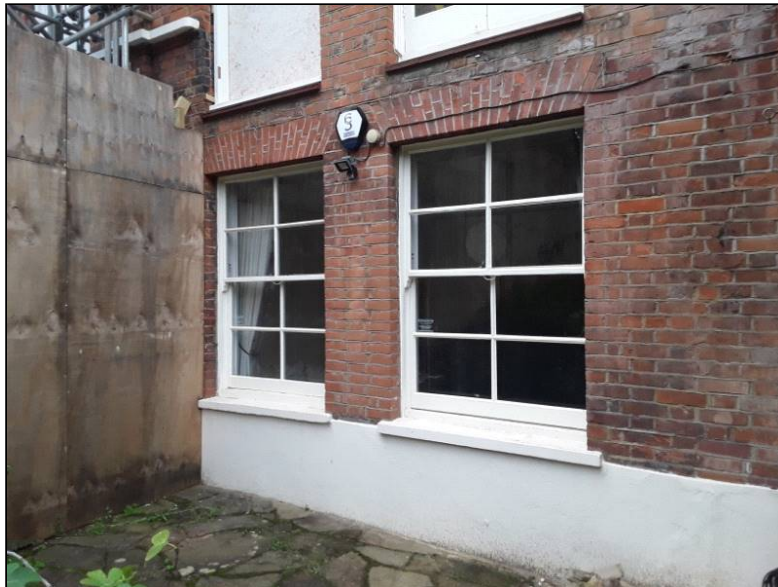
Material Comments:	Non Asbestos Putty to windowss & door
--------------------	---------------------------------------

Action:	No further action required
---------	----------------------------
