EXISTING CONDITION
SECOND FLOOR WINDOW (W2-01)

PROPOSED DRAWINGS
SECOND FLOOR WINDOW REPLACEMENT

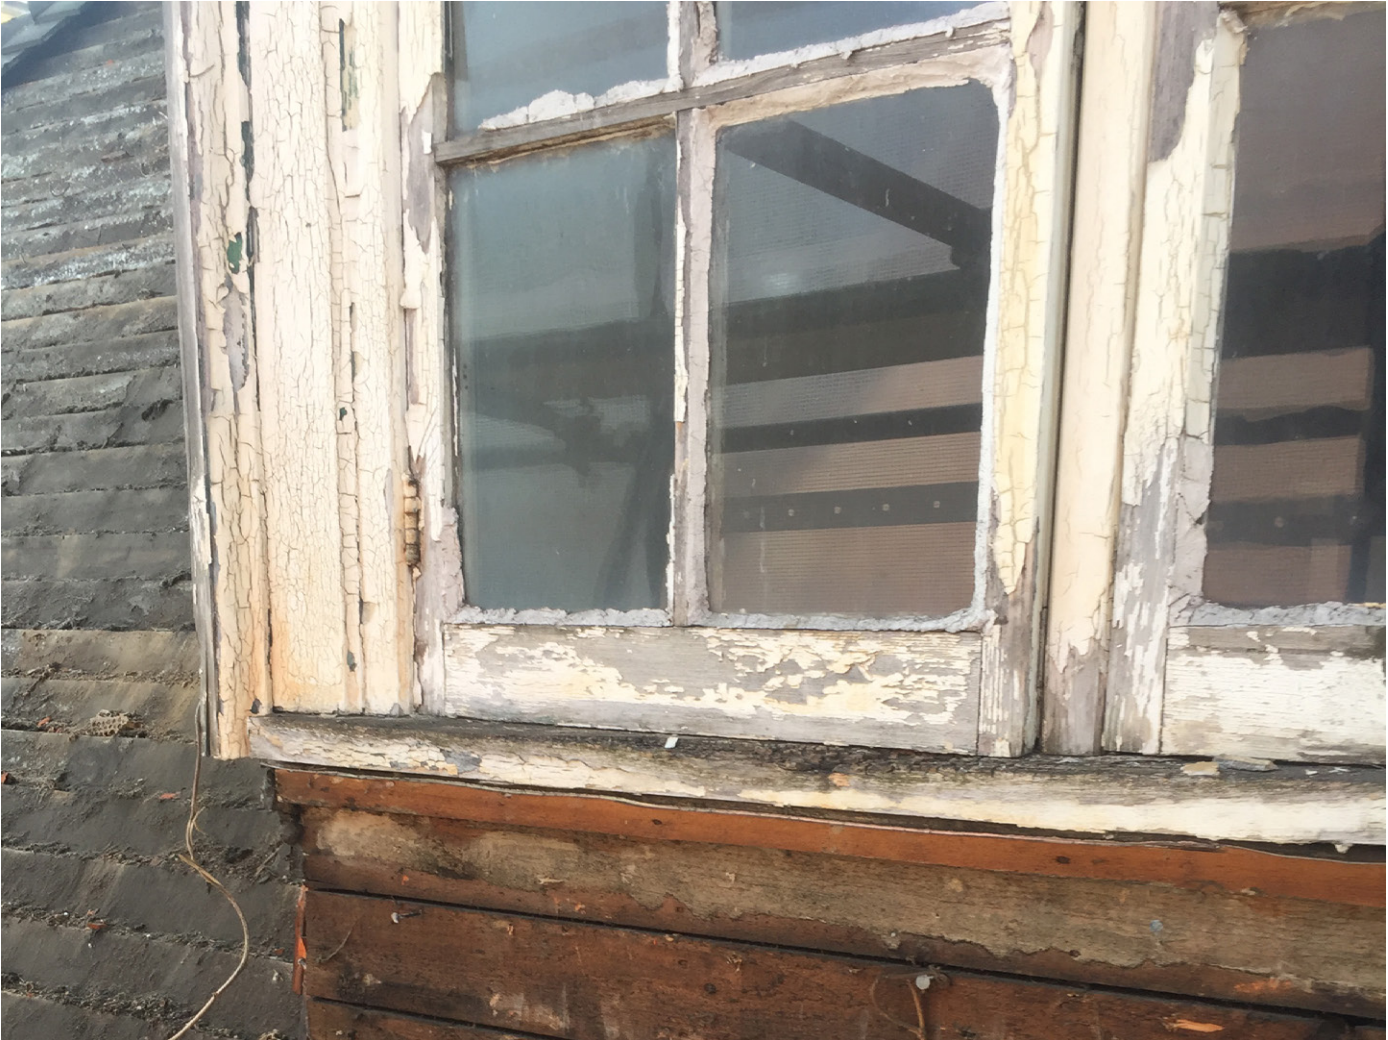
The existing condition of the side-hung timber casement window to the north-east elevation on the second floor is in a state of disrepair with rot present to the sills as shown in the adjacent picture

A window specialist subcontractor had been appointed to carry out survey works to all the existing windows on April 2020 in order to propose remedial works required. The casement windows as highlighted below, including W2-01 required replacement in its entirety due to major deterioration.

Existing timber casement window condition

‘The windows in the worst condition are certainly the casement windows, we recommend these are replaced in their entirety as the casement sashes and sills have deteriorated, these windows are externally fitted so scaffold access would be required.’

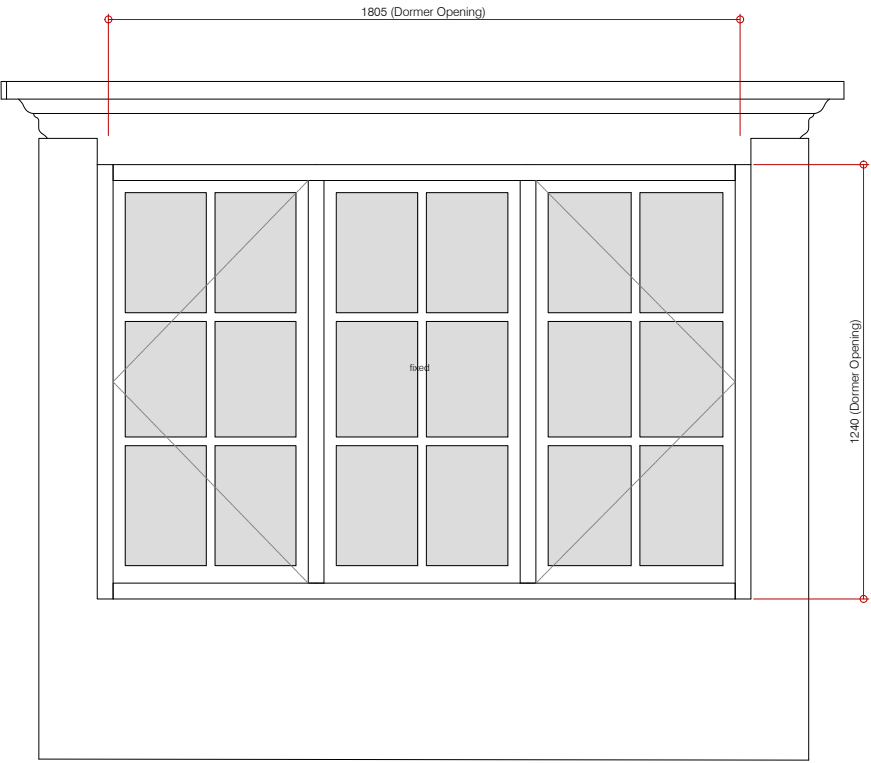
Proposed Window W2-01
Second Floor
Elevation

Adjacent drawings depict the proposed window to replace the existing one which is aged and damaged beyond repair.

- Windows frames to be hardwood timber and painted to match existing. External grade paint application to be applied to all new windows. Contractor to provide sample finishes of both Spray and Brush finish applications for final approval by Kyson & Client. Finishes and profile to match existing. Use Slimlite 12mm double glazed units.
- Where new window openings are created, contractor to provide sample and template to be approved by Kyson before order and installation.
- Ironmongery is proposed to be in Bronze finish.
- All windows and doors to have sensors linked to the building alarm system. It is recommended that the zoning of the alarm system is floor by floor.
- All sash and casement windows external pane to be laminated and fitted with key operated locks.
