Arboricultural Appraisal Report

Subsidence Damage Investigation at:

151 Gloucester Avenue
London
NW1 8LA

CLIENT:	Crawford & Company
CLIENT REF:	<div style="background-color: black; width: 150px; height: 20px;"></div>
MWA REF:	
MWA CONSULTANT:	Giles Mercer (BSc Hons)
REPORT DATE:	11/02/2020

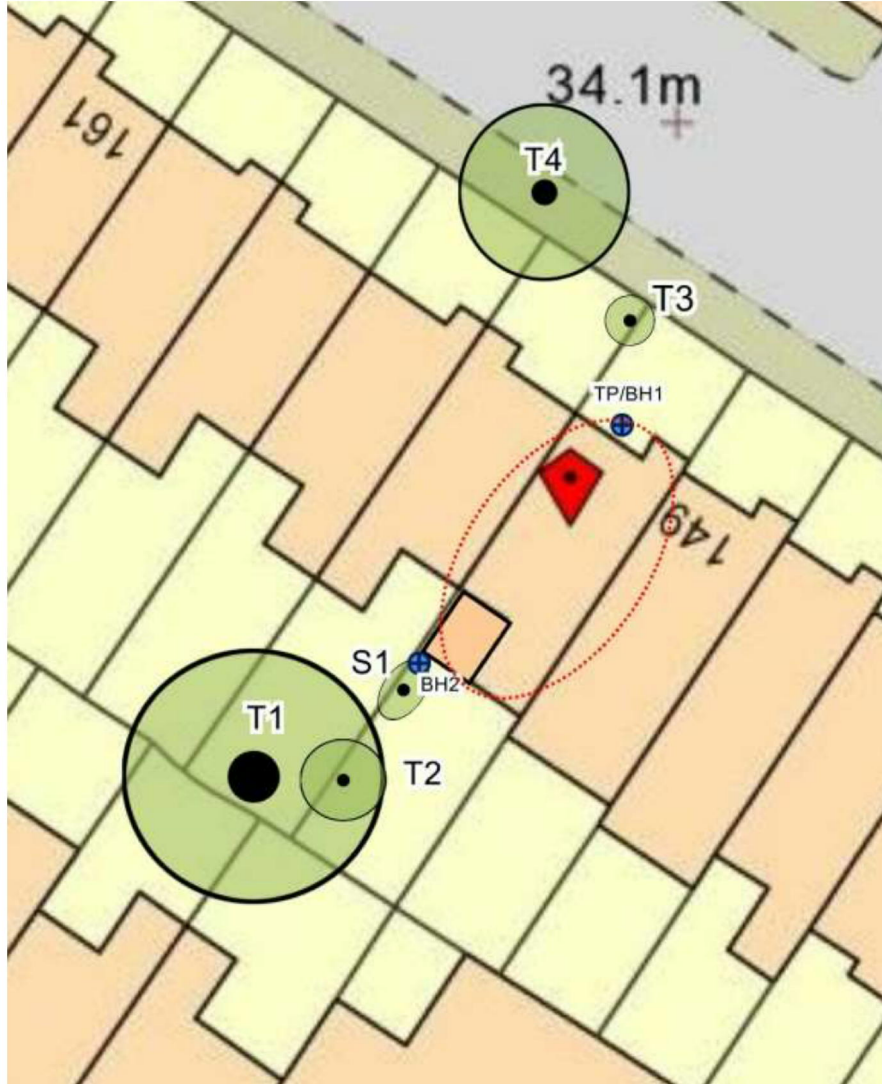
Site Plan

Approximate areas of damage

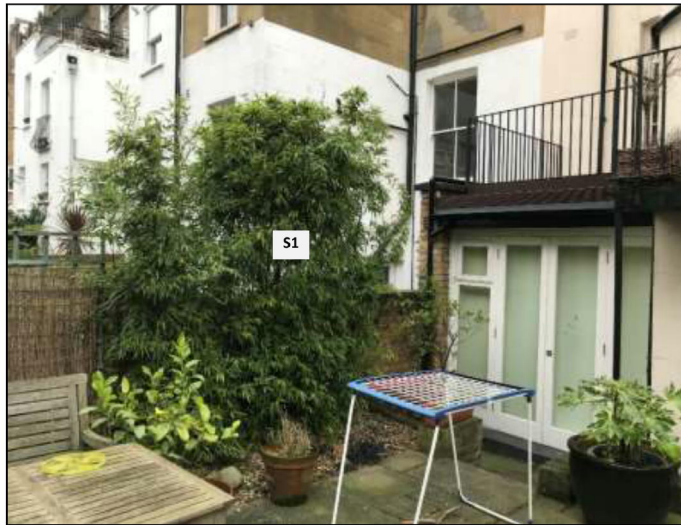
View of S1

Roots were observed to a depth of 1.6m bgl in BH1 and to a depth of 3.1m in BH2 and recovered samples have been positively identified (using anatomical analysis) as *Platanus* spp. (BH1 & BH2) and *Monocotyledon* spp. (BH2), the origin of which will be the Plane trees (T1 & T4) and the Bamboo (S1) confirming their influence on the soils below the foundations.

Based on the technical reports currently available, engineering opinion and our own site assessment we conclude the damage is consistent with shrinkage of the clay subsoil related to moisture abstraction by vegetation. Having considered the information currently available, it is our opinion that the Plane trees (T1 & T4) are the principal cause of or are materially contributing to the current subsidence damage with a secondary influence from the bamboo (S1).

If an arboricultural solution is to be implemented to mitigate the influence of the implicated trees/vegetation we recommend that the Plane trees (T1 & T4) and the Bamboo (S1) are removed. Other vegetation recorded presents a potential future risk to building stability and management is therefore recommended.
