TECHNICAL REPORT ON A SUBSIDENCE CLAIM

**151 Gloucester Avenue
London
NW1 8LA**

DATE 13th November 2018

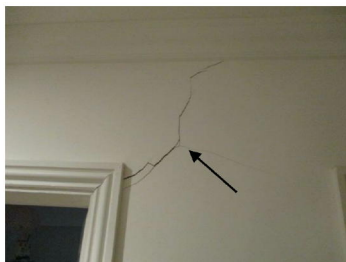
Cracking in basement hallway

Basement Hall - 5mm diagonal crack above rear right hand bedroom door, 3mm diagonal crack above front bedroom door, cracking to ceiling.

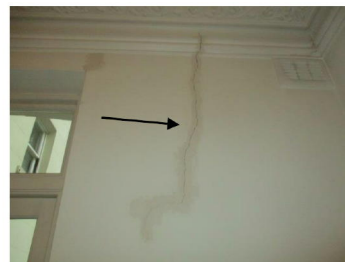
Cracking in ground floor dining room

Dining Room - 3mm vertical tapering crack to right hand side of French doors, cracking to coving.

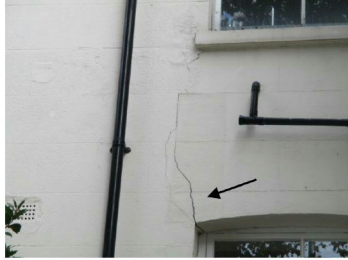
Cracking to rear elevation

Rear Elevation - 6mm vertical tapering cracking above both sides of French doors to terrace, 1mm vertical crack through cill to basement bedroom window, 1mm diagonal crack to left hand side of basement bedroom window, 1mm vertical crack above left hand side of door to kitchen.

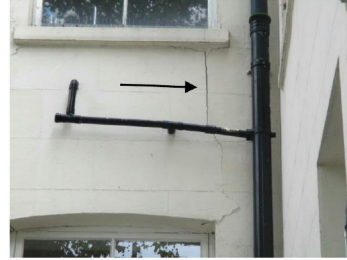
Cracking to rear elevation

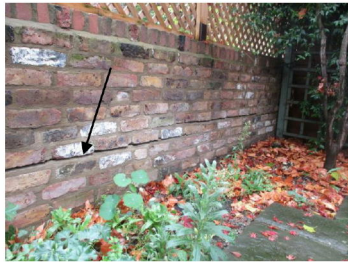
Left Hand Rear Boundary Wall - 17mm horizontal tapering crack at low level along length of wall.

Cracking to rear left hand boundary wall

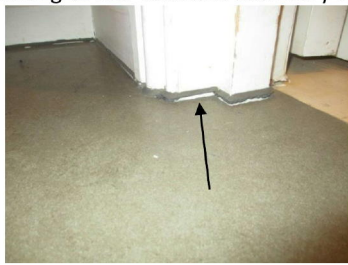
Hallway - Floor has dropped by front door and around into dining room area, front door is out of alignment and lock is difficult to operate, 2mm horizontal crack above left hand side of front door.

View of movement to floor in ground floor hall

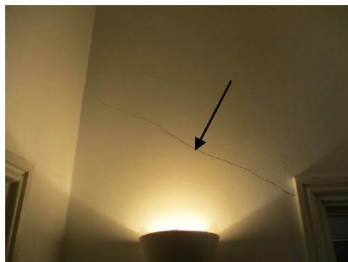
Upper Maisonette - Hall, Stairs and Landing - Cracking to ceiling in entrance section, 2mm diagonal crack above door to lounge, 1mm diagonal crack to right hand party wall, wall / ceiling junction cracking on half landings to rear wall, 3mm vertical crack above front bedroom door, historic distortions noted to stairs.

Cracking in upper flat hallway

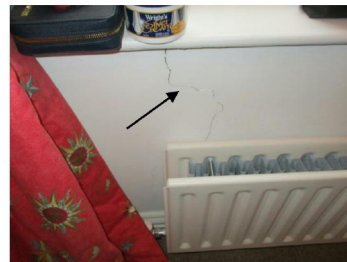
Rear Study - 2mm diagonal crack below window, 1mm diagonal crack above left hand side of hatch, cracking to ceiling, hairline diagonal crack above right hand side of window, coving / wall junction cracking along front elevation, 3mm vertical crack down door frame.

Cracking in upper flat rear study

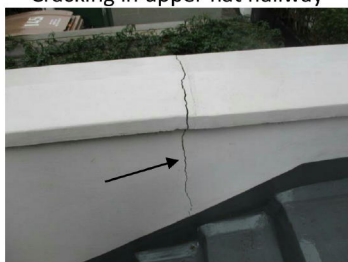
Front Left Hand Boundary Wall - 4mm and 2mm vertical cracks on landing section.

Cracking to front left hand steps boundary wall

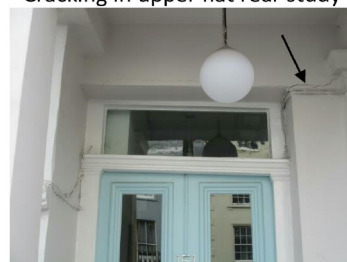
Front Elevation - 3mm horizontal crack above right hand side of front door, significant historic distortion noted to front door frame.

At the time of our visit some significant historic distortions were noted to be affecting predominantly the main front door area and the internal staircases particularly at upper level. These distortions appear to be longstanding and the rectification of these would fall outside of the scope of this claim.

View of historic distortion and recent cracking above front door
