ADDENDUM TECHNICAL REPORT

151 Gloucester Avenue  
London  
NW1 8LA

SUBSIDENCE CLAIM

DATE 29 March 2021

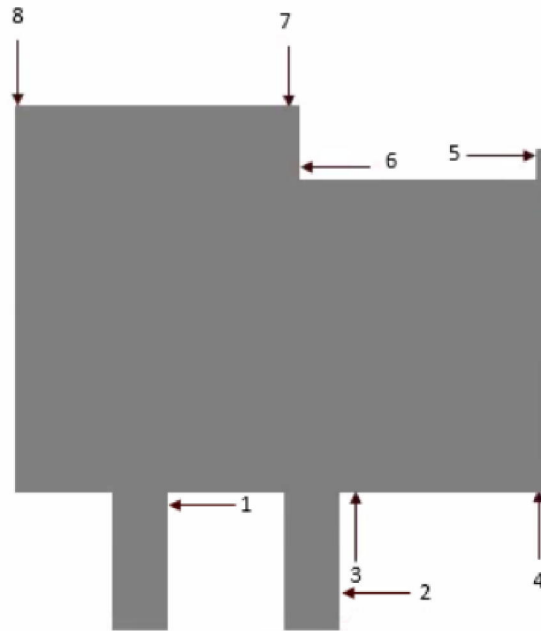
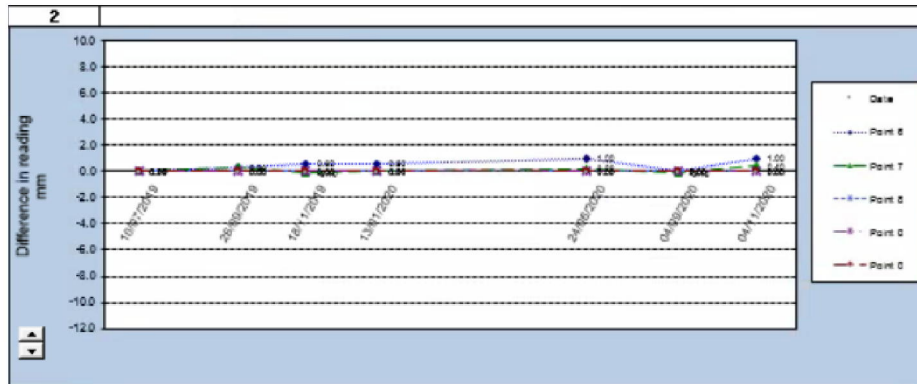
Level monitoring has been completed over the period from July 2019 to November 2020. Over this period, on point 5 to the rear, upward movement has been recorded over the winter months of 2019/2020 followed by downward movement over the summer months of 2020. This seasonal movement confirms a clay shrinkage mechanism. No other type of movement produces these results.

- Level monitoring on point 5 at the rear of the property indicates seasonal cyclical movement with downward movement in the summer months (as the clay shrinks) and upward movement in the winter months (as the clay swells).
