**TITLE: Advanced Arboricultural  
Assessment:**

*1no. False Acacia at 98 Priory Road,  
London, NW6 3NT.*

**DATE:** 17<sup>th</sup> May 2021

**REF:** HWA10154.01

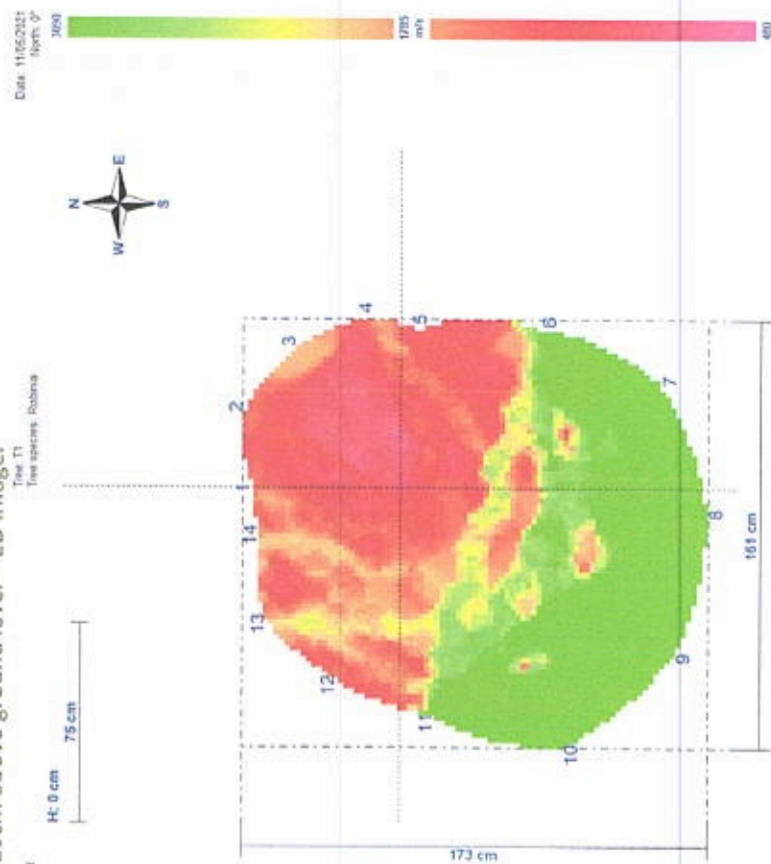
Impulse tomography test of stem at 120cm above ground level – 2D image.

Impulse tomography indicates a large volume of decay altered wood in the northern half of the stem.

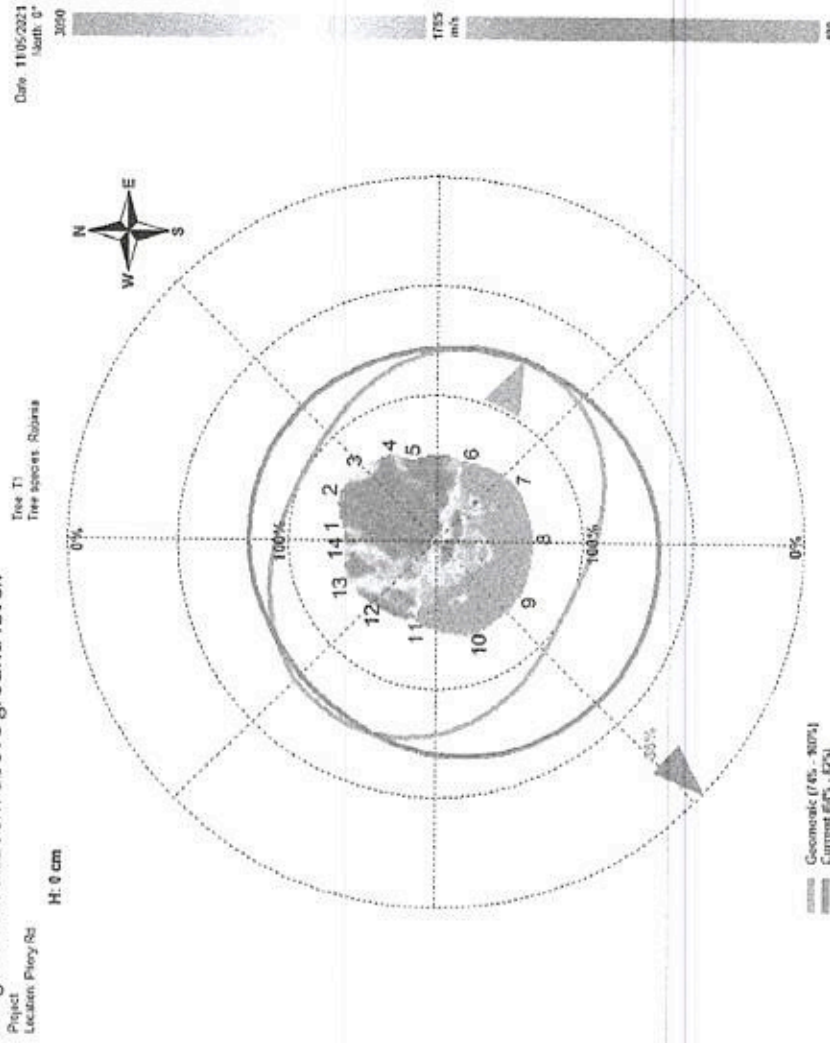
Calculated Mechanical Strength Loss at 120cm above ground level.

- 6.1 T1 is a veteran tree with significant cultural, amenity and environmental value located in a prominent location.
- 6.2 T1 is located in a high-risk zone, within falling distance of a high occupancy area (public highway and footpath).
- 6.3 Sonic tomography indicates a 36% strength loss at the level of the top of the wall (approximately 1.2m), which is significant.
- 6.4 Recent crown reduction works will have reduced the likelihood of catastrophic failure due to wind load and/or storm events, however given the level of decay and its location, it is considered that an unacceptable risk still exists.

The calculated mechanical strength loss resulting from the anticipated decay at 120cm above ground level is 36%; which is significant.

Tree number	Species	Recommended works in relation to Structural condition	Time scale
T1	False Acacia (Robinia Pseudoacacia)	<b>OPTION 1</b> Fell to at or near ground level, grind out resultant stump and plant a replacement.	Within 12 months
		<b>OPTION 2</b> Undertake heavy reduction (to extent shown on Photo 3, Appendix C) and maintain at reduced dimensions by pruning to at or near previous pruning points every third year.	Within 3 months
		Undertake repeat tomograph test in 24 months time to measure extent of decay.	May 2023

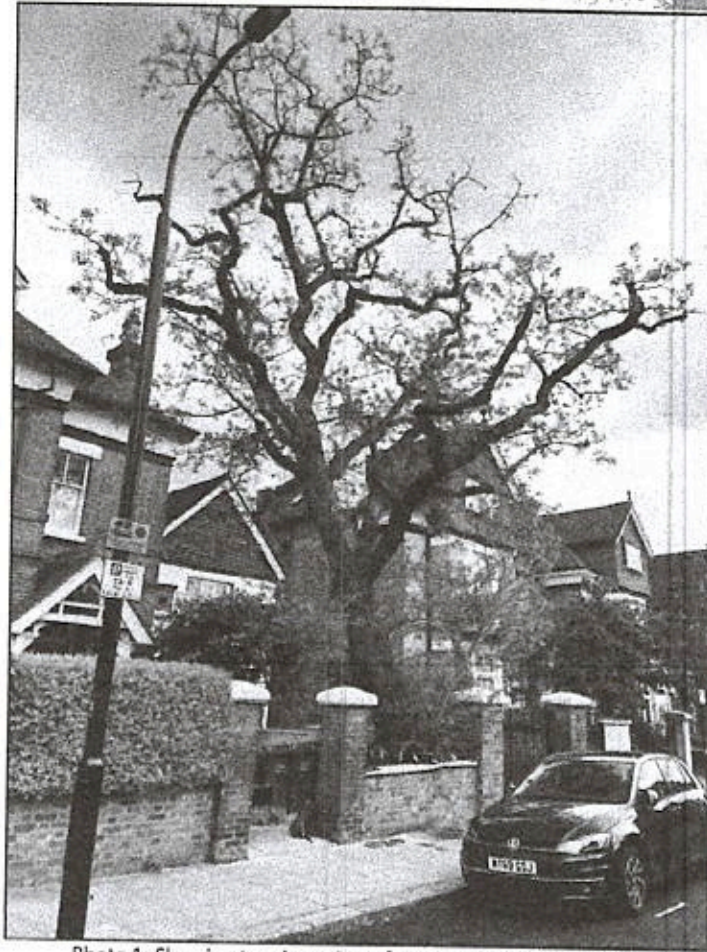
Photo 1: Showing tree in entirety from North western aspect.

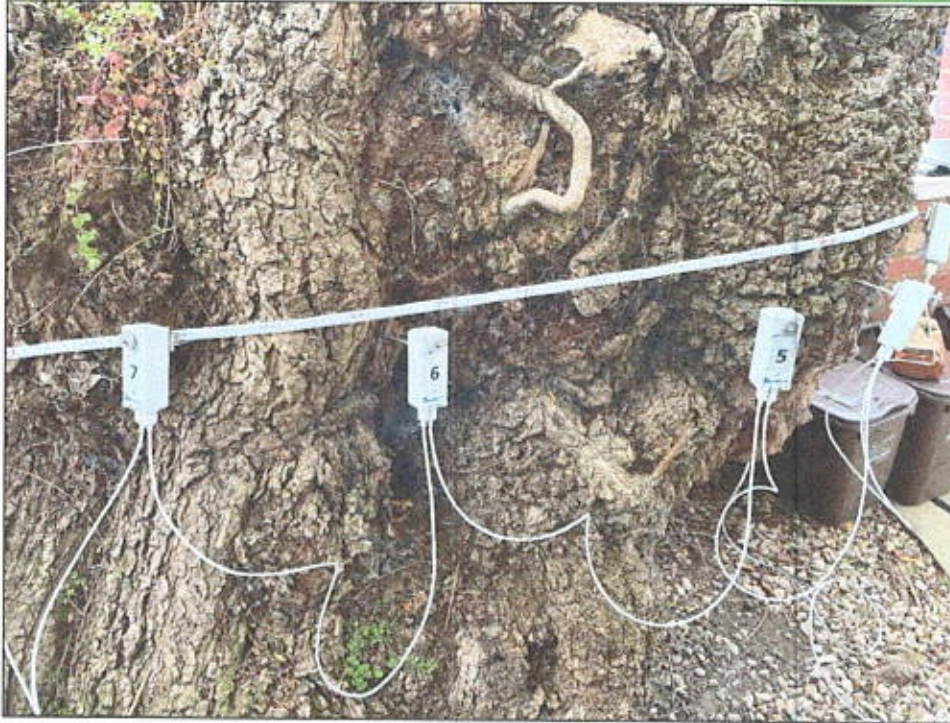
Photo 2: Showing area of necrosis (note adventitious rooting)

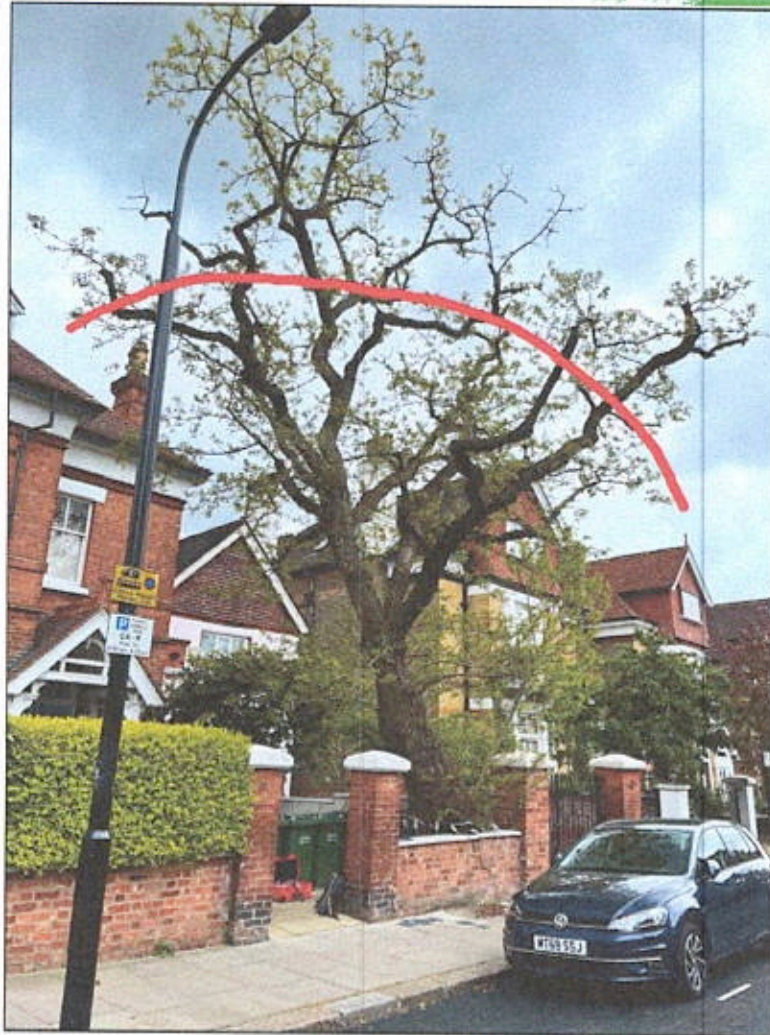
Photo 3: Edited to show potential pruning points to reduce likelihood of failure.
