## STATEMENT OF HISTORICAL SIGNIFICANCE

**33 GLOUCESTER CRESCENT  
LONDON  
NW1 7DL**

Date: 19th November 2021 – Rev. 1

## Masonry repairs @ 33 Gloucester Crescent London NW1 7DL

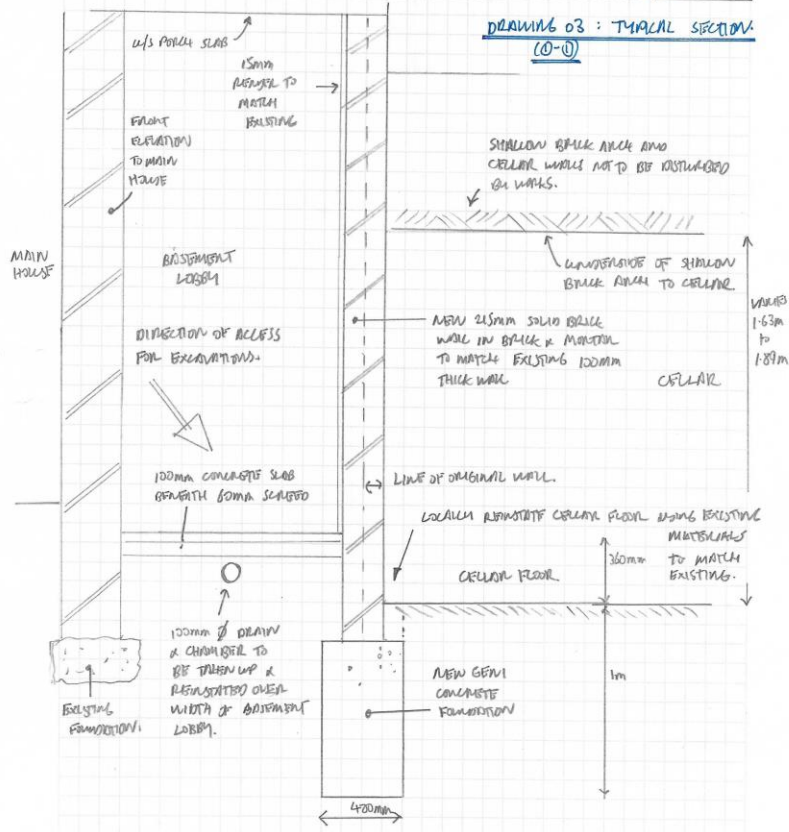
Figure 1 - Underpinning to front Porch

The subsidence to the porch is associated with a downward movement of the front of the structure. This has allowed the front columns and side walls to rotate forward leading to outwardly tapering crack developing between the porch and main house and a substantial slope on the porch floor to the front. The outwardly tapering cracks reach 10mm in width at the junction of the porch and the party wall and approximately 20mm to the right side of the porch with the main house.

There is 2mm horizontal cracking to the right porch column. At the right junction between the porch and main house there is a 10mm diagonal crack at the junction, and the parapet wall to the flat roof above has moved laterally approximately 20mm away from the front elevation.

Overall, the damage to the porch is quite severe and conforms to Category 4 of table 1 of BRE Digest 251. The extent of movement is such that the porch is no longer structurally connected to the main house and that there are excessive distortions to the right column and side wall and the porch floor.

In view of the excessive cracking and distortion to the porch and difficulties in repairing such a fragile structure in-situ, appropriate remedial works would comprise reconstructing a slender half brick wall with a one brick thick wall capable of supporting the loads on a concrete base and underpinning a section of the party wall. The party wall within the porch will be stabilised and structurally tied back to the house, but not reconstructed.

It is proposed to locally underpin the party wall with a traditional concrete base 1m below the cellar wall.

The single skin front wall to the basement lobby to be replaced with a one brick thick wall in matching brickwork and mortar. The existing opening to be replicated in new wall with a lintel to match existing.

- Reconstruct a slender half brick thick wall with a one brick thick wall on a new foundation to adequately support the loads.
- Locally underpin party wall.
- Implement temp works to the party wall porch column to ensure stability during taking down works.
- Upon completion of the masonry repairs the wall will be repainted as existing.
