# Site Investigation Report

Job Information	
Client	Crawford & Co
Client ref	
Visit date	26/08/2021
Report date	01/09/2021

Overview	
Brief	Auger were commissioned by Crawford & Co to undertake a site investigation and CCTV inspection of the underground drainage within the area of concern at the property.
Findings	
Drain Survey	<p><b>Line 1 - From WG1 downstream to MH1</b> Our CCTV survey revealed joint displacements and root ingress, in addition we would like to note WG1 appears to be half recessed, meaning half of the gully is exposed the other half is situated under the property steps (refer to the images below)</p> <p><b>Line 2 - From WG1 upstream to Unknown</b> Our CCTV survey was abandoned less than 1m upstream due to encountering mass root ingress. We unsuccessfully attempted to clear these roots, hence the end location of the pipe is unknown. However we do believe that the rainwater downpipe that serves the customer and the neighbour is the final destination of line 2. This will not be determined until our further investigations.</p> <p>The above mentioned defects to the below ground drainage system have been caused by ground movement.</p>

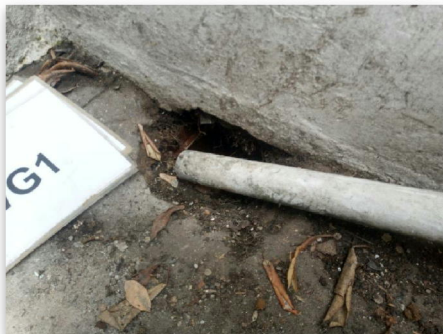
Fig 7.1: WG1, that is half recessed

Recommendations	
	<p>It is recommended that the following repairs are carried out to prevent an escape of water from the system:</p> <p>On line 1, excavate and replace WG1 and 1m of 100 mm pipework at a depth no greater than 1m through thick concrete.</p> <p>This will require tunnelling under the building in order to make a connection to the existing pipework. In the event this option fails due to unforeseen complications, then excavation through the steps is the alternative solution which will involve extensive and costly works to ensure the property is returned to its original condition.</p> <p>From the above excavation install up to 3m of 100mm flexi-liner downstream to the main line</p> <p>On line 2, excavate and replace less than 1m of 100mm pipework upstream from WG1 at a depth less than 1m through thick concrete. From the open excavation carry out extensive root cutting.</p> <p>It will then be necessary to CCTV survey line 2 to check for any further issues. Please note that the further CCTV investigation may reveal additional defects to the drainage system. This will be reported whilst on-site and could potentially cause an increase in repair costs and provide further inconvenience to the customer/occupants.</p> <p><b>We will now refer back to the client in order to progress the claim.</b></p>

The above recommendations allow for the replacement of gullies & connected underground drainage only. The insured should be made aware that the aesthetic appearance of this gully may be different from what is currently in place.

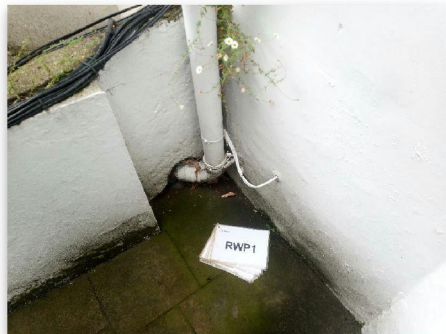
Fig 7.2: RWP1 that deviates off property then we believes loops around and connects into WG1
