ARBORICULTURAL EXPERT REPORT

128 Haverstock Hill, London NW3 2AY

17 November 2021

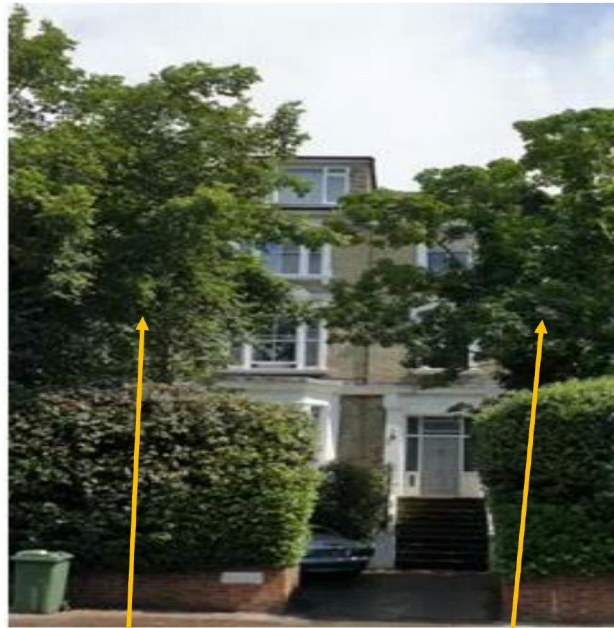
At 7m and 8m distance respectively, roots from Sycamore T1 and Lime T2 would be capable of extending beneath the foundations of the damaged building and causing soil drying to occur, see below.

- **Movement** - Damage was first noticed in July 2021, at a time of year when soil moisture deficits due to tree root activity would be reaching their peak. The area and pattern of movement is consistent with the location of Sycamore T1 and Lime which are by far the most significant items of vegetation nearby.

- **Roots** – Roots were recovered from TP/BH1 and the roots sent for identification and were confirmed as emanating from Lime (3 samples), recently alive. Maple/Sycamore and Lime species can commonly root moderately deeply in clay soils and extend for considerable distances from the parent tree, see below. There do not appear to be any other likely sources of Lime roots nearby.

- Similarly, Maple/Sycamore species have been recorded as causing damage at distances up to 20m with 90% of cases where the tree was within 12m, therefore Sycamore T1, at a distance of only 7m is also capable of rooting and causing soil drying beneath foundations, despite the lack of root identification from the limited sampling exercise that is BH1.

Lime T2

Sycamore T1

The cause of the movement needs to be dealt with first. From the results of the Subsidence Consultant's diagnosis of the damage and the geological factors, we recommend removal of Sycamore T1 and Lime T2. The resulting stumps treated with a herbicide (e.g. Glyphosate Eco-Plugs") to prevent regrowth occurring. Based on our analysis, we are satisfied there is no adverse heave risk to the risk address.

T1 Sycamore	Remove (fell) to near ground level and treat stump to prevent regrowth
T2 Lime	Remove (fell) to near ground level and treat stump to prevent regrowth
Insured	Conservation Area
