Site Investigation Report

Job Information	
Client	Crawford & Co
Client ref	
Visit date	07/06/2021
Report date	11/06/2021

Auger were commissioned by Crawford & Co to undertake a site investigation and CCTV inspection of the underground drainage within the area of concern at the property.

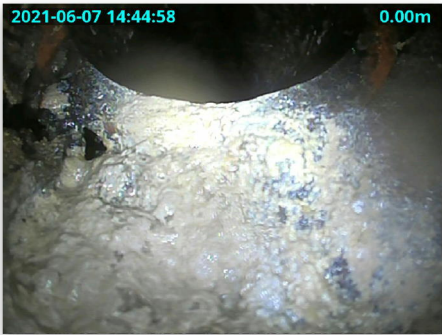
We were unable to survey this line due to the tight restricted access, entrance into the manhole will be required to survey this line

Fig 2.1: Line 1, pipework at higher level than channelling

Line 1 - Auger recommend to attempt to survey from within MH1. Assess condition of channelling and benching within MH

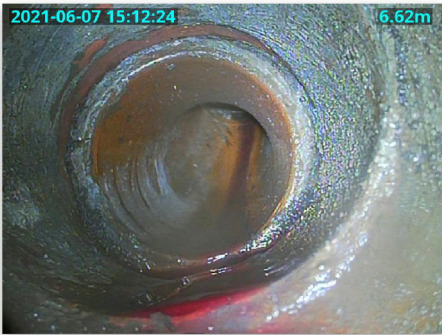
Our CCTV survey revealed joint displacements throughout the line and large displacements directly downstream from the gully, this will be resulting in an escape of water.

Fig 2.2: Line 2, joint displacement

Line 2 - Auger recommend to excavate and replace SWG1 and 2.0m of 100mm pipework at a depth no greater than 1.0m through tiles over concrete then install 7.0m of 100mm flexi liner downstream to MH1

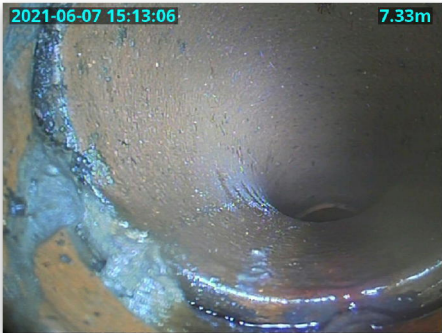
Fig 2.3: Line 2, joint displacement

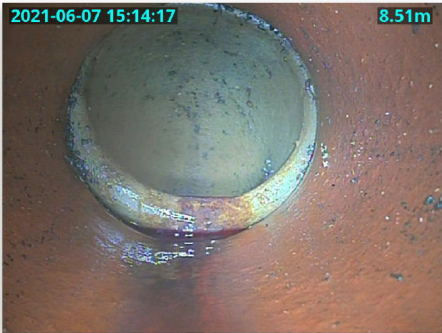
Fig 2.4: Line 2, joint displacement

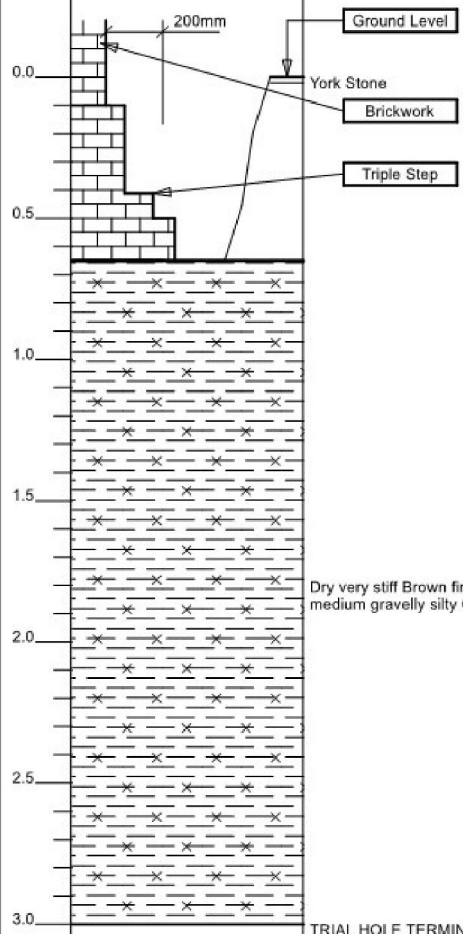
Trial Hole Log No.1

Ground Level				
		York Stone				
		Brickwork				
		Triple Step				
0.5						
			140kpa		Soil @ 0.65m	Root @ 0.65m
1.0			140kpa		Soil @ 1.15m	Root @ 1.15m
1.5			140kpa		Soil @ 1.65m	
2.0		Dry very stiff Brown fine to medium gravelly silty CLAY	140kpa		Soil @ 2.15m	
2.5			140kpa		Soil @ 2.65m	
3.0		TRIAL HOLE TERMINATED	140kpa		Soil @ 3m
