## Arboricultural Appraisal Report

### Subsidence Damage Investigation at:

1 Mornington Crescent  
London  
NW1 7RH

CLIENT:	Crawford & Company
CLIENT REF:	[REDACTED]
MWA REF:	[REDACTED]
MWA CONSULTANT:	Andy Clark
REPORT DATE:	08/10/2021

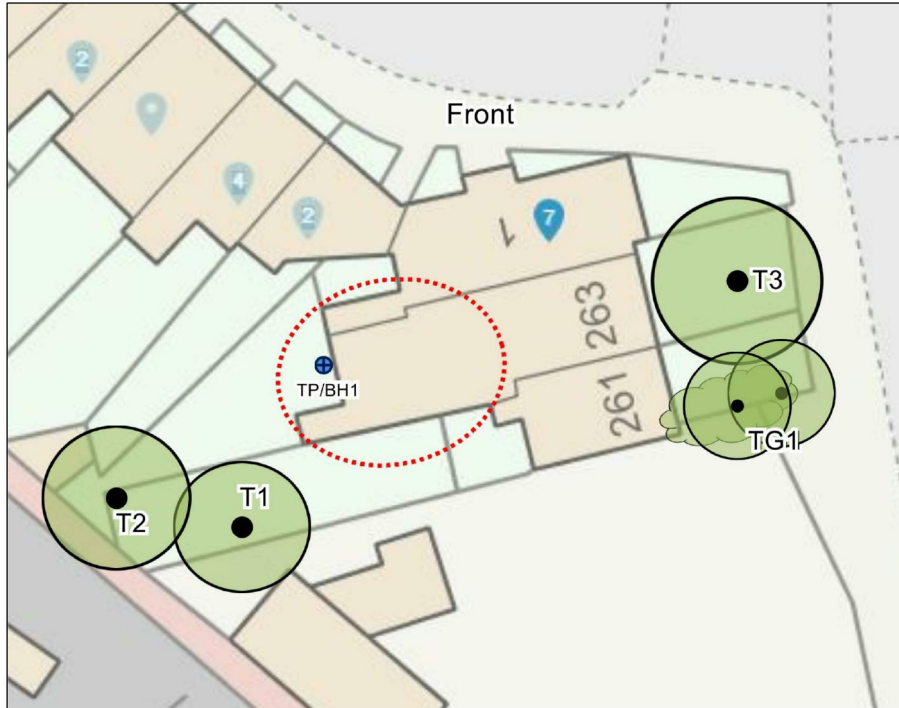
Site Plan

Approximate areas of damage

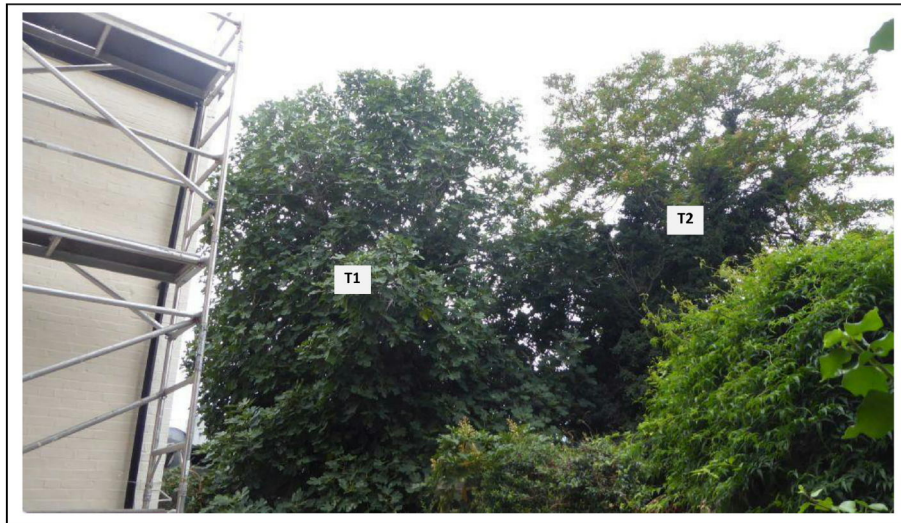
The origin of the *Hedera* spp. or the related *Fatsia* spp. roots will be from nearby recently removed Ivy growth, which is not considered relevant to the damage. The tentatively identified either *Ulmus* spp. or *Leguminosae* spp. will be from the T2 Pagoda.

Irrespective of the identification of recovered root samples, our survey has identified vegetation within influencing distance of the building with a current potential to influence soil volumes below foundation level; the most significant of which in relation to the current damage are T1 Fig and T2 Pagoda.

View of T1 and T2

If an arboricultural solution is to be implemented to mitigate the influence of the implicated trees/vegetation we recommend that T1 Fig and T2 Pagoda are removed.

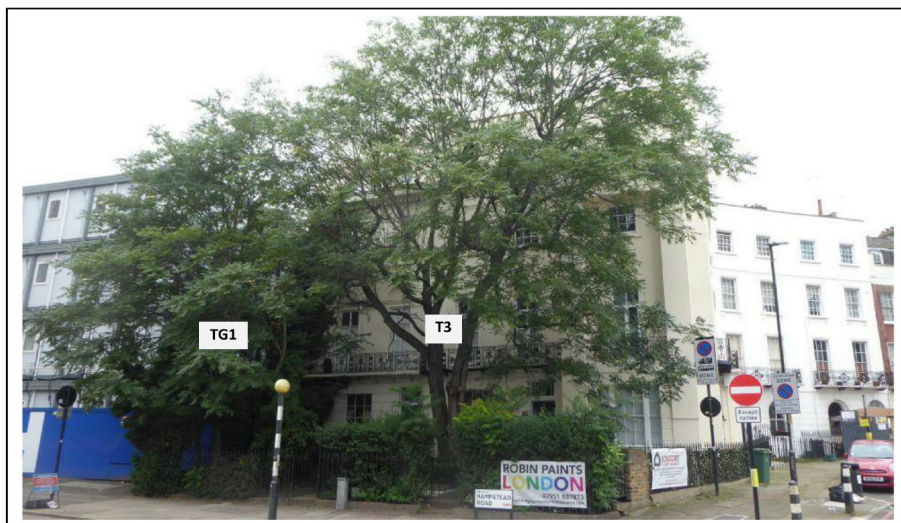
Other vegetation recorded presents a potential future risk to building stability and management is therefore recommended. Recommended tree works may be subject to change upon receipt of additional information.

View of T3 and TG1

Tree No.	Species	Ht (m)	Dia (mm)	Crown Spread (m)	Dist. to building (m)	Age Classification	Ownership
T3	Pagoda	14.5	6820	10.0	3.5	Younger than Property	Policy Holder
Management history		No significant past management noted.					
Recommendation		Remove (fell) to near ground level and treat stump to inhibit regrowth.					
TG1	Pagoda [lapsed self-sown] and ivy with mixed spp. shrub understorey	12.5 *	280 Ms *	8.0	0.1	Younger than Property	Third Party 261 Hampstead Road, NW1 3EA
Management history		No significant past management noted.					
Recommendation		Remove (fell) Pagoda stems and ivy to near ground level and treat stumps to inhibit regrowth.
