## TECHNICAL REPORT ON A SUBSIDENCE CLAIM

**Cruickshank Residents Association Ltd  
1 Mornington Crescent  
London  
NW1 7RH**

## SUBSIDENCE CLAIM

DATE 15<sup>th</sup> September 2020

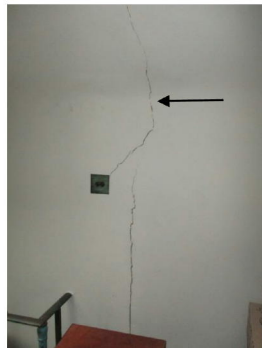
Cracking on rear addition junction in flat 6 rear bedroom

**Rear Bedroom** - 5mm vertical tapering crack on rear addition junction right hand side, 2mm vertical tapering crack on rear addition junction left hand side, cracking to ceiling, wall / ceiling junction cracking around rear wall, 3mm diagonal crack to left hand flank in study room.

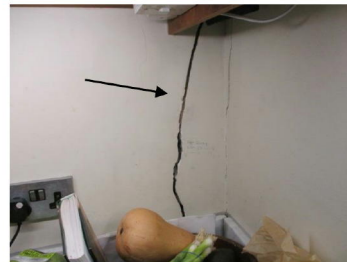
Cracking in flat 6 kitchen

**Flat 6 - Kitchen** - 11mm vertical tapering crack to left hand flank in rear corner, 1mm vertical crack above right hand side of flank window, wall / ceiling junction cracking along rear wall.

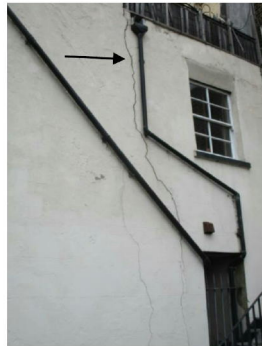
Cracking to rear addition

**Rear Addition** - 10mm vertical tapering separation down right hand side junction as viewed from flat 6 roof terrace, 15mm vertical tapering cracking to brickwork on rear corner of main building as viewed from flat 6 roof terrace, historic bowing noted to external walls of main building, 20mm vertical tapering crack on junction of two storey section to left hand flank, 20mm vertical tapering crack on junction of three storey section to left hand flank (left hand flank viewed from HS2 compound).

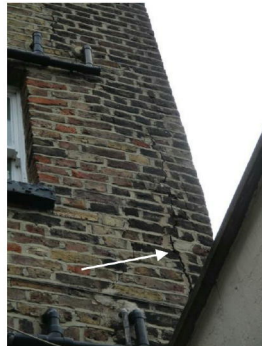
Cracking to rear elevation

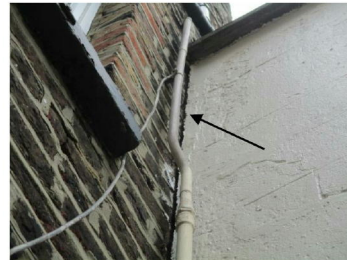
The pattern and nature of the cracking affecting the rear addition structure is indicative of an episode of subsidence. The cause of the movement appears to be clay shrinkage.

View of separation at rear addition junction

Although the cause of the movement needs to be dealt with, we note the involvement of Housing Association trees to the rear of the property. Unfortunately, they will require certain investigations to be carried out to demonstrate the influence of their vegetation.

Typically, these investigations would involve trial pit(s) to determine the depth and type of footings, boreholes to determine the nature of the subsoil/influence of any roots and monitoring to establish the rate and pattern of movement. It may also be necessary to obtain a specialist Arboricultural Report.

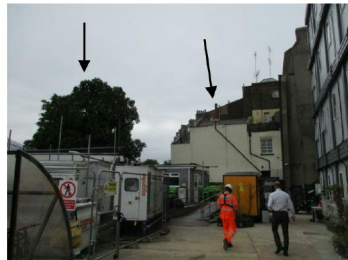
The presence of shrinkable clay beneath the foundations and the proximity of vegetation where there is damage indicates the shrinkage to be root induced. This is a commonly encountered problem and probably accounts for around 70% of subsidence claims notified to insurers.

View of rear addition and trees to rear

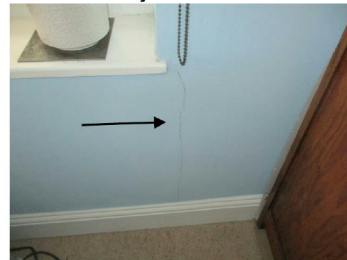
**Flat 3 - Lounge** - 1mm vertical crack below right hand side of flank window, hairline diagonal crack above flank window, hairline vertical crack down rear left hand corner junction - Not subsidence related damage.

Unrelated cracking in flat 3 lounge

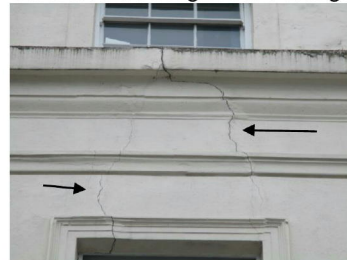
**Front Elevation** - Various 1mm - 5mm cracks in render noted at all levels above and below windows and doors, historic distortions and previous repairs noted to window and door openings - Not subsidence related damage.

The damage noted to the front section of the main property is not the result of subsidence because the pattern and nature of the cracks is not consistent with foundation movement. Apart from some minor, isolated cracking noted in Flat 3 which does not appear to be replicated externally and therefore is unlikely to be the result of foundation movement, the cracking appears to be restricted to the external rendered parts only. Previous repairs and distortions were noted across the front elevation indicating that there have been previous issues with cracking to the render historically. Whilst outside the scope of our instructions, the damage would appear to be possibly the result of normal wear and tear commonly found in rendered properties of this age and construction.

Typical render cracking to front elevation

Further investigation of the damage affecting the front section of the property is beyond our brief which is to determine if the cause is due to subsidence or other events covered by the insurance policy. Consequently, you may wish to consider engaging the services of an appropriate construction professional to ensure the correct remedial action is taken in respect of this damage.

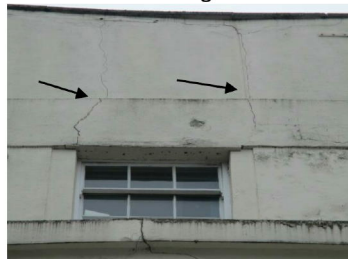
Typical render cracking to front elevation
