## Arboricultural Appraisal Report

### Subsidence Damage Investigation at:

Somerset House  
31 Dartmouth Park Hill  
London  
NW5 1HR

| REPORT DATE: | 17/02/2020 |

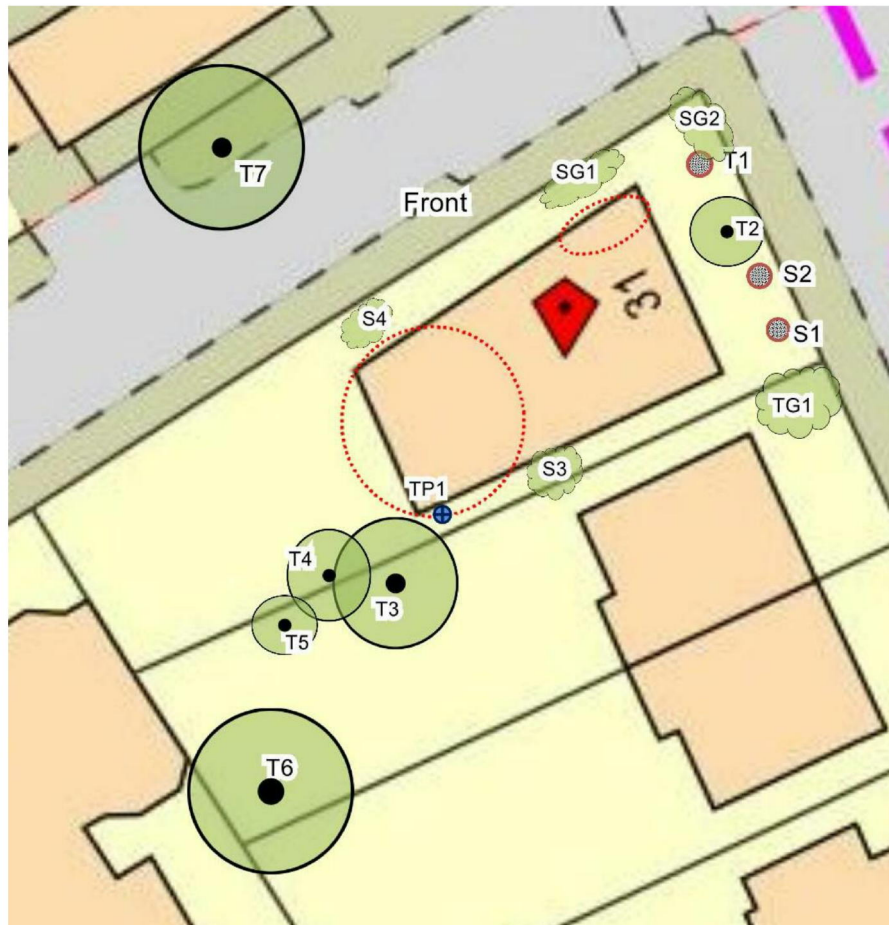
Site Plan

Approximate areas of damage
