**Arboricultural report on tree related subsidence  
at 1 Elsworthy Terrace London NW3 3DR**

September 2018

Sylvan Resources Ltd. forestry and arboriculture

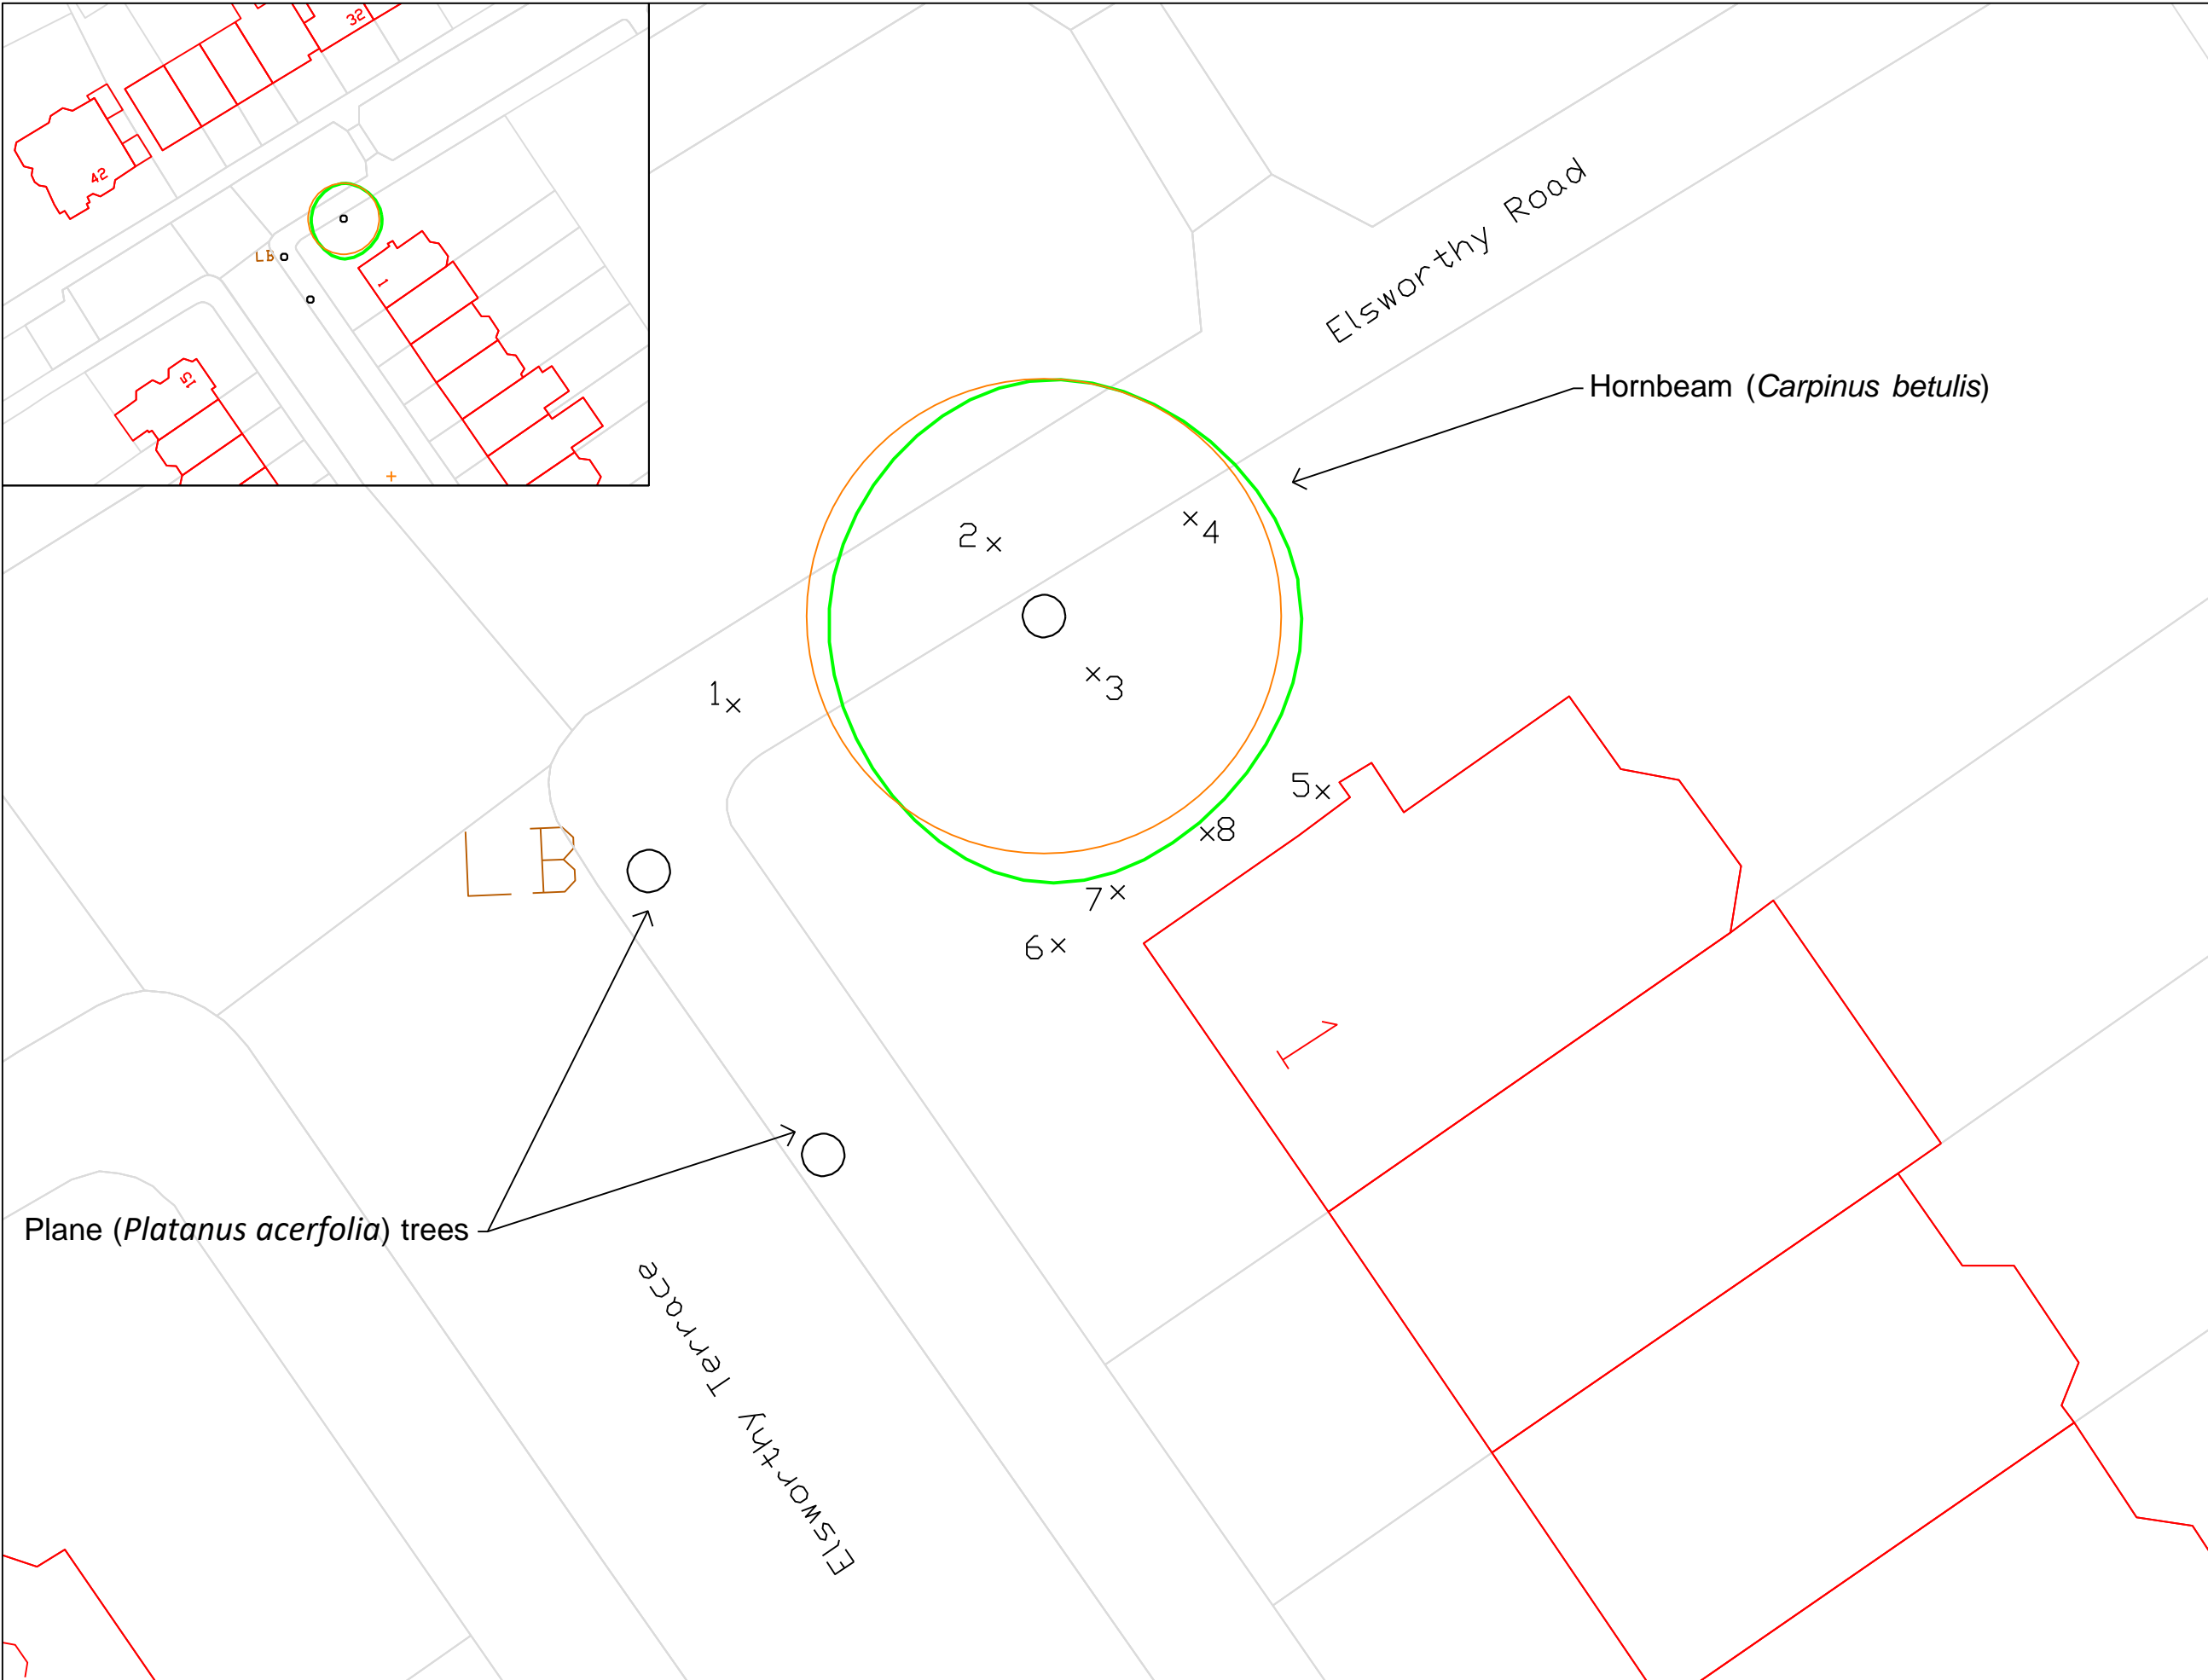
**Appendix A**  
**Site Plan**

- 4.3 The site plan (Appendix A: Site Plan) and photographs (Appendix B: Figures 1 – 4) show the location of the Hornbeam and two street trees, both London Planes in Elsworthy Terrace.

- 4.6 A trial pit was dug at the location indicated on the appended site plan. Soil and roots samples were taken from the pit. The root samples have been sent away for identification and the findings of which are pending.

- 4.7 The pit was excavated to a depth of 600mm and the soil down to this level was found to consist of made up ground comprising topsoil, brick and other building rubble. As such its plasticity was not tested. This decision was also influenced by the location of the pit. Ideally it should have been excavated against the wall of the building, but this would have required breaking a concrete path which could only have been done with the permission of the freeholder. Since we did not have this or the means to break the path and repair it afterwards, the pit was excavated in a garden area near to the site of the subsidence.

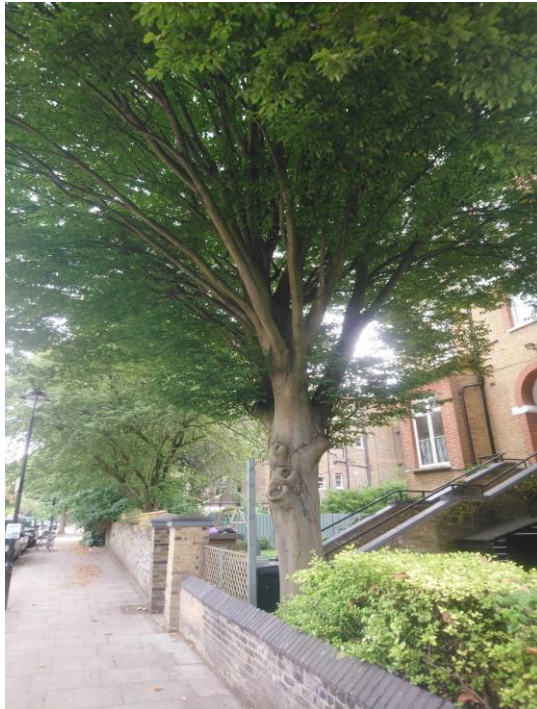
*Figure 1: Hornbeam (Carpinus betulis) as viewed from the pavement looking the northeast (Location 1)*

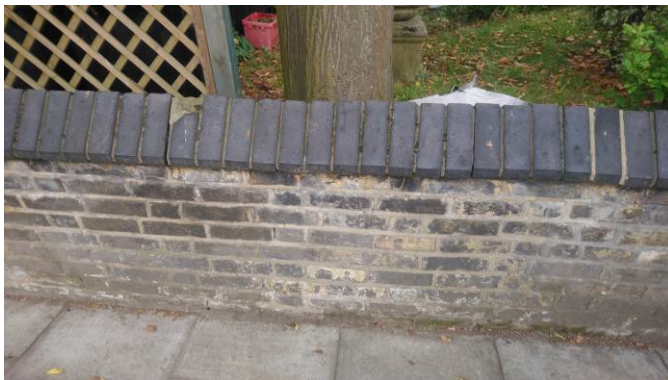
*Figure 2: Hornbeam (Carpinus betulis) as seen from the pavement (Location 2)*

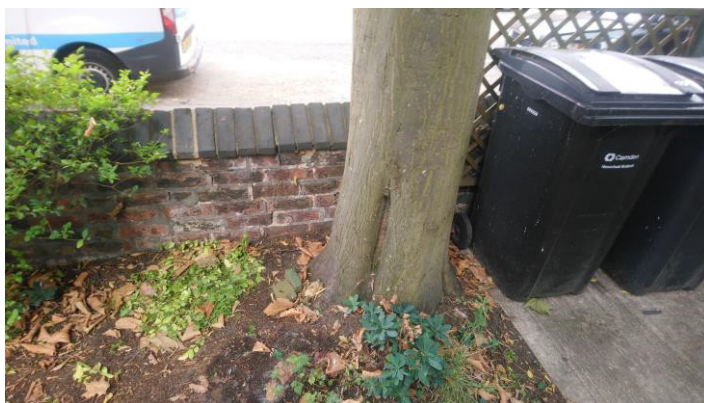
- 4.4 The hornbeam tree, estimated to be over 60 years old, has a diameter of approximately 460mm, measured 1.2m from ground level. The tree is 20m high and its first major branch arises from its stem approximately 3m from ground level on its north east side. Its crown spread is 5.5m north, 6m east, 6.2m south and 5m west, part of its canopy is touching the building. Evidence of previous tree work is manifested by an occluding wound. Basal damage occurs on the south side of the tree, within the garden (Appendix B: Figure 3). We assessed the tree as being in good condition.

*Figure 3: Hornbeam (Carpinus betulis) as seen from the property garden (Location 3)*

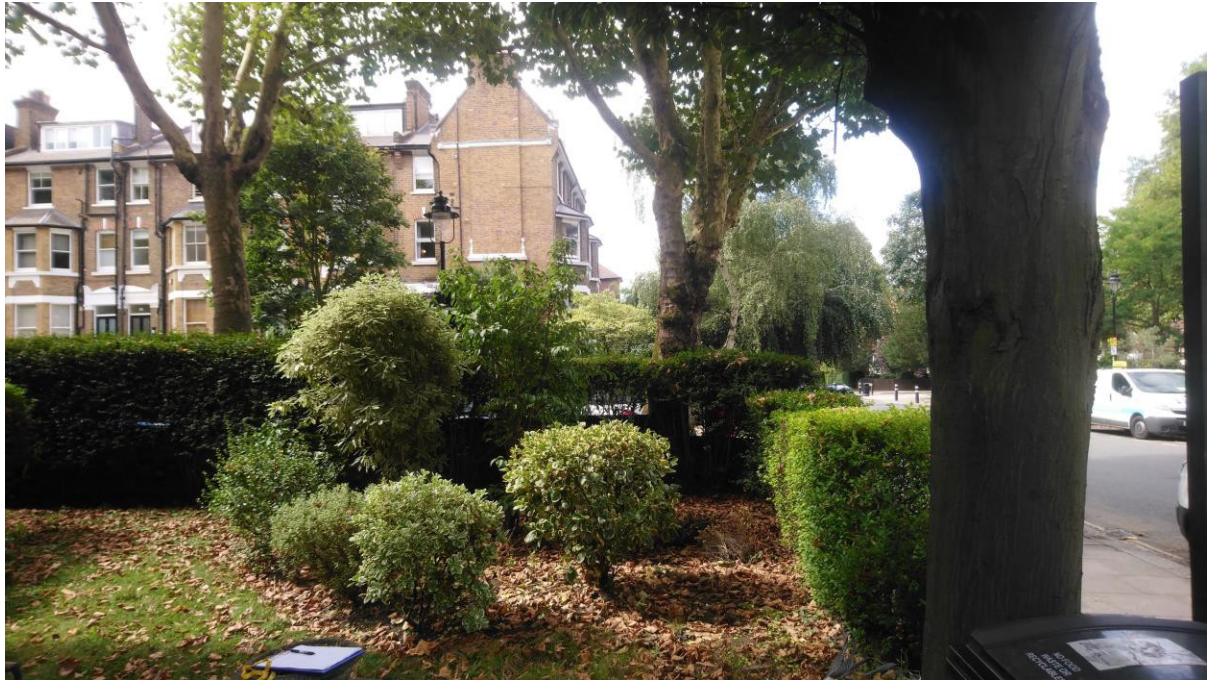
- 4.5 Although we had not been instructed to inspect them we noted the presence of two Plane Trees (*Platanus Acerfolia*) on the west side of the property in Elsworthy Terrace. One of these is likely to be the tree referred to by Quest Gates Ltd as having caused the first subsidence claim. Both trees are mature.

- *Platanus acerfolia* has a high-water demand. Hipps, Davies et al (2014) quote research which indicates that these trees do not affect buildings when they are planted more than 15m away from them, 10% of damage cases occur when the trees are 10-15m from buildings, 90% of damage cases occur when the trees are less than 10m from buildings and 50% when they are within 5.5m of buildings. One of the Plane trees falls within 10m of the building, the other is slightly further away but within 15m of it.

*Figure 4: Hornbeam and Plane Trees as viewed from the entrance path to the property looking southwest (Location 4)*

- 5.6 The alternative solution is to reduce the canopies of all three trees and repeat this process every three years as Hipps and Davies et al (2014) recommend. The cost of this work might be charged to Freehold company if the local authority is unwilling to bear the cost of pruning its trees.

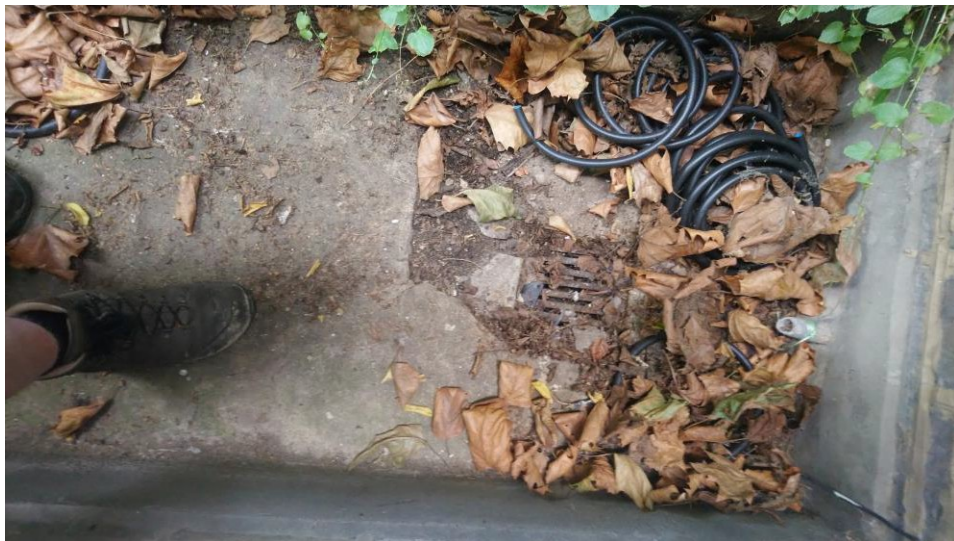
2.1 The property is owned by Messers Yonatan Arbel and Ramit Maimon who purchased it in March 2018. Before this date, on behalf of a previous owner Mr Benjamin Philips, the property's freeholders Mountview Estates Ltd. submitted a claim for tree related subsidence damage to their insurers Aviva. Aviva's loss adjusters Quest Gates Ltd concluded that the damage had been caused by a Plane tree (*Platanus acerfolia*). The claim was successful, repairs were made to the building and the offending tree was reduced. A further claim for subsidence damage was also made before 2015. Quest Gates believed the damage which comprised subsidence below a bathroom window and adjacent to access steps and cracked tiles in a bathroom was caused by a nearby tree growing in the grounds to the property. This was refuted by Mountview Estates who alleged that the damage was caused by damaged drains. A survey by Geocore Site Investigations Ltd concluded that the drains were undamaged.

*Figure 5: Location of drain (Location 5)*

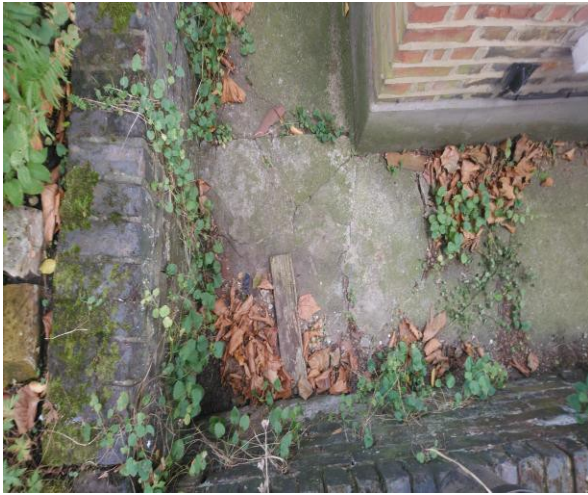
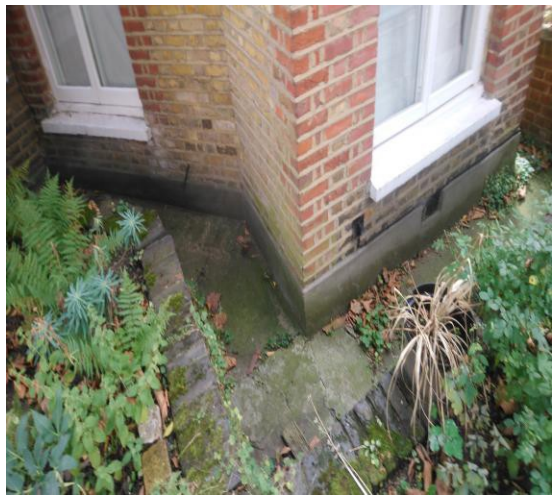
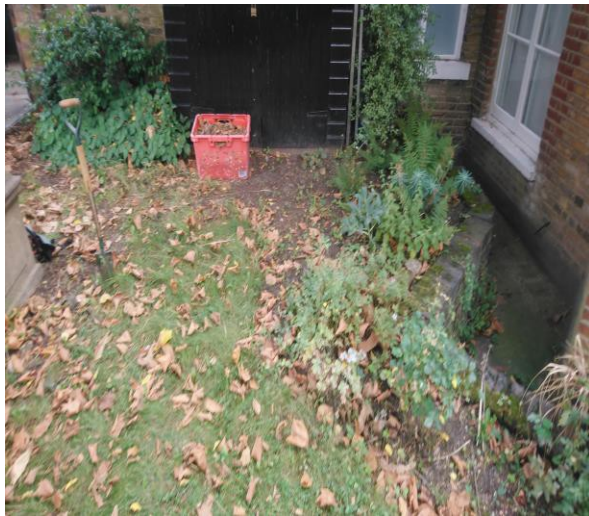
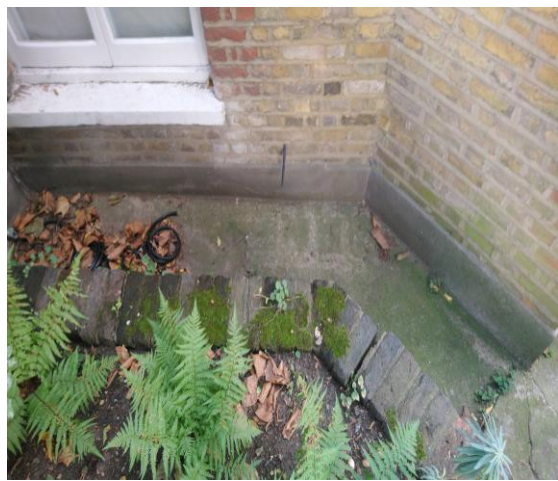
*Figure 6: Photos showing the changes in level around the edge of the property (Locations 6-8)*
