Simon Pryce Arboriculture

Site: 8A Hampstead Hill Gardens

Subject: Trees and proposed building work. Survey and Arboricultural Impact Assessment

Reference: 21/061

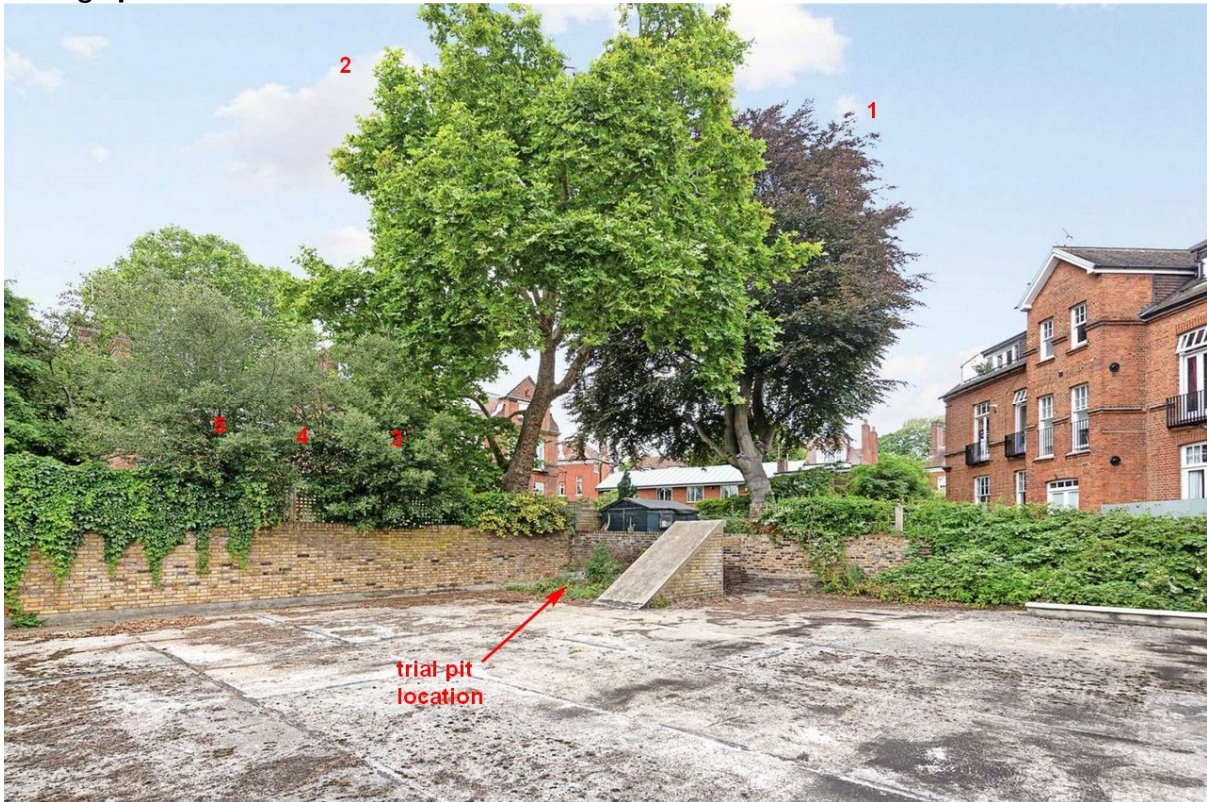
- 3.3 On 8 April 2021 a trial pit was dug in a small patch of soft ground in the far right hand corner of the roof next to the boundary. This revealed that the right boundary wall with no.6 has a stepped brickwork footing while the rear wall next to no.2 is newer looking brickwork with a concrete foundation. The patch of topsoil is about 300mm deep on a layer of oversite concrete, with rubble below that. The only roots were above the concrete and seen to coming from the ground vegetation growing in the patch of soil. See photos 1 and 2.

1) Trial pit location

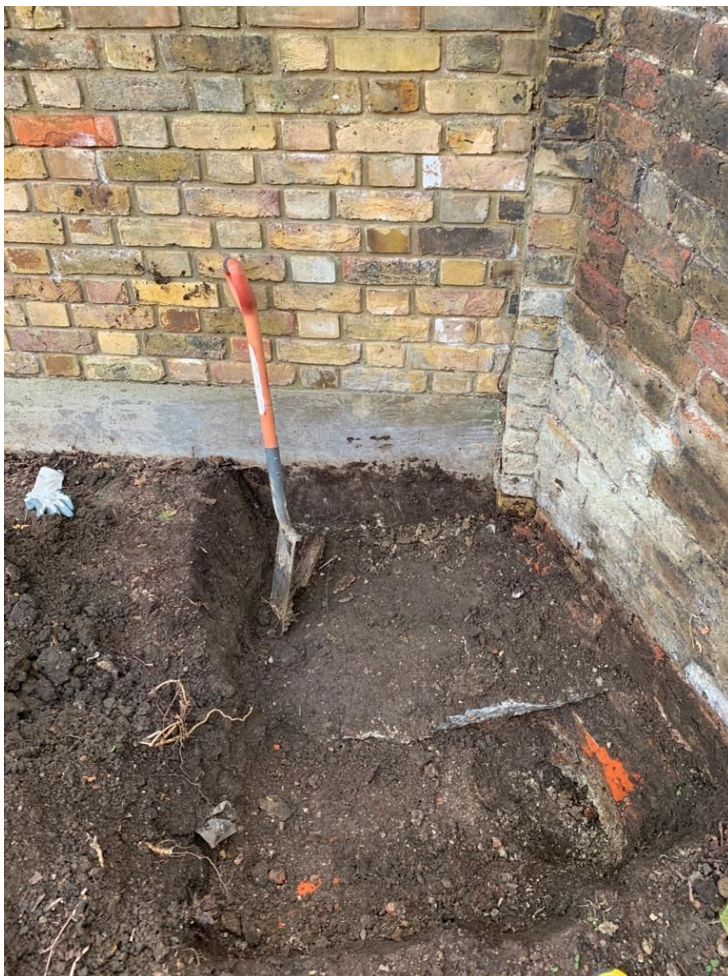
2) Trial pit showing minor roots in soil above oversite concrete. Ground level on the far side is about 0.9m higher (approx. 10 brick courses)
