Architecture for London

Photographs
68 Albert Street NW1 7NR

December 2021

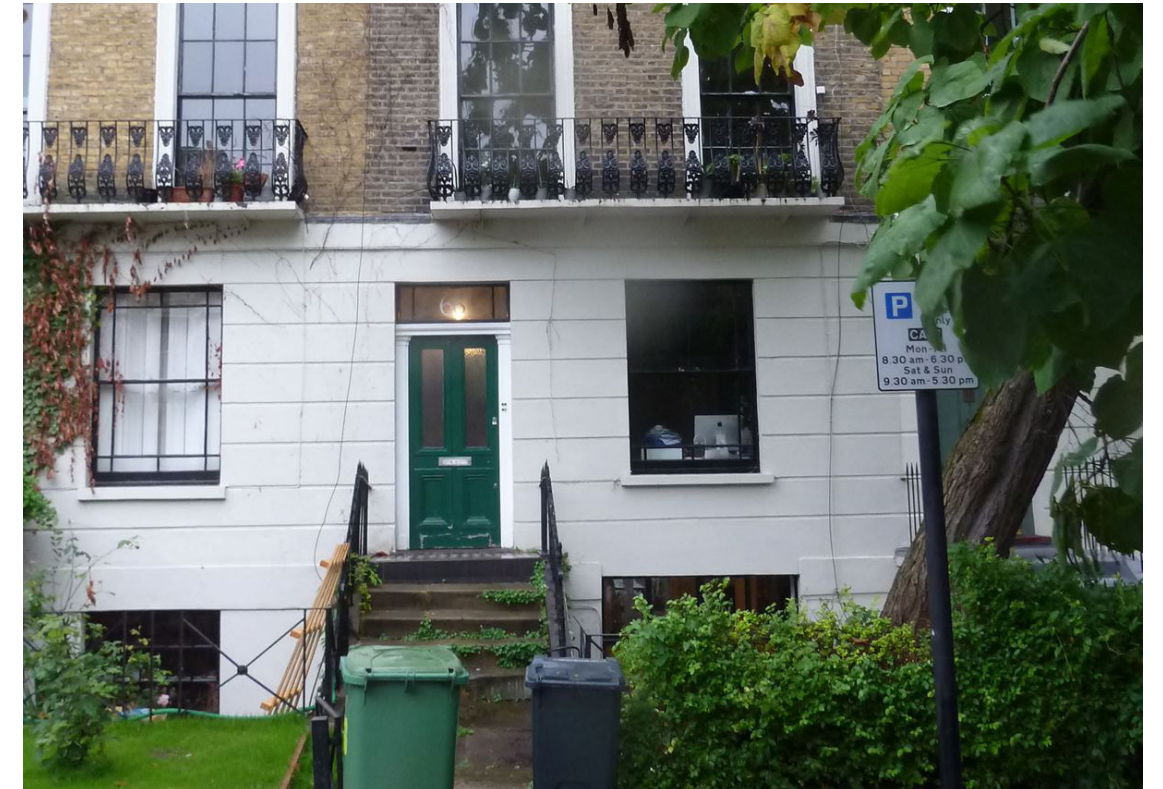
1. Front elevation from street
Replacement of lower ground floor glazing - See GA200.
2. Rear elevation
Demolition of infill extension - See GA201.
Demolition of rear outrigger flank wall to lower ground floor. Note openings are modern in construction with concrete lintels. Wall in very poor condition - See GA099.
Demolition of concrete balcony - See GA201.

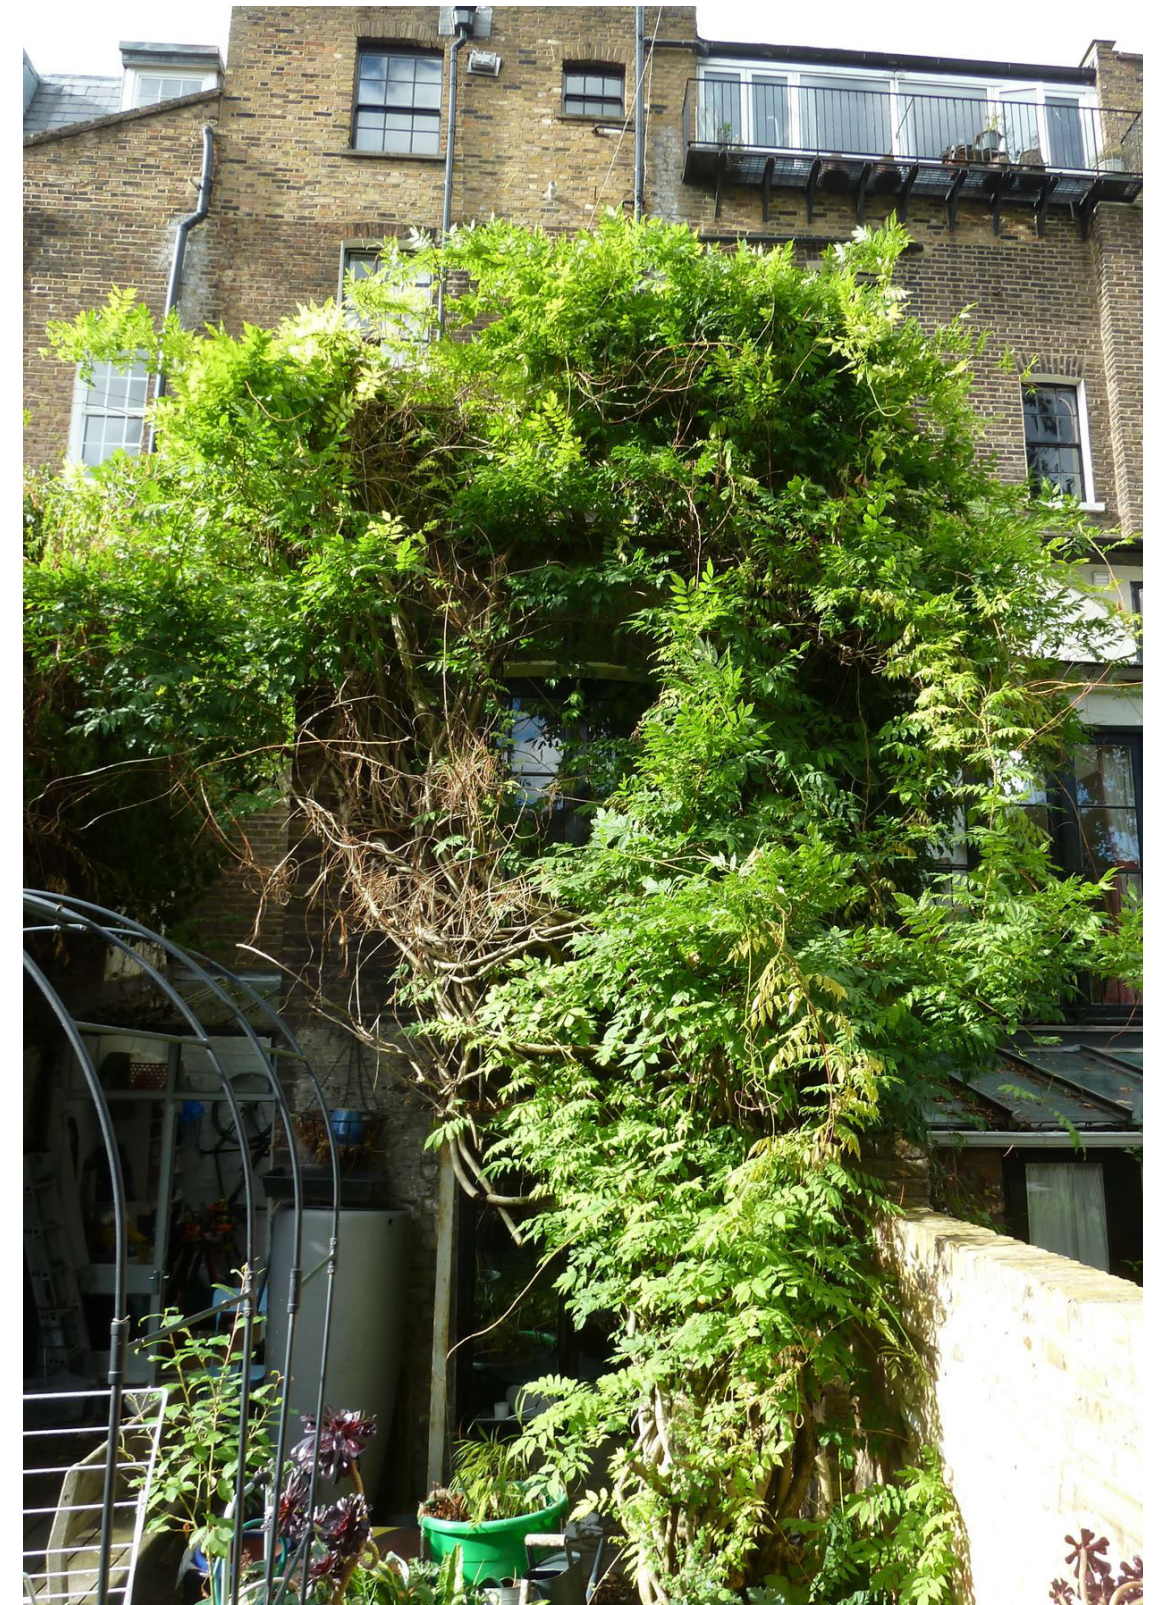
3. Rear outrigger from garden
Outrigger in very poor condition and overgrown
Rake out and re-point mortar - see GA201.
New staircase and wall built out to support replacement landing -
see GA201.

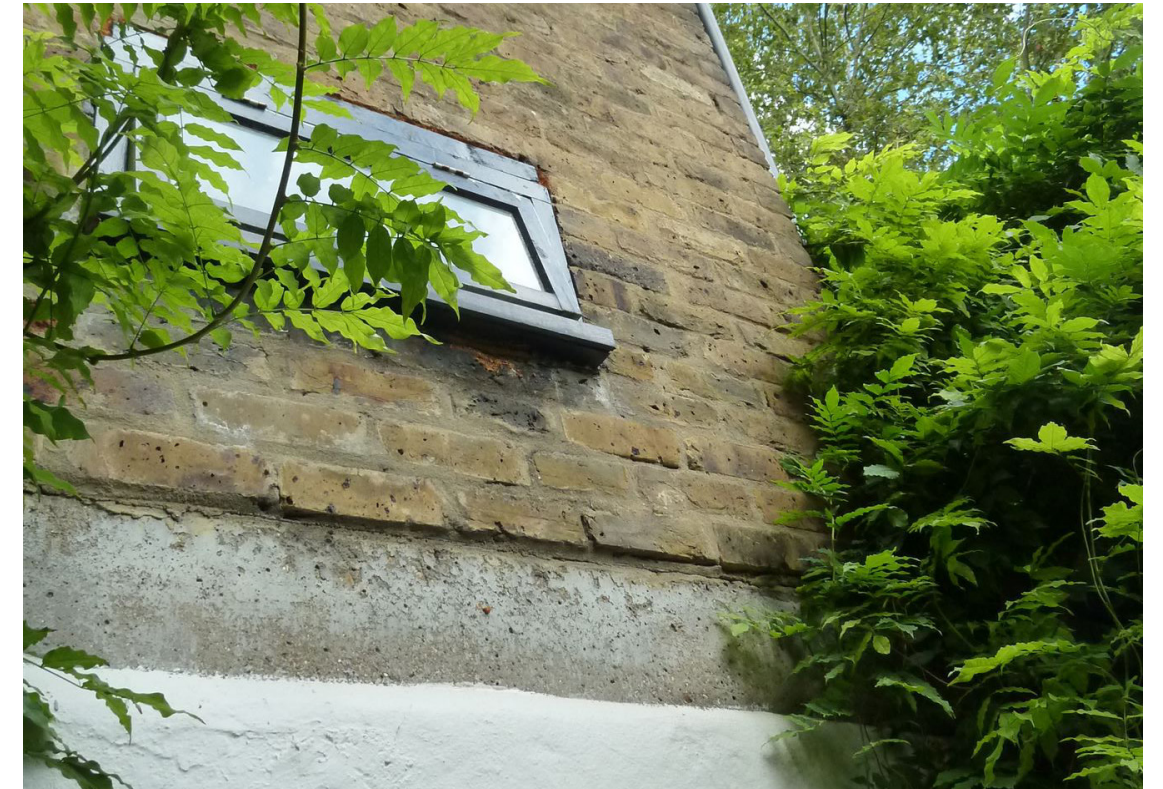
4. Flank wall of 1st floor extension
Existing 1st floor extension modern brick construction on concrete plinth - proposed design extends by 1950mm - see GA 301.
5. View from 1st floor Study toward garden
Proposed 1st floor infill extension between outriggers. Massing of proposed extension lower than existing outrigger - see GA201.

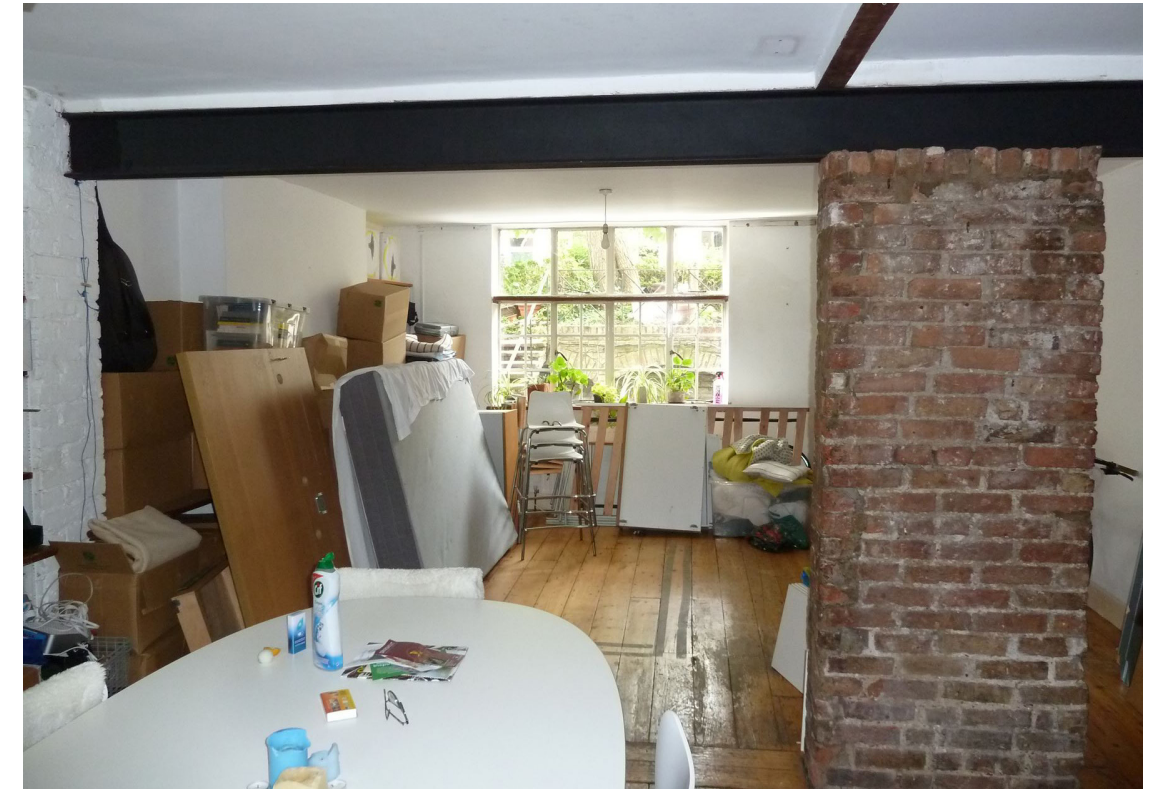
6. Lower Ground Floor
Modern open-plan arrangement with steel beam supporting ceiling
Proposed design to divide space into two bedrooms - See GA099.
7. Lower Ground Floor
Outrigger ceiling height currently unsuitable for occupation
Proposed design to lower FFL by 595mm - See GA300.

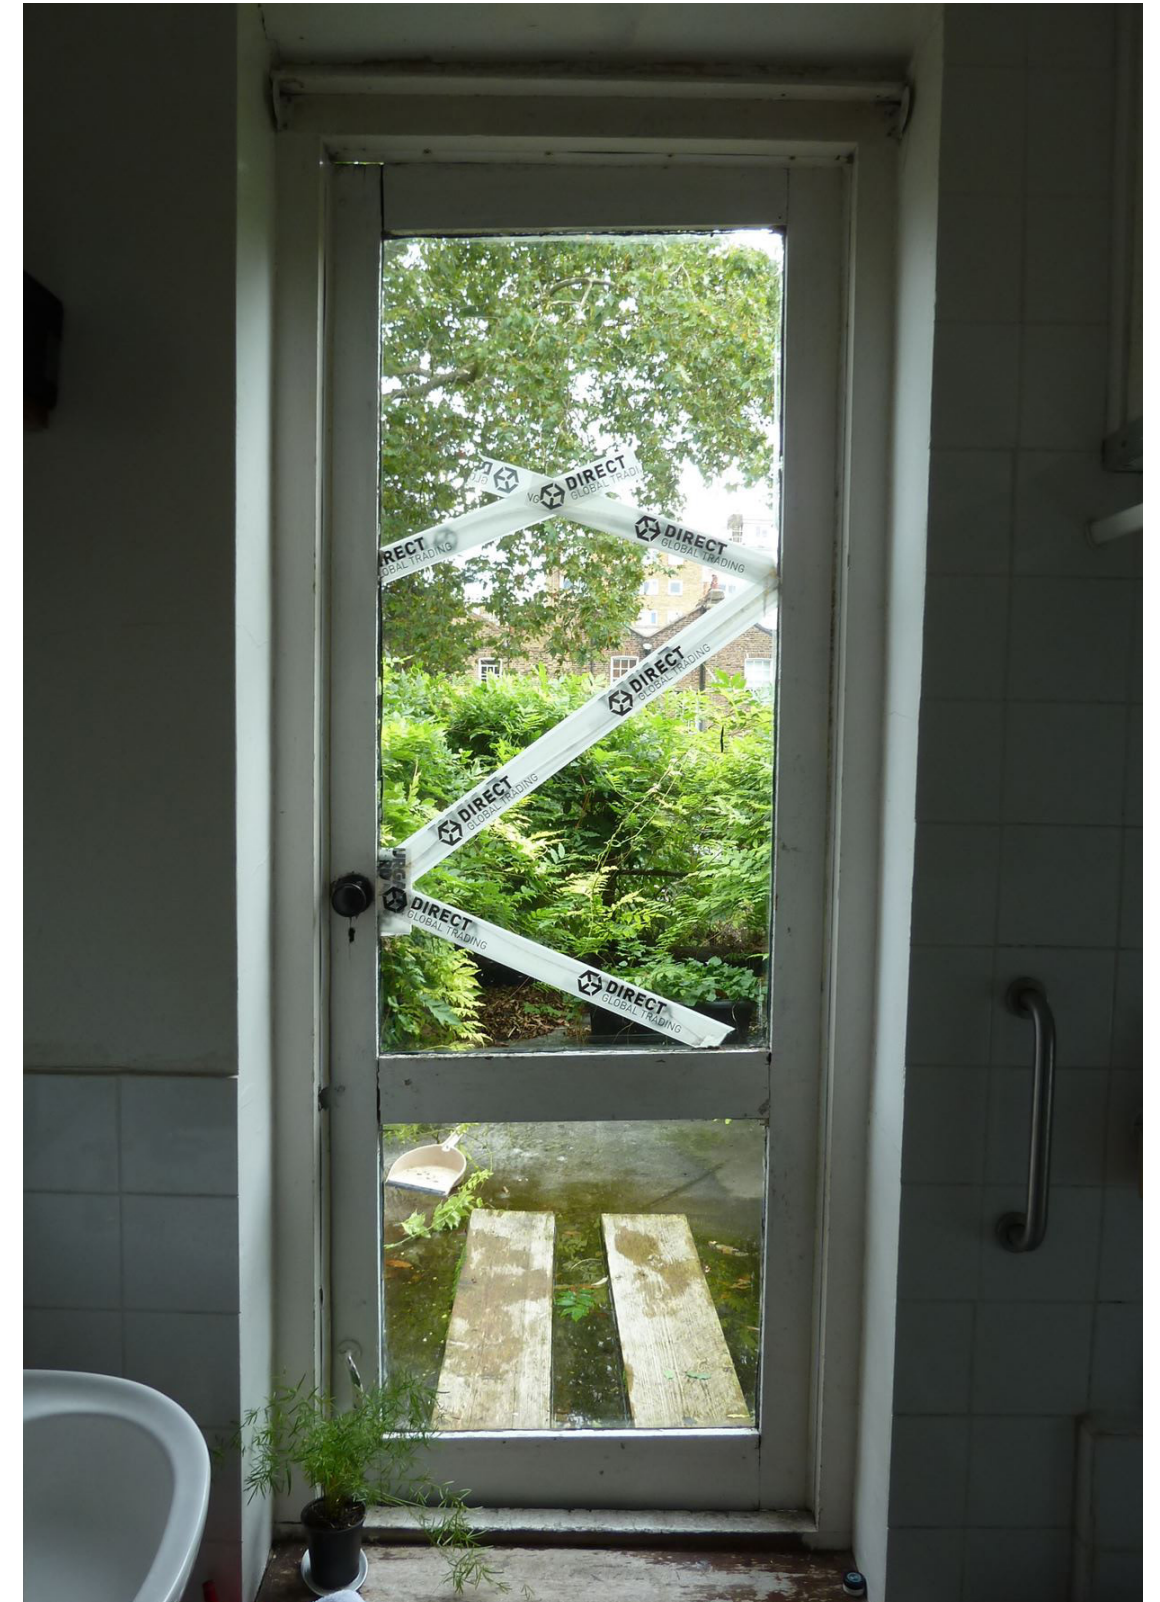
8. 1st floor bathroom and roof terrace
 The bathroom is cramped and damp and the roof terrace railings are dangerously low.
 The proposed design extends the bathroom by 1950mm and the roof is glazed. New railings to the roof terrace will allow for safer use - see GA301.

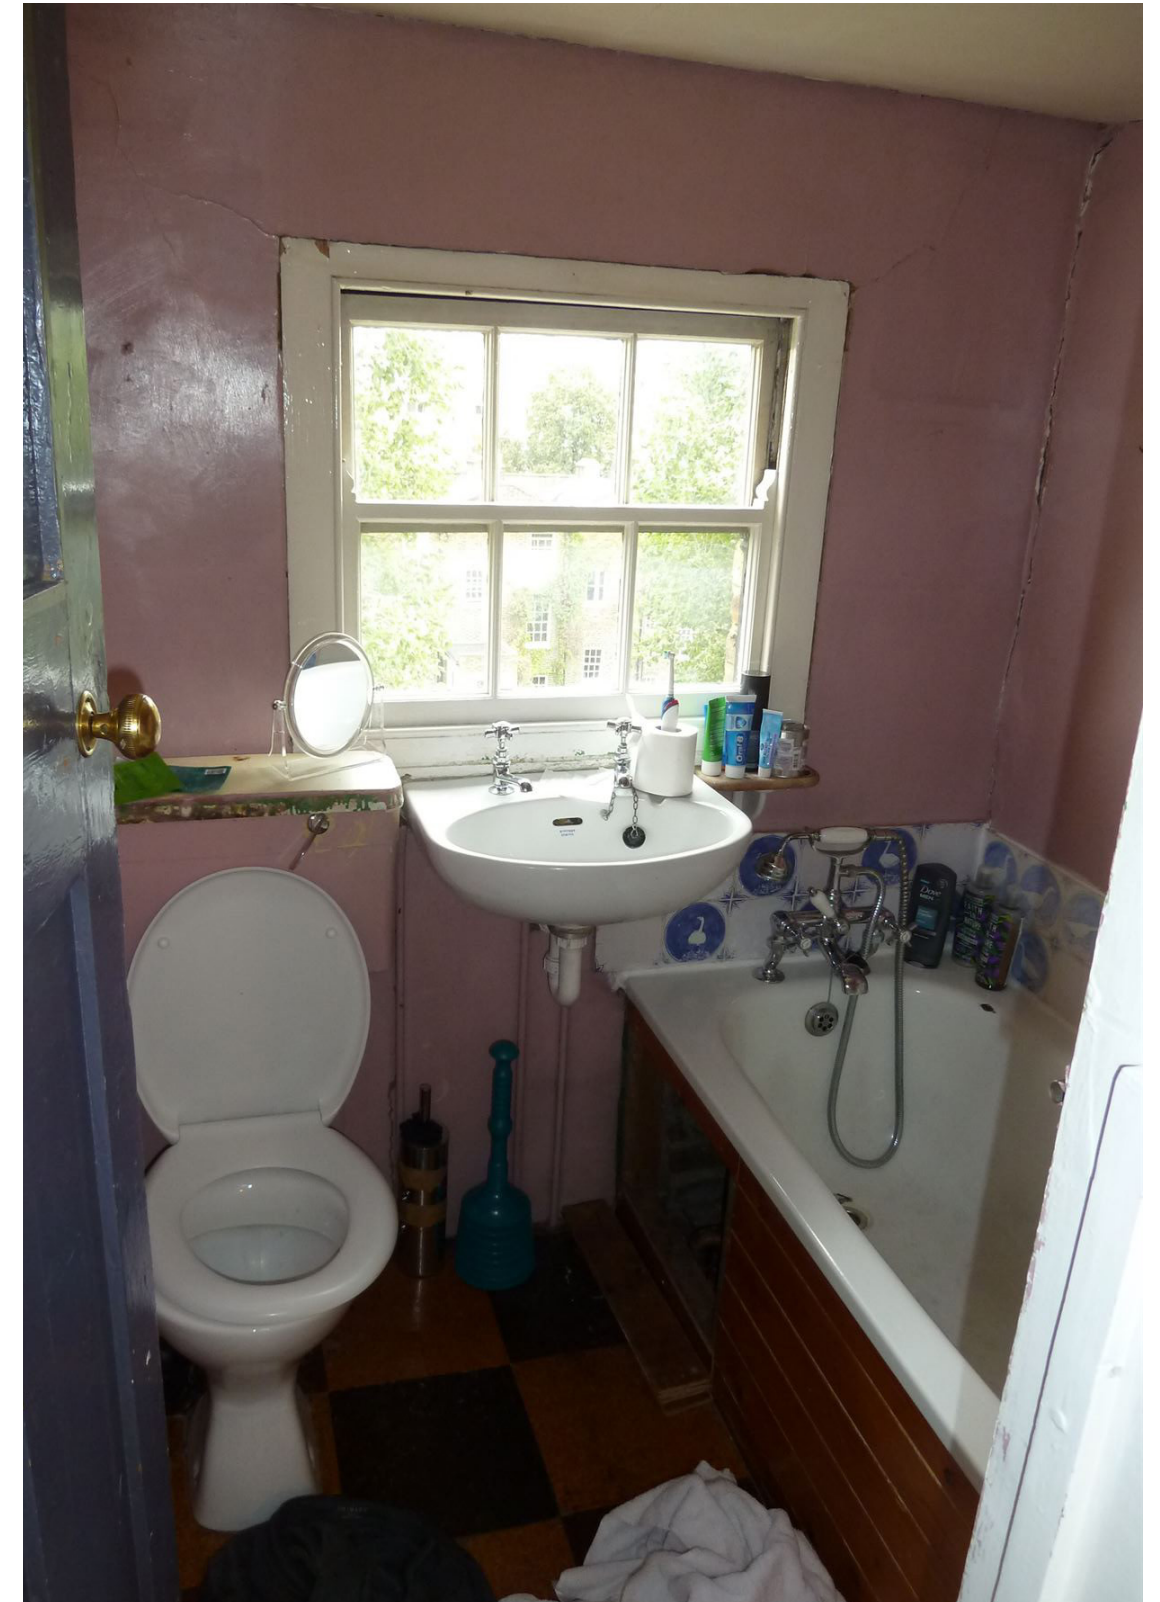
9. 3rd floor bathroom
 The bathroom is cramped and the ceiling is too low to accommodate a shower
 The proposed design extends the ceiling height by inserting a roof light into the modern dormer extension - see GA301.

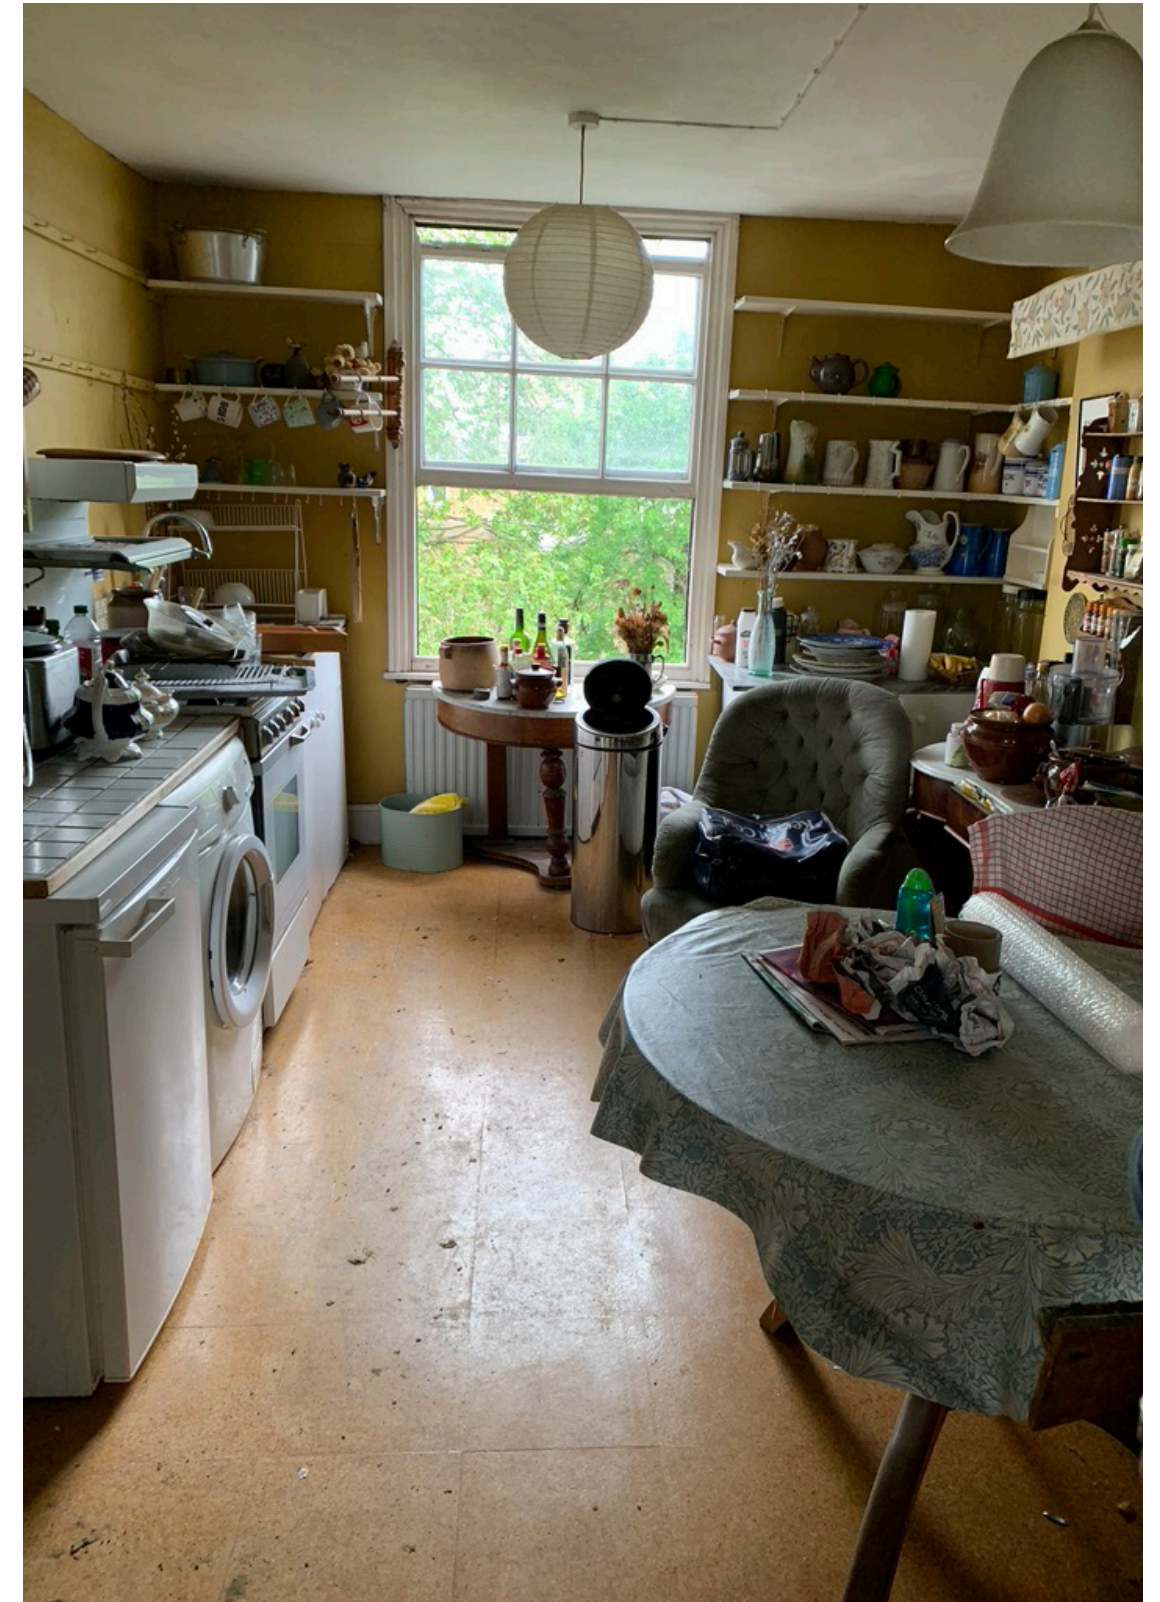
10. 3rd Floor
 Kitchen in unsuitable location and in poor state of repair
 Proposed design relocates the kitchen to the 1st floor, adjacent to the living room.
