BS5837 Arboricultural Report,

Arboricultural Impact Assessment

OUR REFERENCE	AC.2021.426
CLIENT	Mr Karl Noonan
SITE	Flat 2, 68 Priory Road, Camden, London, NW6 3RE
REPORT BY	I S Thompson (known as Tom) MArborA., BSc. (Hons) Arb, MSc. eFor
DATE	20th October 2021
DATE OF SITE VISIT	1st October 2021

**Side extension to existing residential ground floor
apartment.**

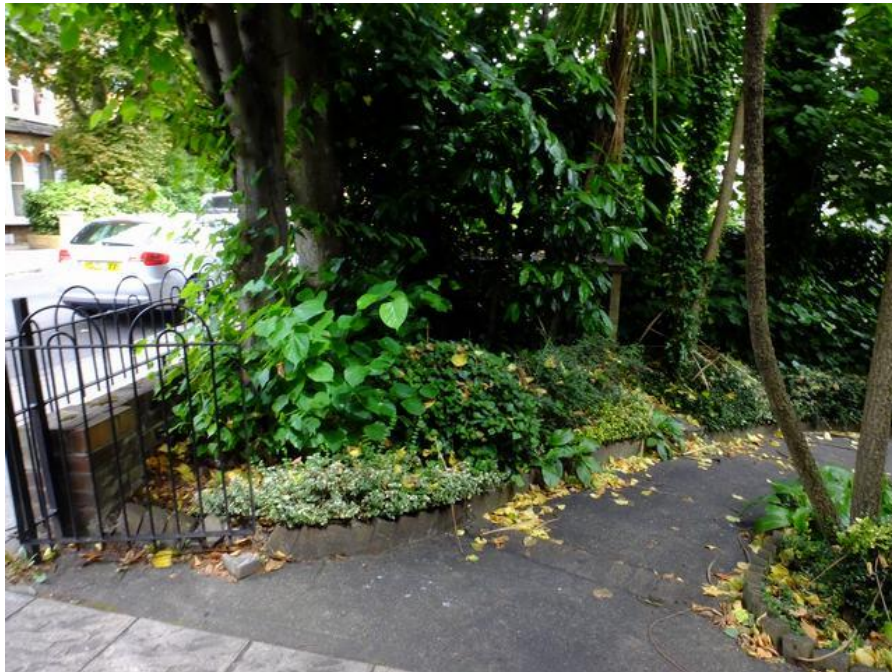
Image 1 Base of T1, on left and T2 and T3, right.

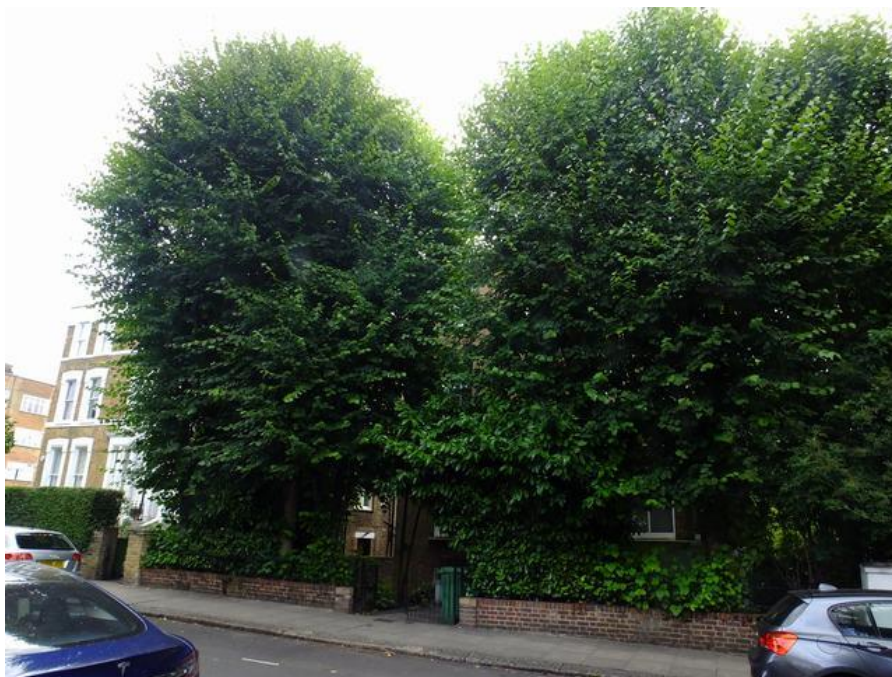
Image 2 T2 and T3 to left of the entrance and T6 and T7 to the right of the entrance.

- 12.2** There are only two dead or dying trees that are proposed for removal as part of this applications. These are T02 and T03 both lime trees.
- 12.3** If at any time additional pruning works are required permission must be sought from the Local Planning Authority first and then carried out in accordance with BS 3998 Recommendations for Tree Works 2010, unless otherwise specified with clear justification for any deviation from the British Standard.

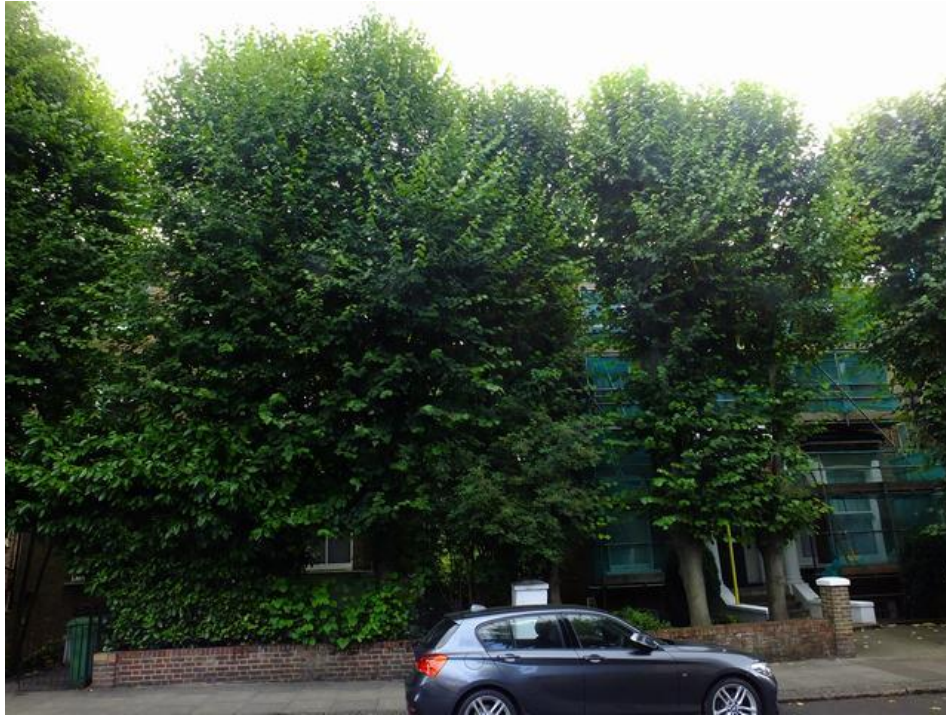
Image 3 T8, in the centre at the rear.

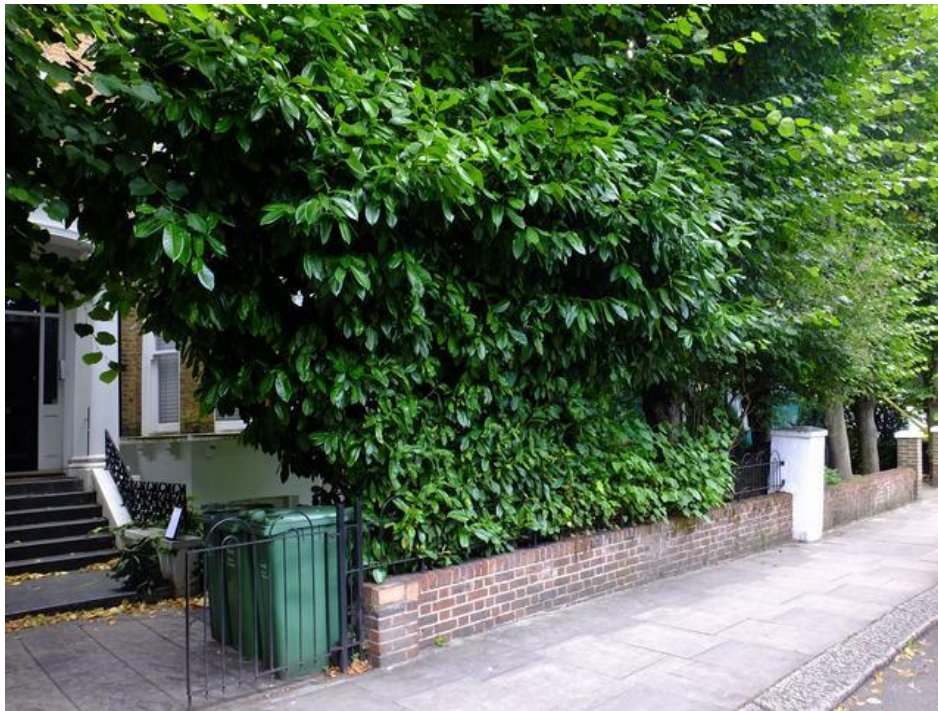
Image 4 T4, Chery laurel bush.

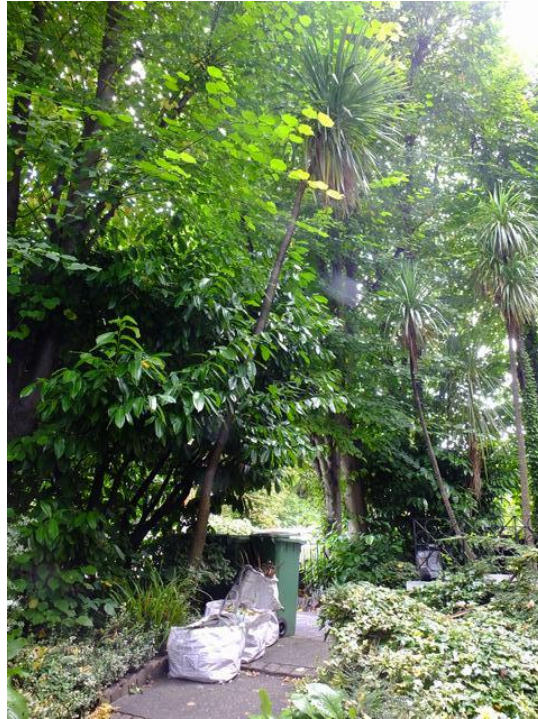
Image 5 Cabbage palms, T5 on left and T1 on the right.

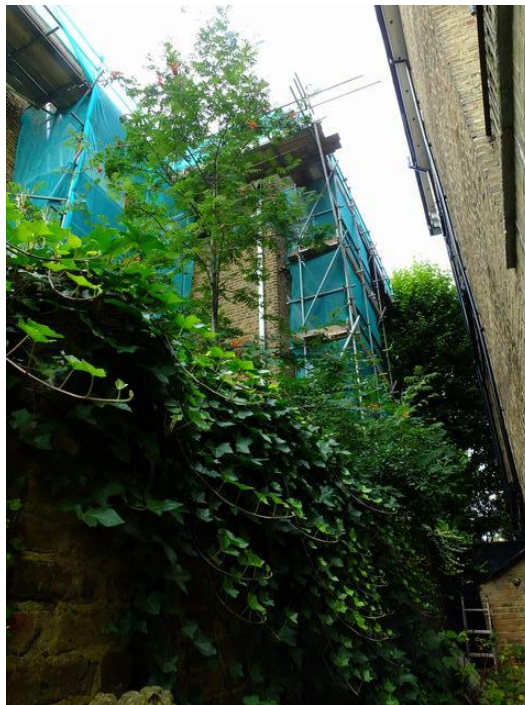
Image 6 T9, a small rowan tree in the adjacent property.

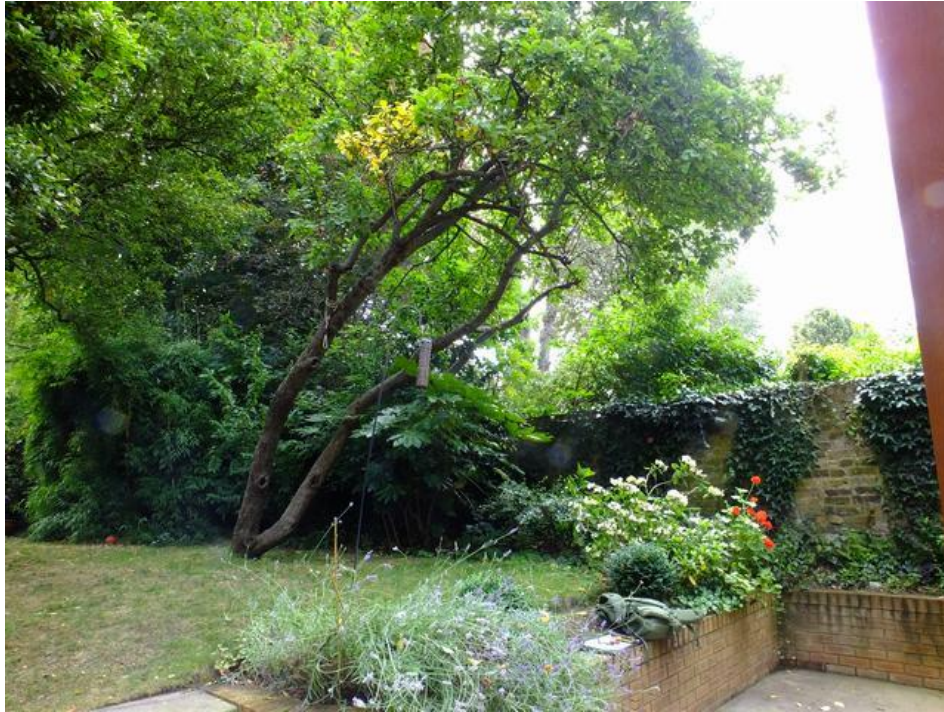
Image 7 T10, an aging apple tree in the rear garden, behind a retaining wall.

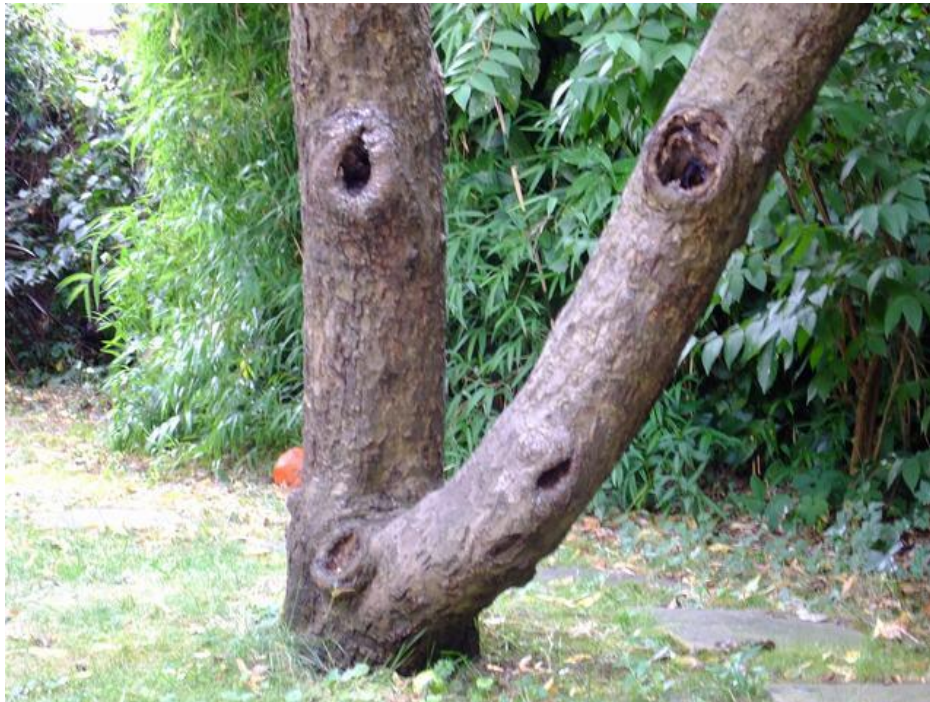
Image 8 Stems of apple tree with signs of decay.

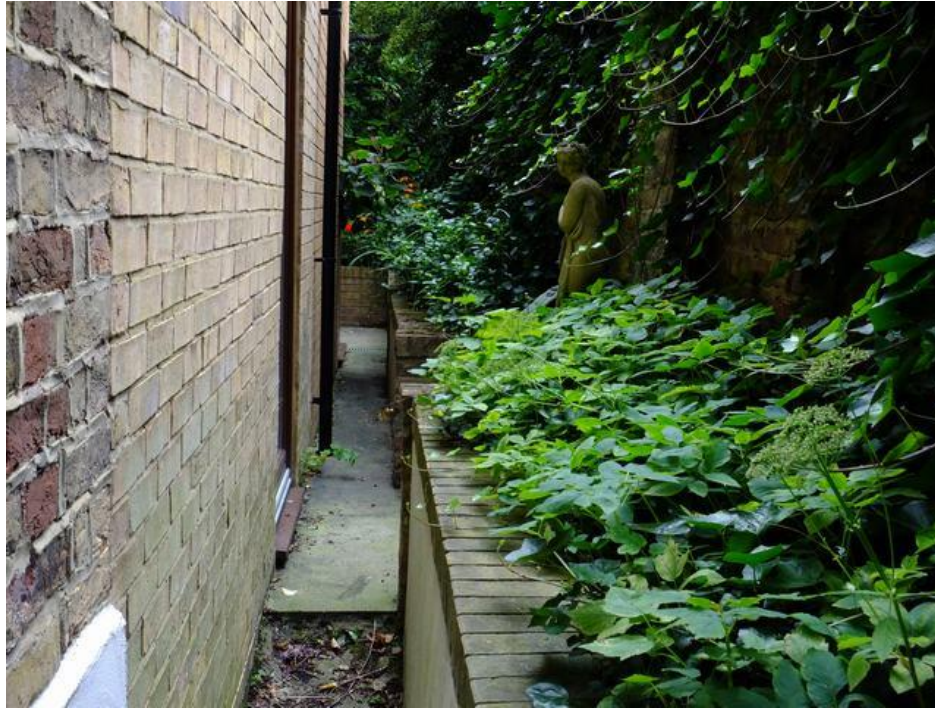
Image 9 Rear planting bed is to be retained so there is no need for fencing due to access.

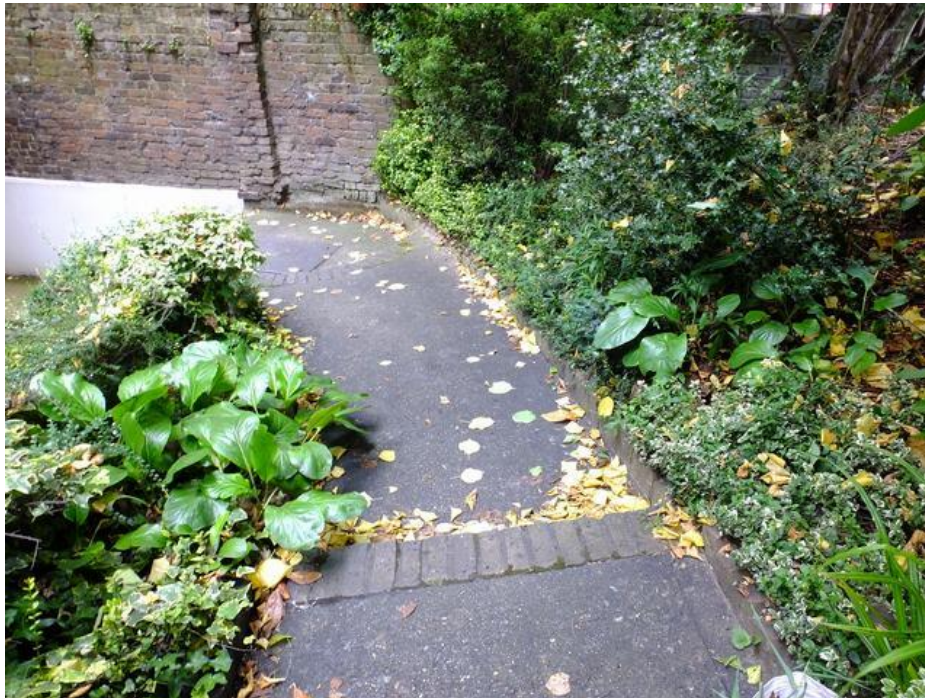
Image 10 Path sloping down to the entrance.

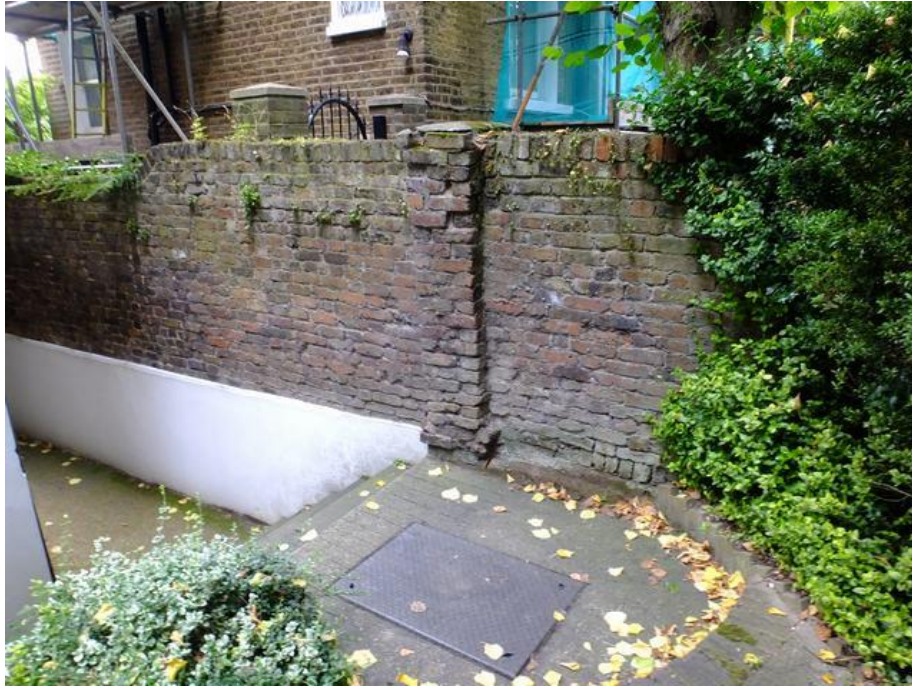
Image 11 Inspection cover for existing services, so roots likely to have been restricted or severed.

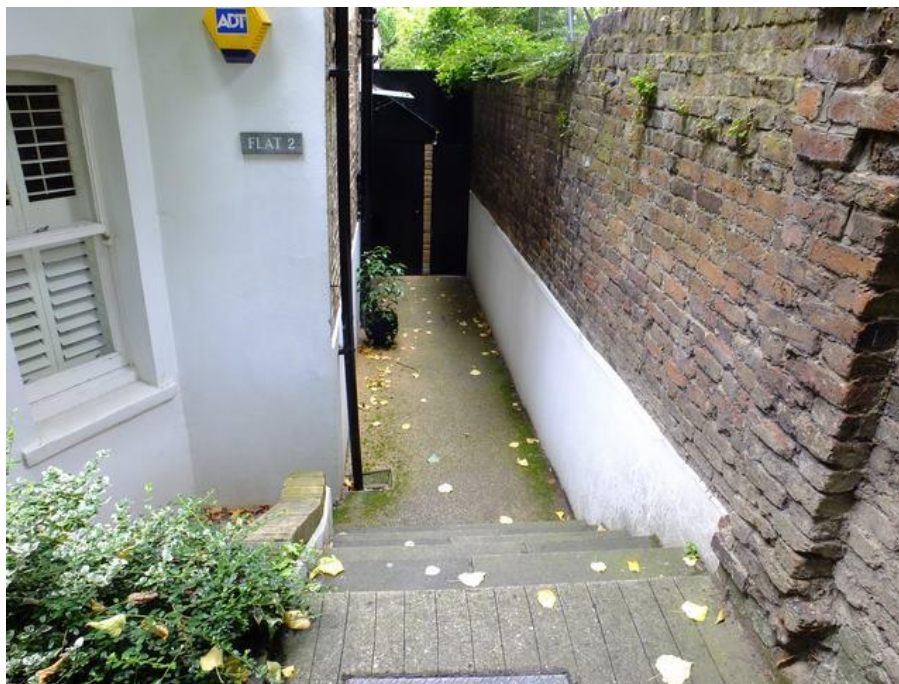
Image 12 Steps leading down to the entrance, with some space for materials.

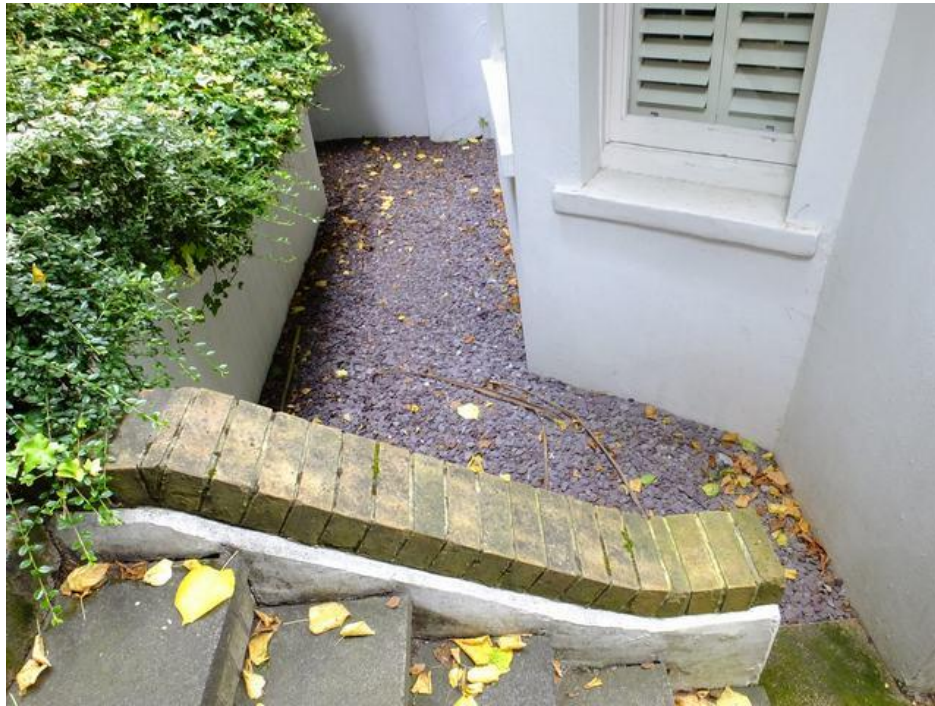
Image 13 Further space to the front of the apartment for materials to be stored.

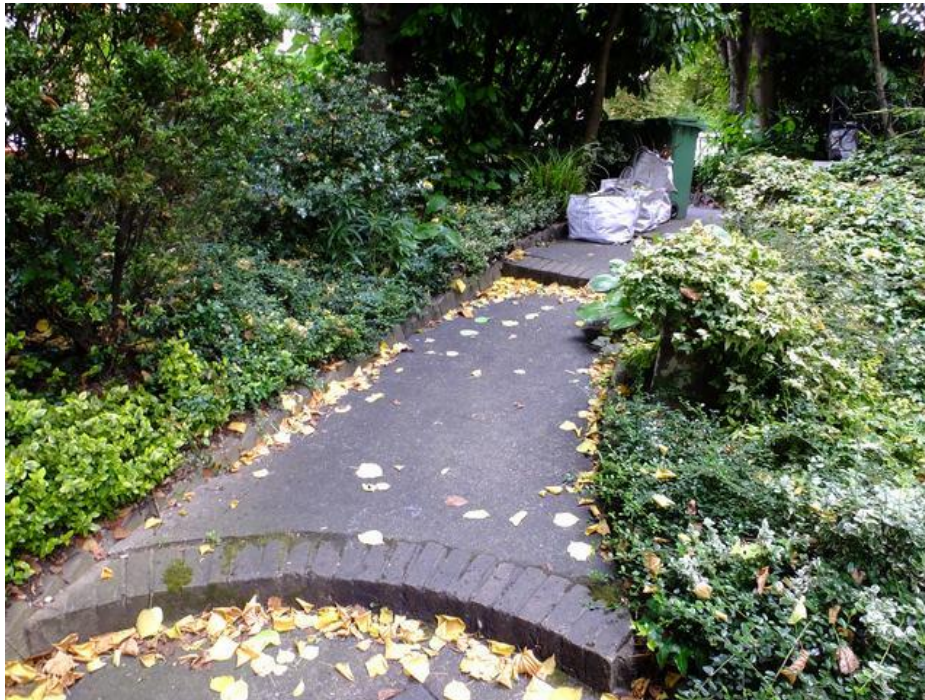
Image 14 View looking up the path to the site entrance.
