Tree Inspection Report

6 Downshire Hill
London
NW3 1NR

December 2021

AR/MF/0187/21

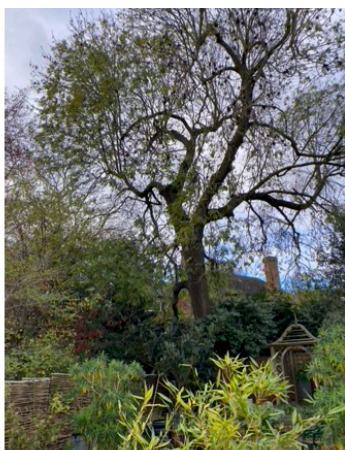
Tree T1 as viewed in a westerly direction showing reduced form of tree

4.6 Remedial works shall provide crown reduction of the tree to managed lapsed previous reduction points in relation to the location and form.

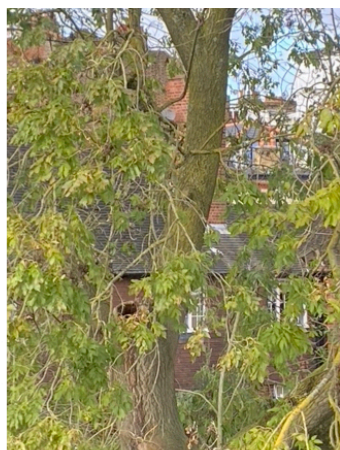
- Lean to south with good buttress roots to north
- Crown break at 5-9m height
- Decay to south east at 0.2-2.5m from likely bonfire damage; occluding with reaction growth - decay extends maximum 200mm within open cavity at base / 100mm within at 1.5m height
- Decay pocket at 8m height from poor pruning wound holding water
- Main wounds on main stem and branch framework generally occluded
- Over-extended lateral to east at 5m height extending to north east. Previously crown reduced; lapsed 6-8 years by 4-5m branch lengths

Open cavity in mid crown to south resulting from poor pruning wound

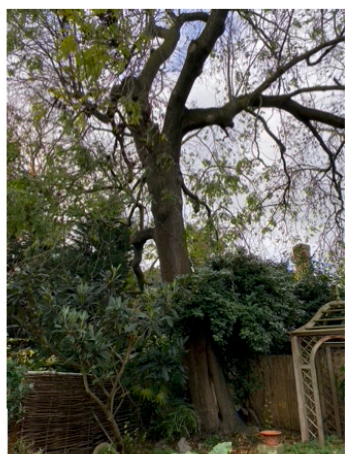
Tree T1 showing lean to west as viewed in a north westerly direction

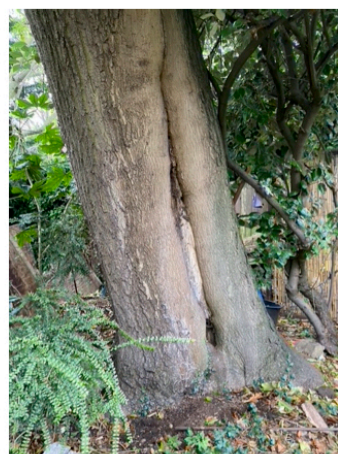
- (i) For area of decay on main stem relating to bonfire damage, significant occluding growth and reaction is evident
- (ii) Previous crown reduction works have been undertaken to manage the tree in relation to highlighted structural defect and large species of tree for rear garden location

Cavity to south / east of main stem with occluding growth

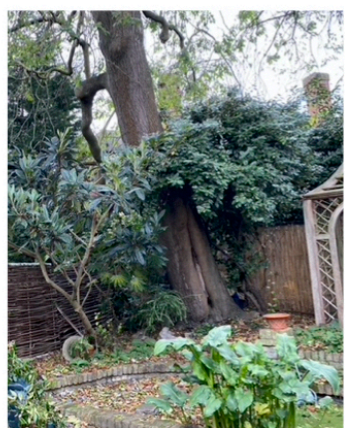
Initial main stem and lower crown showing low growth developing

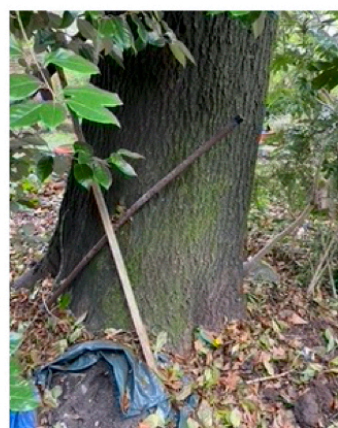
Main stem - to north west as viewed in an easterly direction

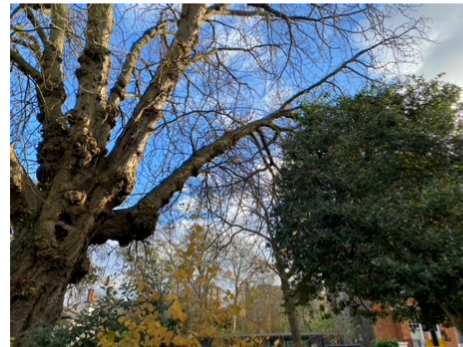
- 4.5m to south east
- Main branch framework union at 4-6m height.
- Large over-extended south west lateral over highway with weighted initial sweep
- Large over-extended north east lateral over no.7. Remaining crown element comprised from 6 upright leaders with limited crown shaping historically

(iii) Where limbs are over-extended to the south west and north east the reduction of these limbs is specified to reduce extent of wind loading upon areas of the crown further exposed than that of the main crown element

Over-extended southern lateral over highway as viewed in an easterly direction

4.6 Remedial works shall provide selective crown reduction of the tree where end weighting is occurring over the highway and also over No.7 Downshire Hill to balance the tree. Furthermore a climbing inspection shall be undertaken when implementing these works to inspect the main unions, large decay pockets within the main stem and initial branch framework; any significant findings shall be reported and appended to this report with further actions prescribed as necessary.

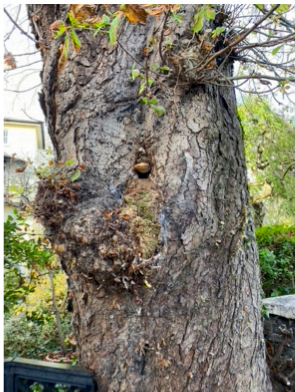
- Cavities also exist within the main stem t union at
 - 3.0m to west - occluding w/ reaction wood
 - 3.5m to north west occluding w/ reaction wood
 - 4.0m to south to south east of branch union with limited occluding growth

Cavity and occluding growth at 2.2m to south east of main stem

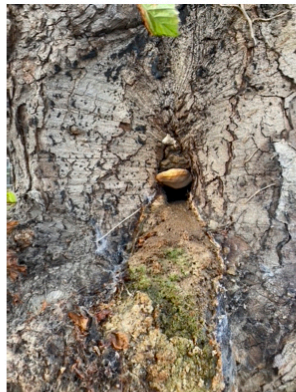
- Lean to south with accentuated buttresses to north within raised soft landscape of front garden; base flush with highway to east
- Cavity at 2m height to south with fruiting body (*Phellinus igniarius*) at least 3-4 years age; seepage from wound which is largely occluded. Probe enters within open cavity up to 150mm maximum. Decay sealant previously applied highlighting extent of occluding growth

(i) For area of decay on main stem relating to fruiting body *Phellinus igniarius* and absence of significant decay beyond this point as indicated by minimal incursion within the main stem by probe, it is likely that the area of decay has compartmentalised. The fungus characteristically is often restricted to dysfunctional areas – branch stubs or old wounds¹ as is the case with this historic wound relating to limb removal over the highway.

Phellinus ignarius fruiting body within previous pruning wound (historic)

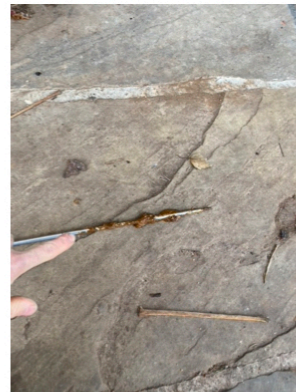
Probe showing limited extent of open decay (entering 120-140mm maximum)

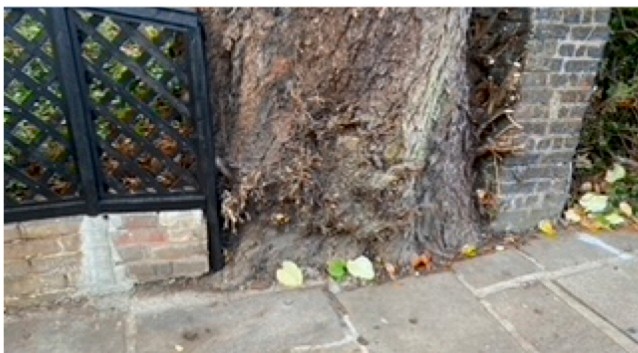
Base of tree within edge of highway as viewed in a north westerly direction

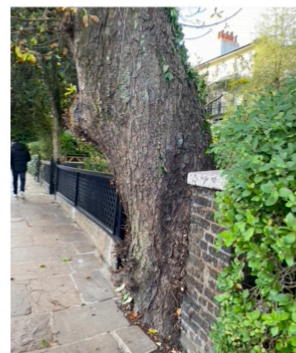
Base of tree within edge of highway as viewed in a southerly direction
