ENERGY AUDIT OBSERVATIONS AND RECOMMENDATIONS

9196 - CECIL SHARP HOUSE

14/09/2018 *by Andy Love,*

This design note sets out the Observations and Recommendations from the Energy Audit Wednesday 1st August 2018 ahead of distributing a wider report providing the full Energy Audit and Feasibility Study document.

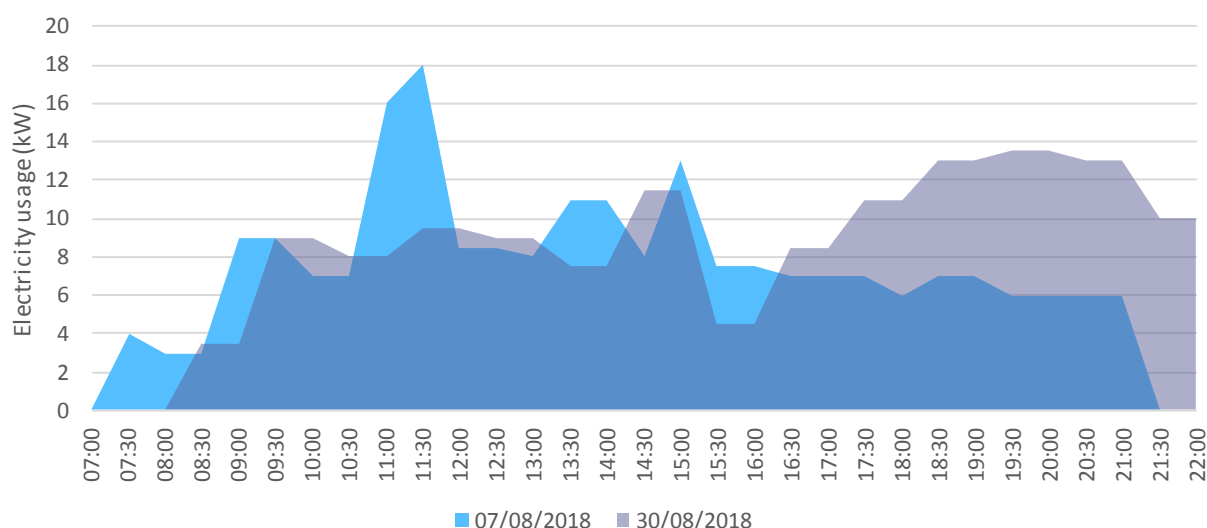
The metering data for Tuesday 7th August seems to suggest that there was a significant event between 10.30am-12pm that increased the base load from 9kW-17kW. It would be worth considering further investigation into this event to understand the reasoning. Initial assumptions are that the kitchen equipment was all on at once (preparing for lunch time) along with a potential increased occupation in the main hall, but this will need to be verified. Should this be from the kitchen equipment it may be worth considering how the kitchen is operated at low occupancy periods i.e. during summer could the café be serving 'cold-plates' only? The 8kW increase at this time, if a regular event over the year, could be contributing £500 towards the electricity bills.

Thursday 30th August was notable for in the evening a concert was held (assumed in the main hall); therefore, the AHU and/or lighting load was likely increased during the period of 6.30pm-10.30pm an approximate electrical load increase of approximately 7kW; if it is assumed that concerts occur four/five times weekly this translates to an approximate £700-£900/year electricity energy bill.

Figure 1: Typical mid-week daily electricity use under summer conditions (Tuesday 7th August and Thursday 30th August)

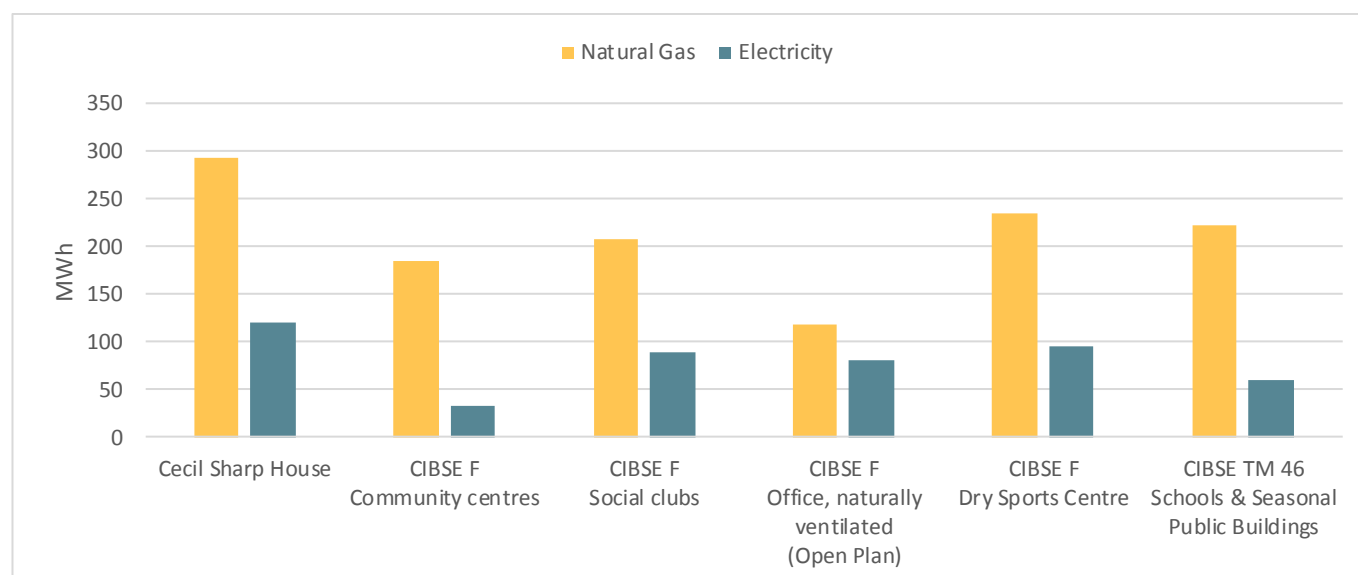
In comparison to the benchmarks, Cecil Sharp House seems to be underperforming. On average, Cecil Sharp House is consuming 100MWh natural gas consumption and 49MWh electricity consumption when compared to the CIBSE benchmarks and on average this is £9K over the expected energy bills.

Figure 2: CIBSE F and CIBSE TM46 benchmark comparisons for natural gas and electricity use in existing buildings

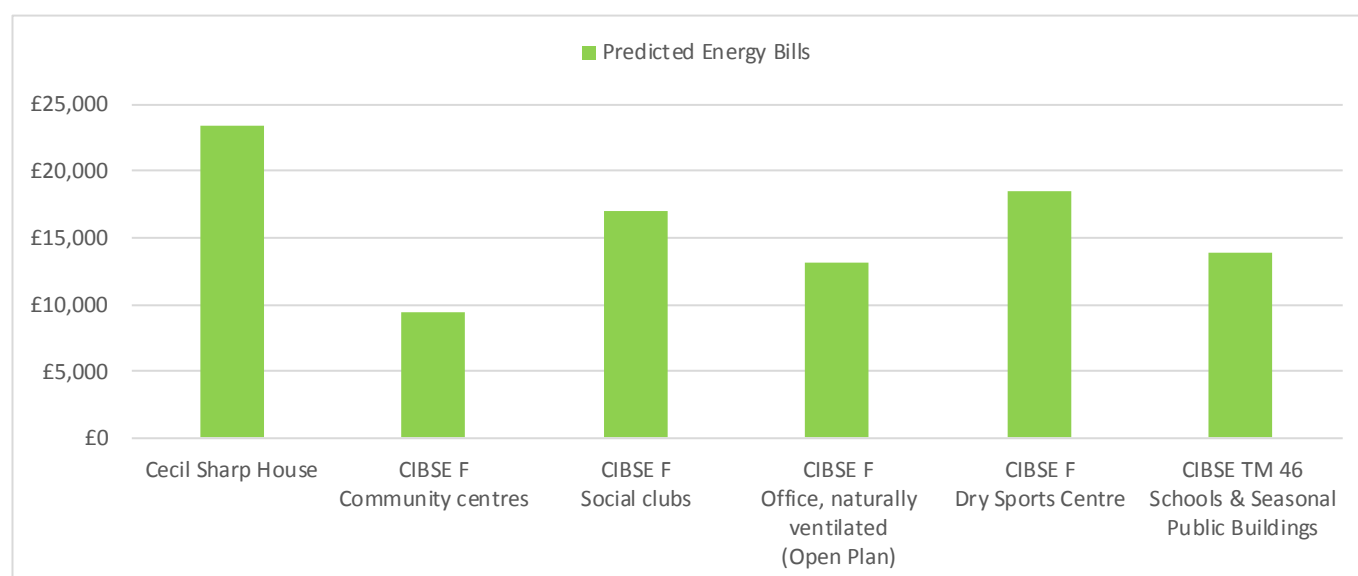
Figure 3: CIBSE F and CIBSE TM46 benchmark comparative energy bill costs

be commonly expected of an existing building with the same Net Internal Area (NIA) assuming 'Good Practice'⁷:

- £1.8k - £5.3k natural gas increase against benchmark.
- £3.1k - £10.6k electricity increase against benchmarks.
