A SCHEDULE OF CONDITION REPORT

For windows at

**Great Ormond Street Hospital (GOSH) for Children,
Level 6 Southwood Building Great Ormond Street London, WC1N 3JH**

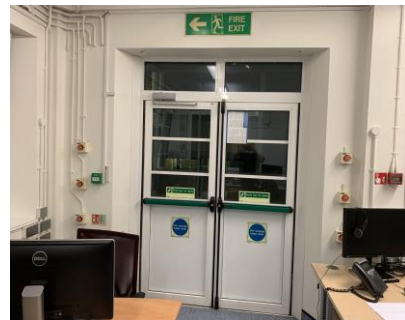
| REF | WINDOW | DESCRIPTION | GENERAL CONDITION | PHOTOS | | |
|---|---|---|--|---|--|--|
| NEW 01 | 81. | Existing double door with fanlight. | N/A | | | |

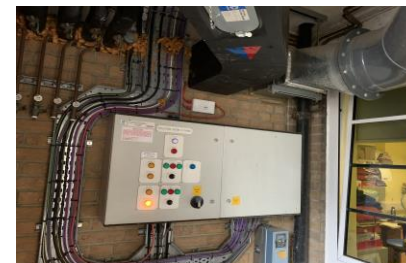
| REF | WINDOW | DESCRIPTION | GENERAL CONDITION | PHOTOS |
|---|---|---|---|---|
| NEW 07 | 18A. | Currently no window in this position. This wall location houses mechanical and electrical units, cables, pipes, and ducts. | N/A | |

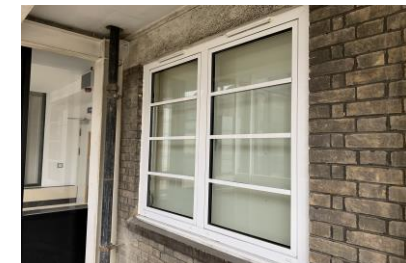
| REF | WINDOW | DESCRIPTION | GENERAL CONDITION | PHOTOS |
|---|---|---|---|---|
| EX-54 | 24A. | PPC Aluminium, double glazed casement window. 2 tilt and turn openers inwards. Lockable lever handles, and lower frame locks. | Decent serviceable condition with no significant defects noted. | |
