Arboricultural Report

Site: 7 Rosecroft Avenue London NW3 7QA

*Survey undertaken: Trees in relation to design, demolition and construction –
Recommendations.*

6th June 2019

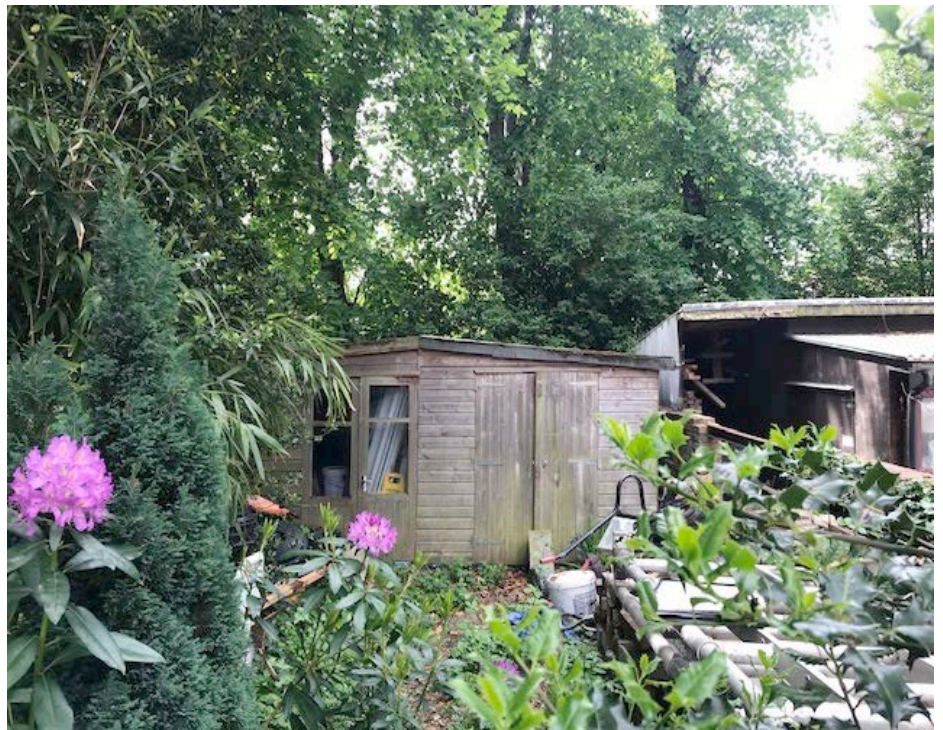
Photo1: Illustrates existing garden shed taken from rear garden aspect looking west. Outbuilding in rear garden of No.9 is to the right of photo.

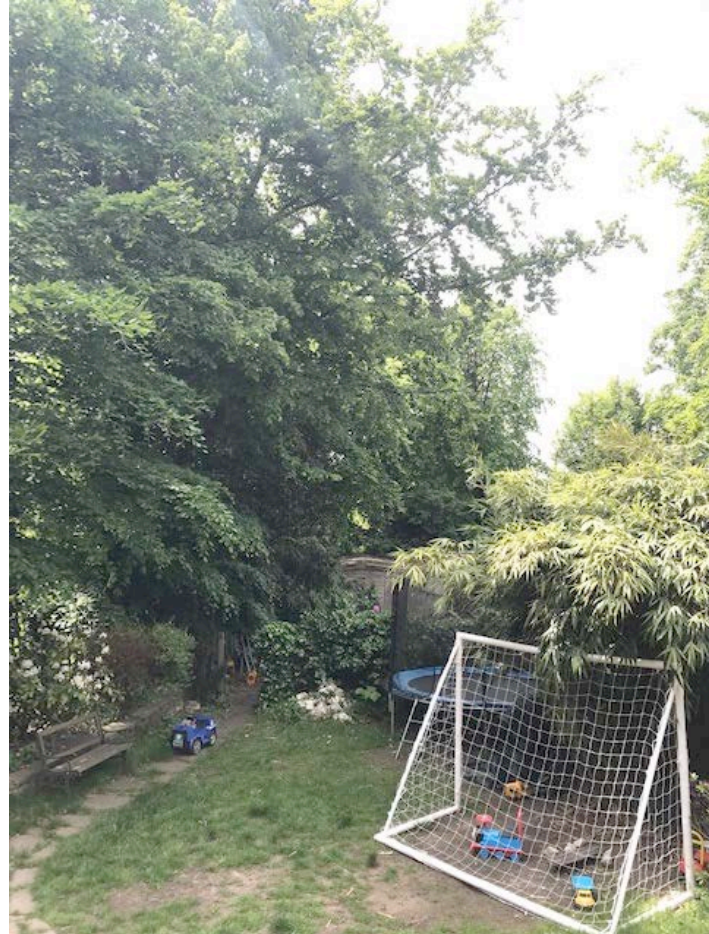
Photo 2: Access pathway through rear garden into bottom section via left hand side. Taken looking west. Mature trees dominate south boundary with overhanging canopies from T2, T3 & T4. Vegetation in right of photo is classified as bamboo, which does not require BS5837 protection.

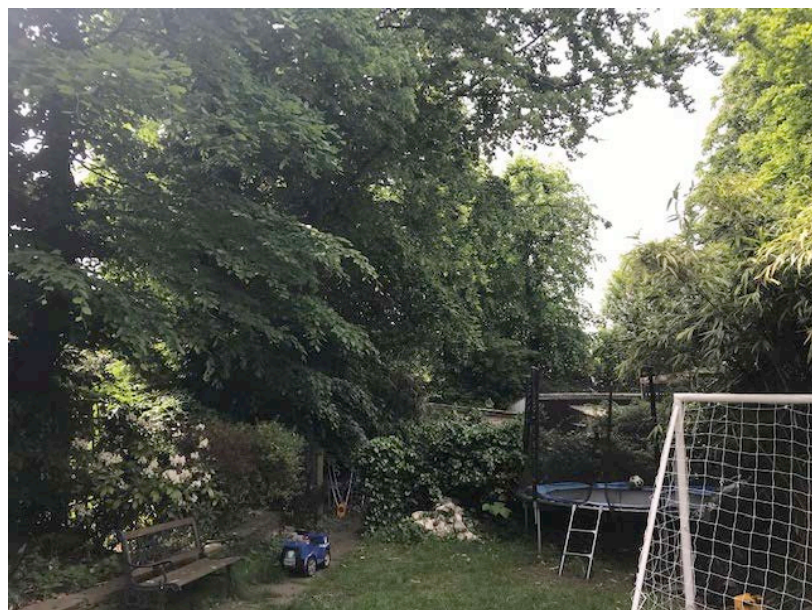
Photo 3: Taken from same position as photo 2 in landscape aspect to illustrate extent of vegetation visible from rear of property no.7.

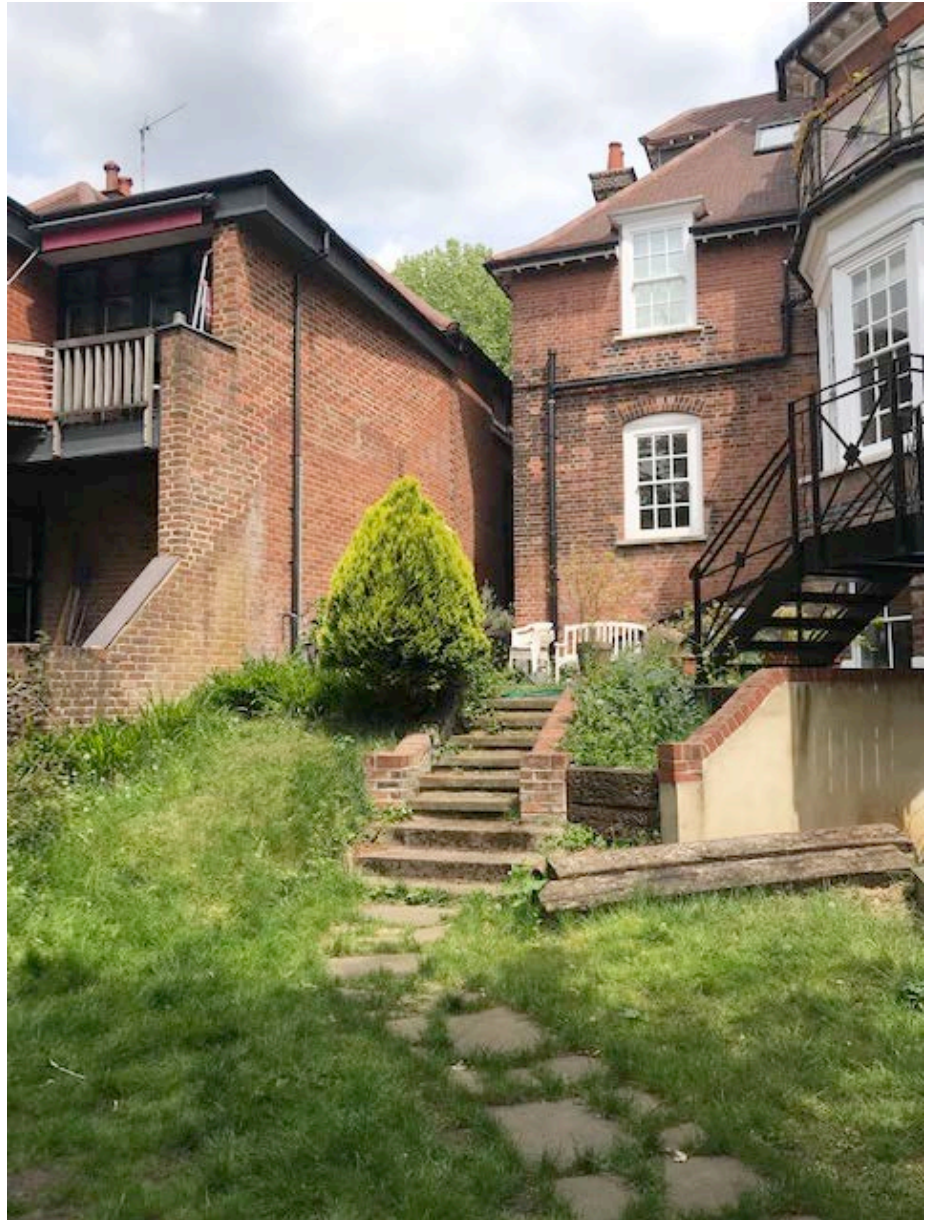
Photo 4: Taken facing east towards number 7 rear elevation and illustrates side access pathway to be used for extraction and delivery of materials (No access for plant or heavy machinery)

Side return in between number 9 and number 7 Rosecroft Avenue provides access for extraction and delivery of materials. Access is 800mm wide. This leads down steps into lower level of garden where it would be advisable to install ground protection matting to mitigate damage to communal areas of the rear garden. A communal driveway is present however a number of residential vehicles will require access and therefore should be kept free from construction traffic.

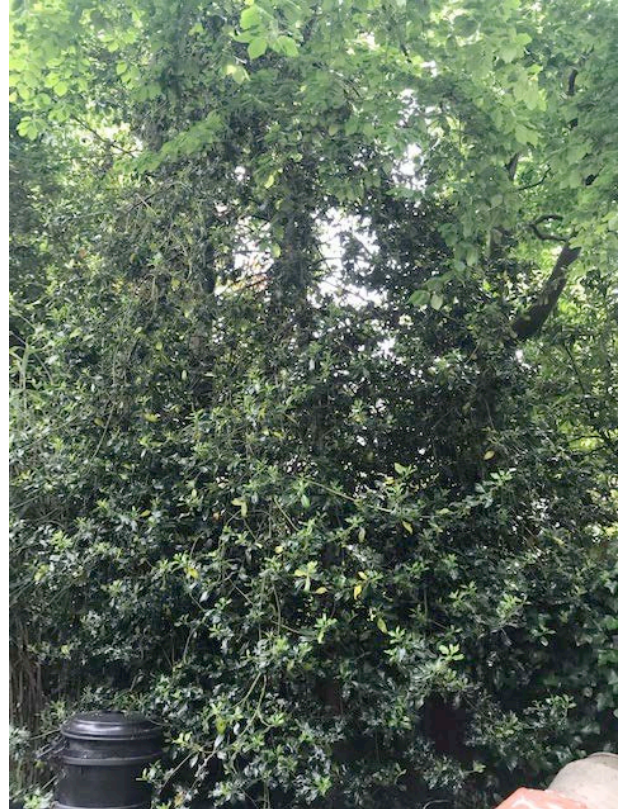
Photo 5: T5 - Holly, is incorporated within plans. Photo illustrates the tree growing under T4. The tree has a stipulation for removal, as it will cause future heavy shade within this area of the garden if incorporated within the proposed development.

T5 – Holly: Fell to ground level and remove stump.

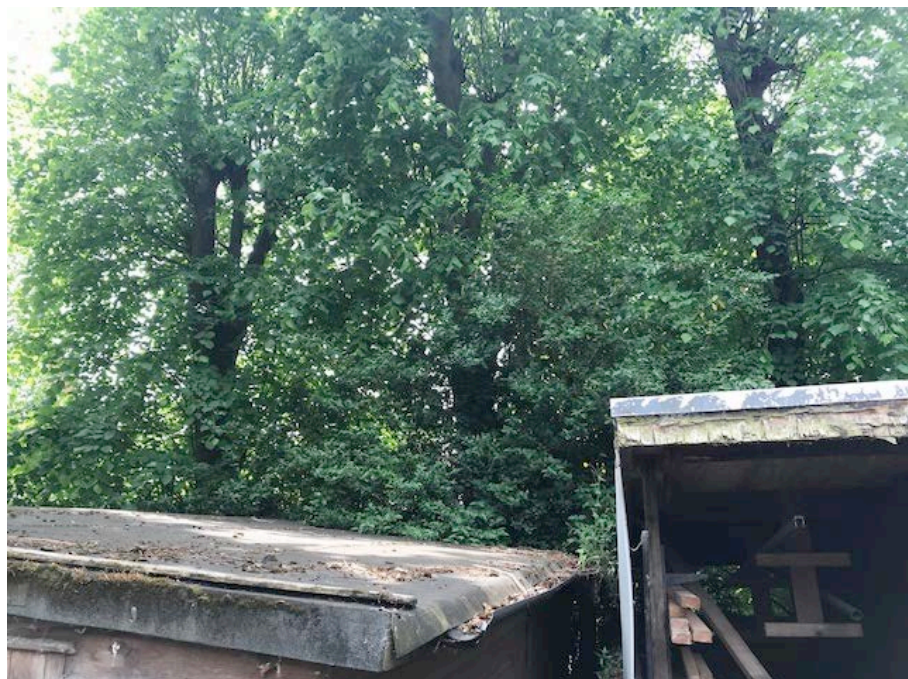
Photo 6: Three lime trees growing in the rear garden of 15 Hollycroft Avenue. The trees appear to be maintained on a regular basis. The ground level is approximately 1m lower than that of rear garden of no.7 Rosecroft therefore roots of these trees would not be impacted via compaction or excavation during the proposed development.

T7 – Lime: No work required. Soil and planting level is a minimum of 1m below that of the proposed development separated by double brick course retaining boundary wall. Roots will not extend into site.

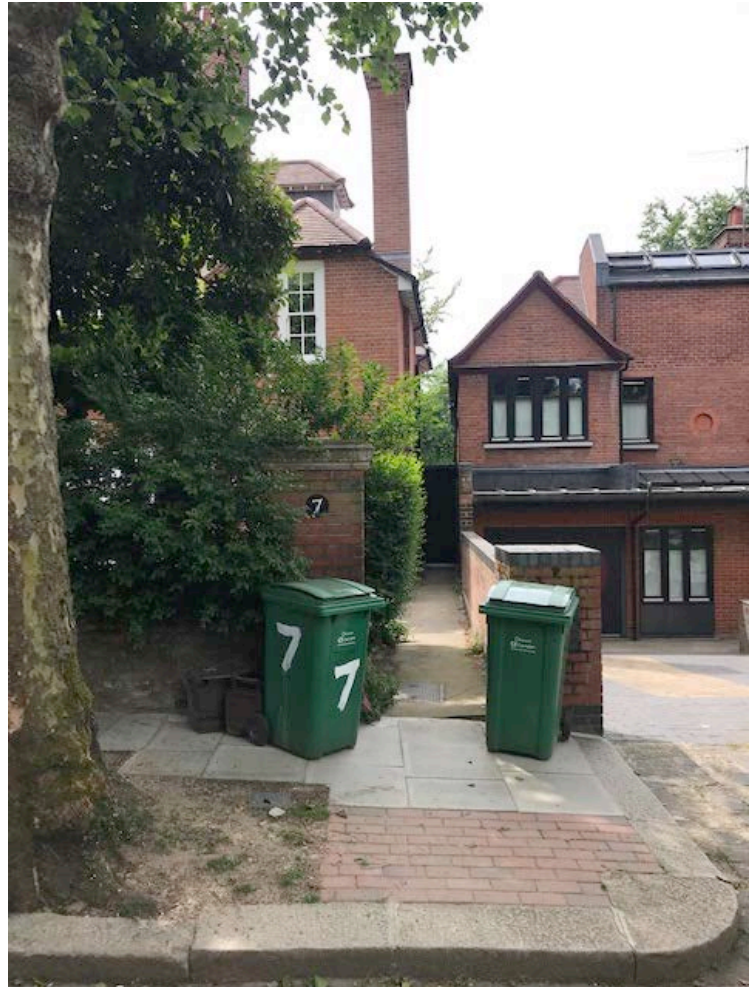
Photo 7: Depicts side access from street level leading down to rear garden. The street tree in the left of photo is a mature London Plane. On larger scale developments the stem of these trees are protected throughout the duration of works however for such a small scale project with no heavy machinery access nor concrete mixer delivery I would consider tree stem hoarding unnecessary.

Neither crane operations nor HIAB vehicle unloading should be carried out underneath the canopy or adjacent to the stem of the London Plane tree, which grows outside the side access to number 7 Rosecroft Avenue. Should Camden require protection of this street tree, a 3m high timber hoarding should be installed around the tree stem to mitigate mechanical damage throughout the proposed development.
